# ALARA in Repair of Reactor Vessel Flange Surface at Krško NPP, 2019

CONTRACTOR:  
**FRAMATOME**

# INTRODUCTION

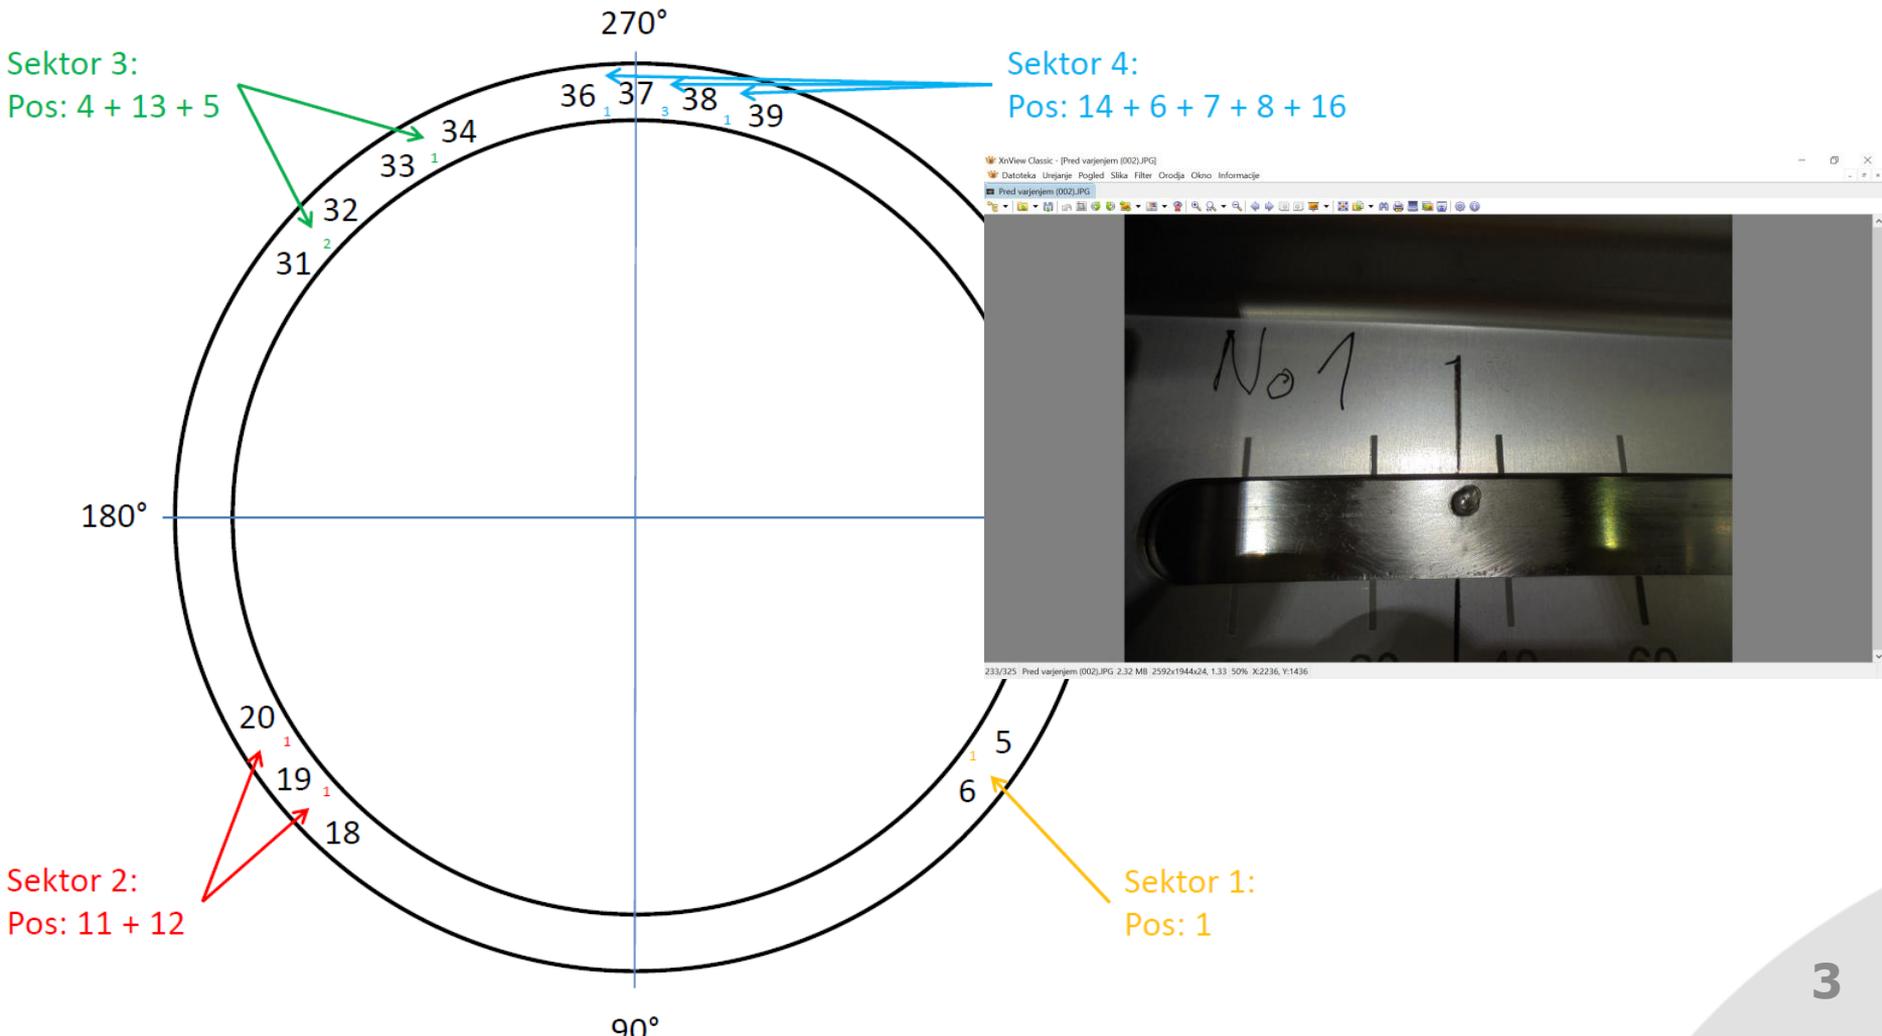
Location of the 11 indications on the RV Flange based on Laser Scanning measurement.

Final decision on repair: 11 + 5

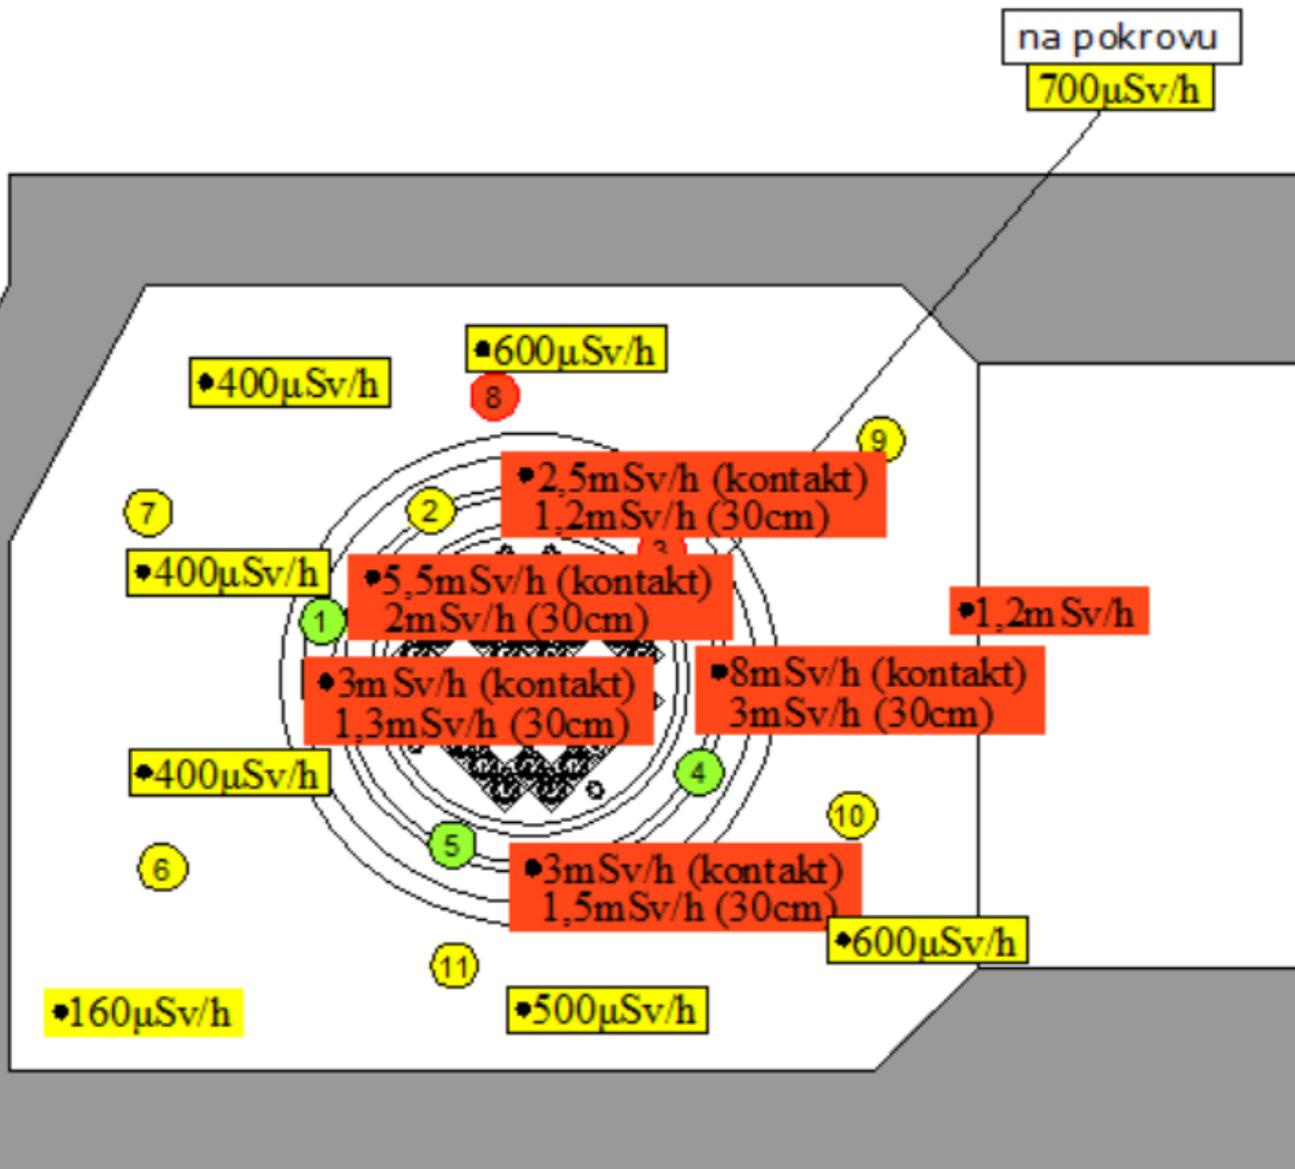
# RV FLANGE CONTACT DOSE RATES AND CONTAMINATION ON THE SMEARS RADIATION SURVEY AFTER INSTALLATION OF THE COVER

BRIS KONTAMINACIJE	
Bq/100 cm <sup>2</sup>	
8	6000 βγ tla 3 α R <sub>alfa</sub> =0,05%
3	5000 βγ prirobnica 2 α R <sub>alfa</sub> =0,04%
9	2600 βγ tla 0 α R <sub>alfa</sub> =0,00%
6	2500 βγ tla 0 α R <sub>alfa</sub> =0,00%
11	2000 βγ tla 0 α R <sub>alfa</sub> =0,00%
7	1000 βγ tla 0 α R <sub>alfa</sub> =0,00%
10	800 βγ tla 0 α R <sub>alfa</sub> =0,00%
2	800 βγ prirobnica 0 α R <sub>alfa</sub> =0,00%
4	300 βγ prirobnica 0 α R <sub>alfa</sub> =0,00%
5	300 βγ prirobnica 0 α R <sub>alfa</sub> =0,00%
1	100 βγ prirobnica 0 α R <sub>alfa</sub> =0,00%

Locations with dose rate > 0,5 mSv/h need lead blankets
