Radiological Investigation with the Polaris-H CZT Imaging Gamma Spectroscopy System at D. C. Cook

2015 ISOE NATC Alara Symposium

1. Hydrolase Event
2. Elevated Dose Rates in HTC
3. U1 W CTS Hx Elevated Dose Rates
4. Waste Gas System Elevated Dose Rates

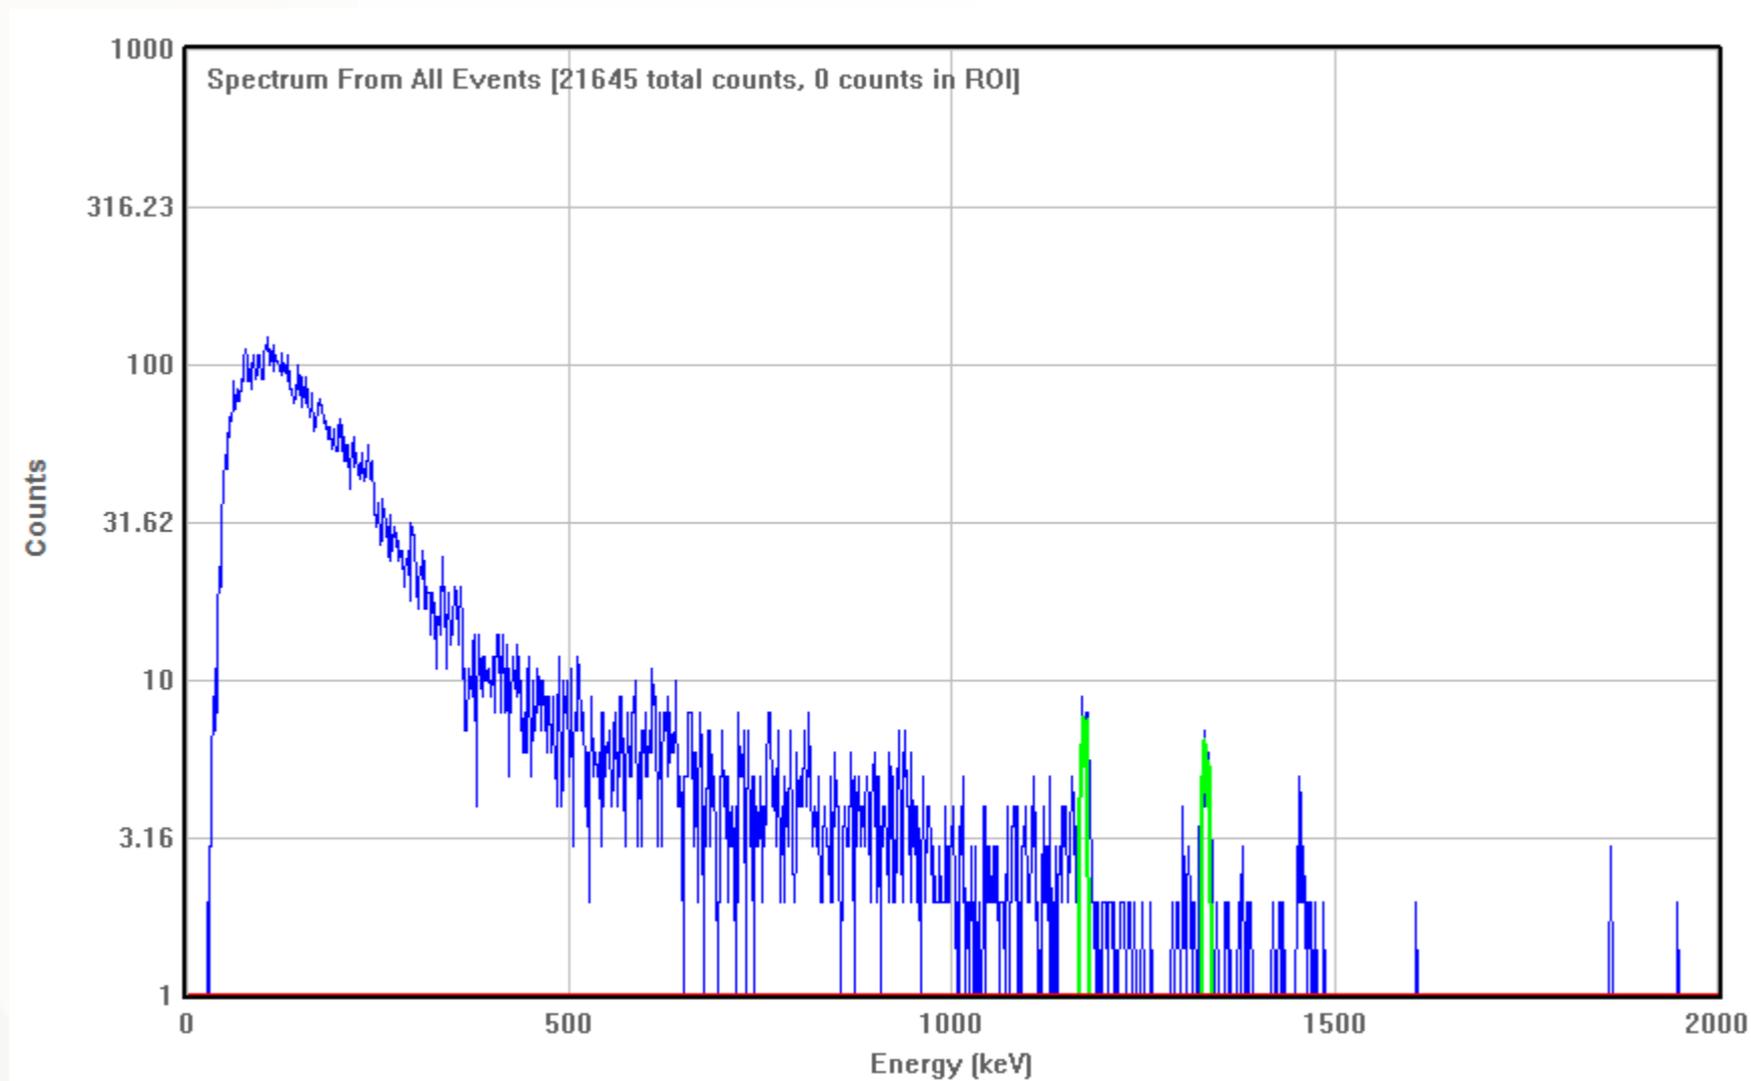
- Cause of internal contamination is the hose in the station drain line syphoned back into hydro pump.
- Check valve failed
- Hoses are usually drained on completion. Due to time constraints this did not happen.

Measurement date: 07-25-2014

Measurement time(s): 08:31:34 (45.5 min)

Selected Isotope(s): * Co-60

- New hydro pump was procured
- Now pump into 55 gallon drums then to station drains
- Procurement of in-line check valve to prevent backflow
- Plant DI water was sampled at the source to the hydrolaser and found to contain no contamination
- No activity from this event entered the plant DI system

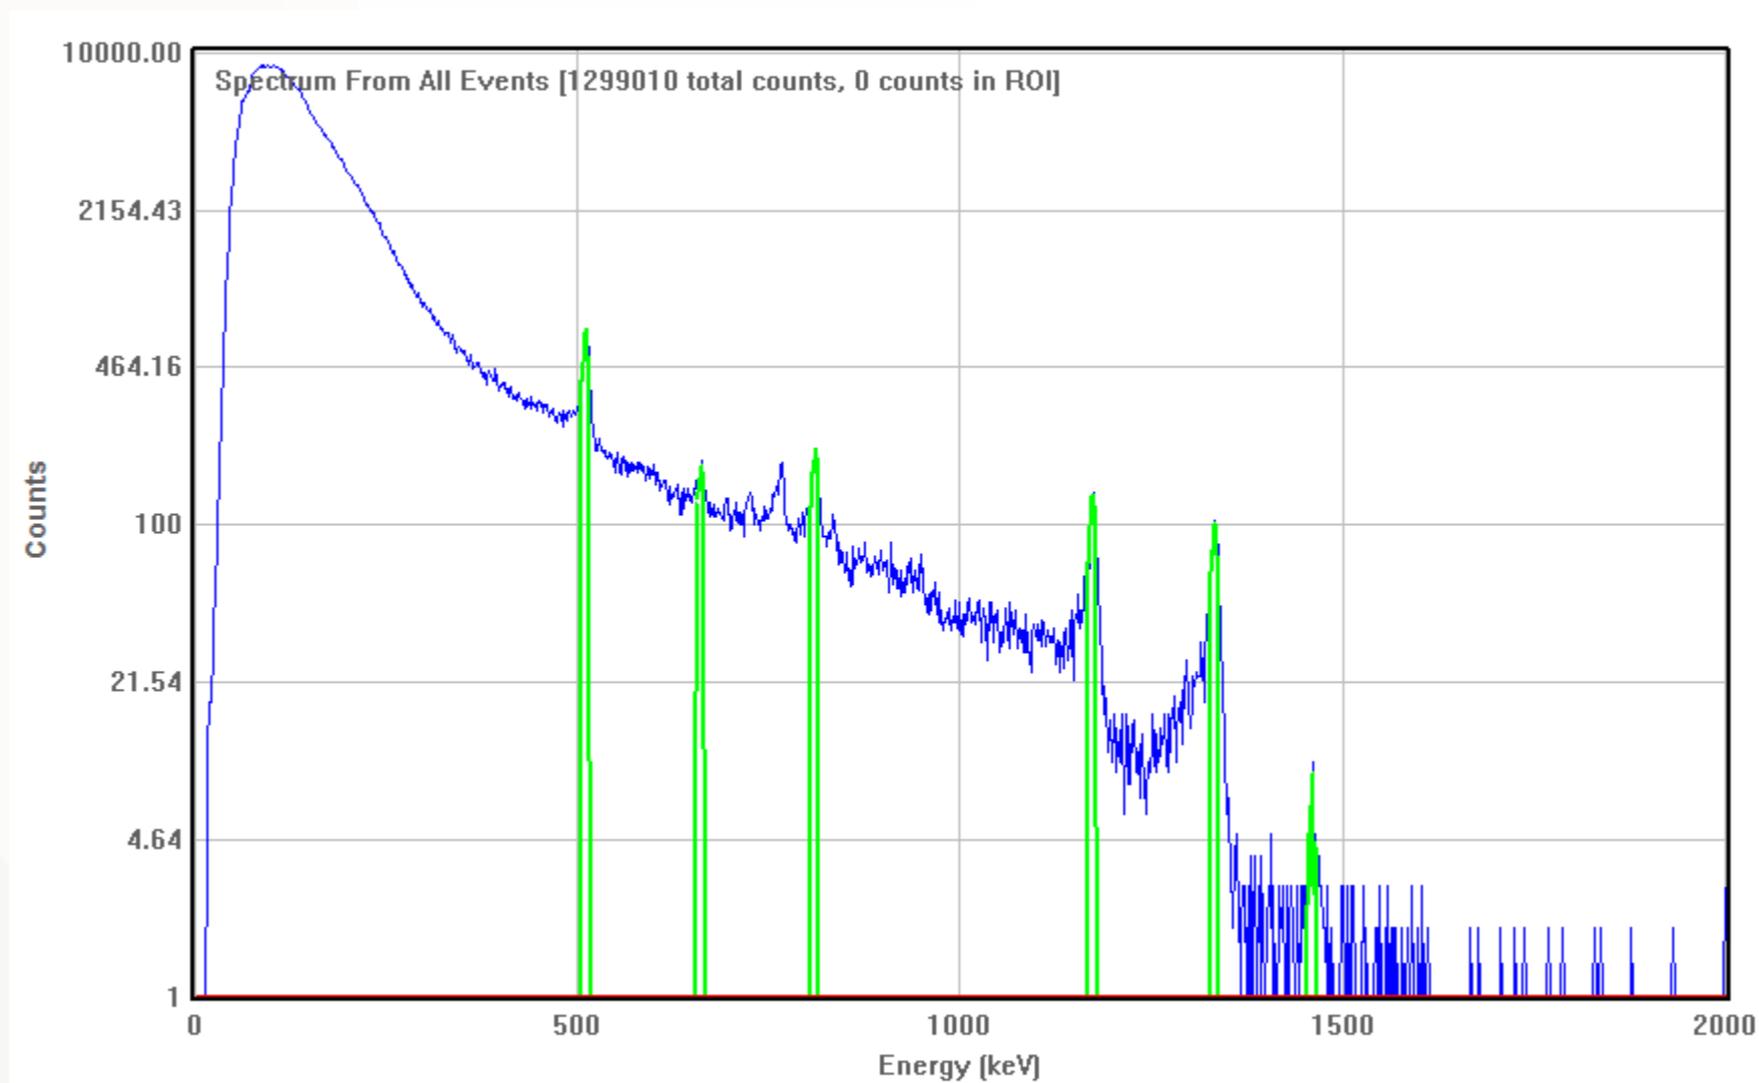
Co-58, Co-60, Nb-95, Zr-95 & Cs-137

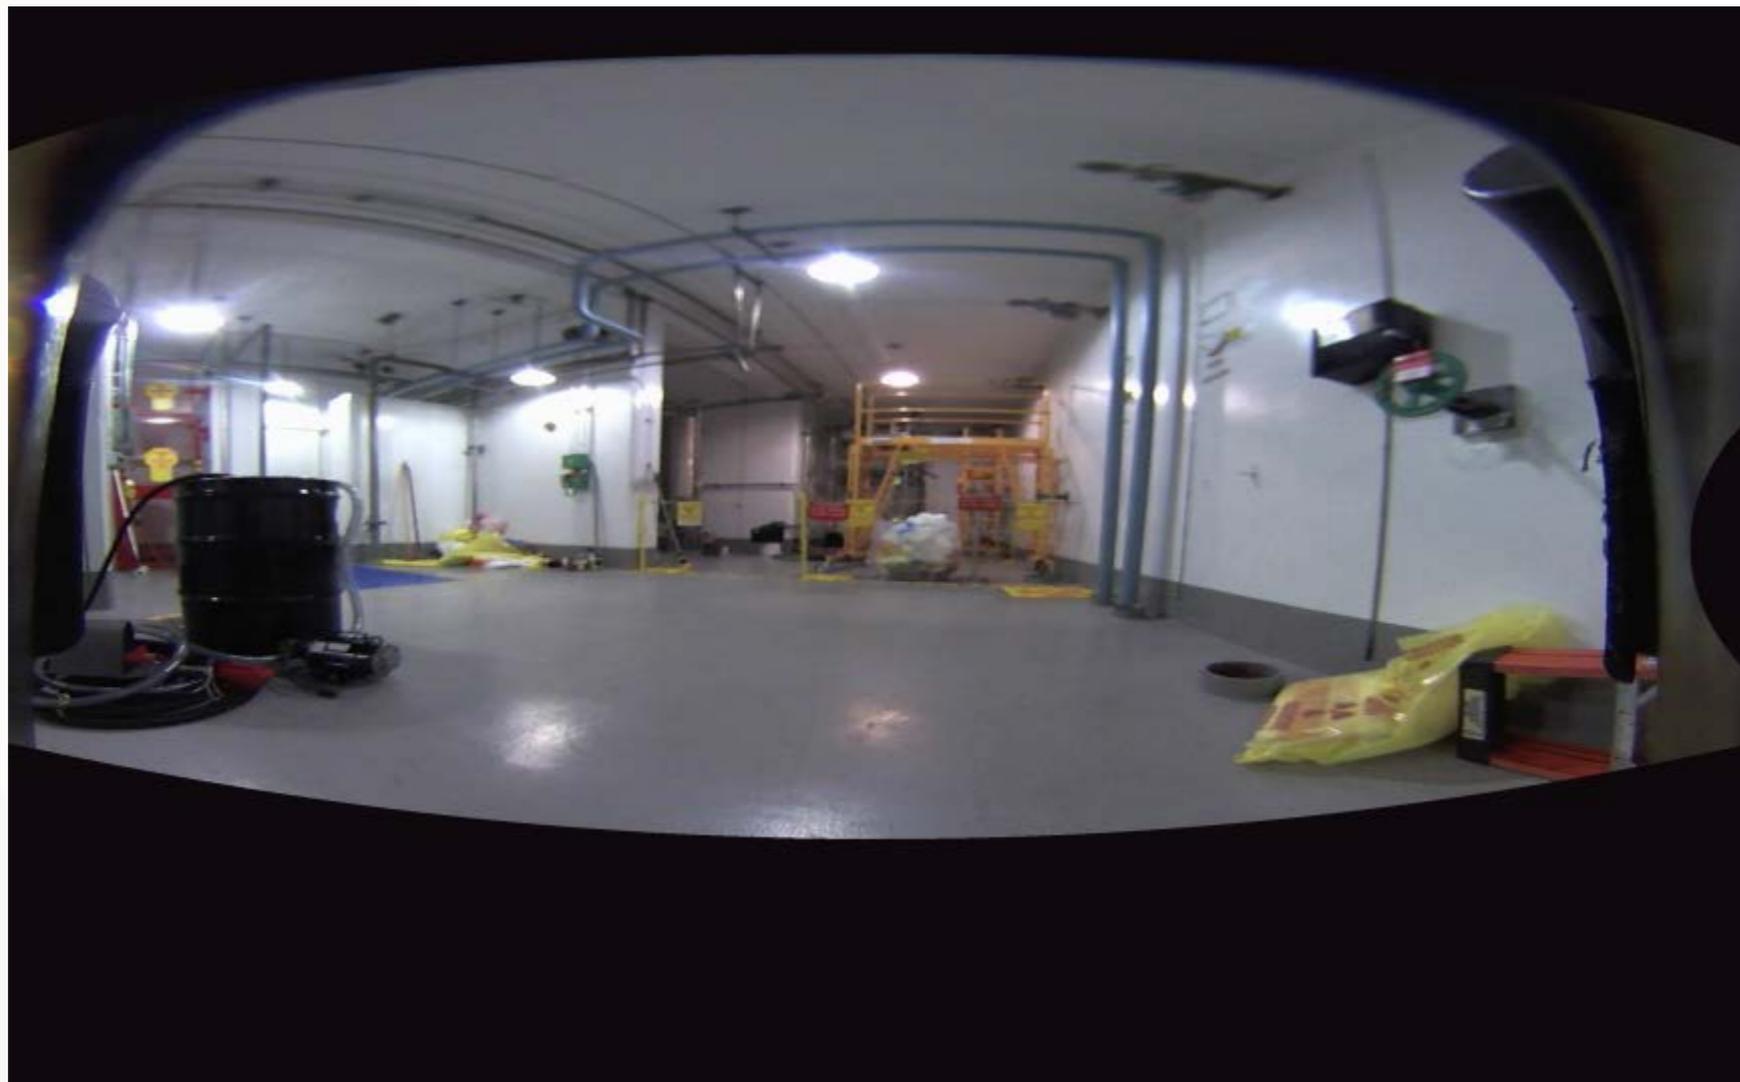
Measurement date: 07-30-2014

Measurement time(s): 10:53:30 (67.7 min)

Selected Isotope(s): Co-58, Co-60, Cs-137, Nb-95

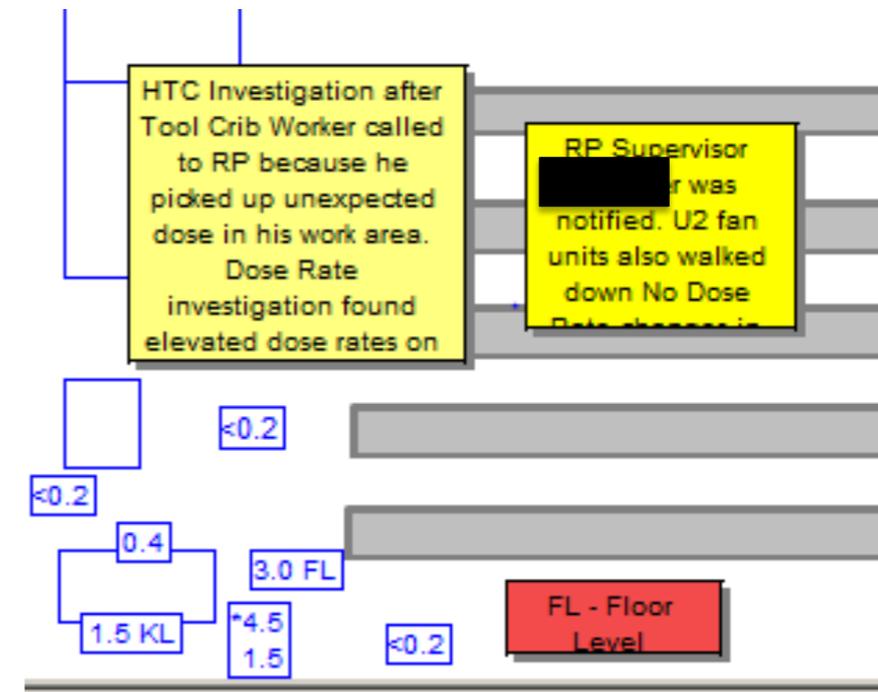
- On 9/10/14, a tool crib worker received an unexpected dose accumulation of 0.1 mRem while in the Hot Tool Crib (HTC).
- Dose was streaming through the floor covers from a drained demin vessel.

Elevated Dose Rates (9/10/14)

- HTC Workers Instructed to avoid whole area near floor cover
- Increased Importance to Refill Demin prior to refueling outage
- Filled Demin decreased Dose Rates

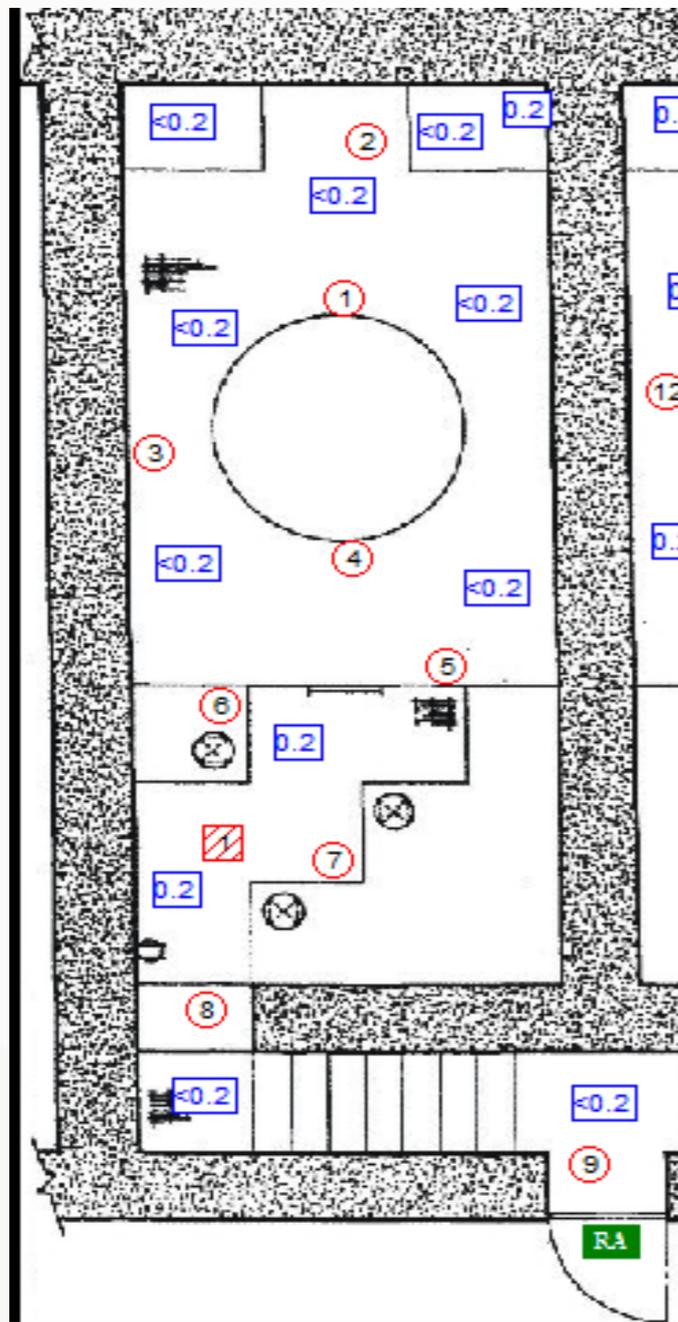
11/3 – Routine Survey

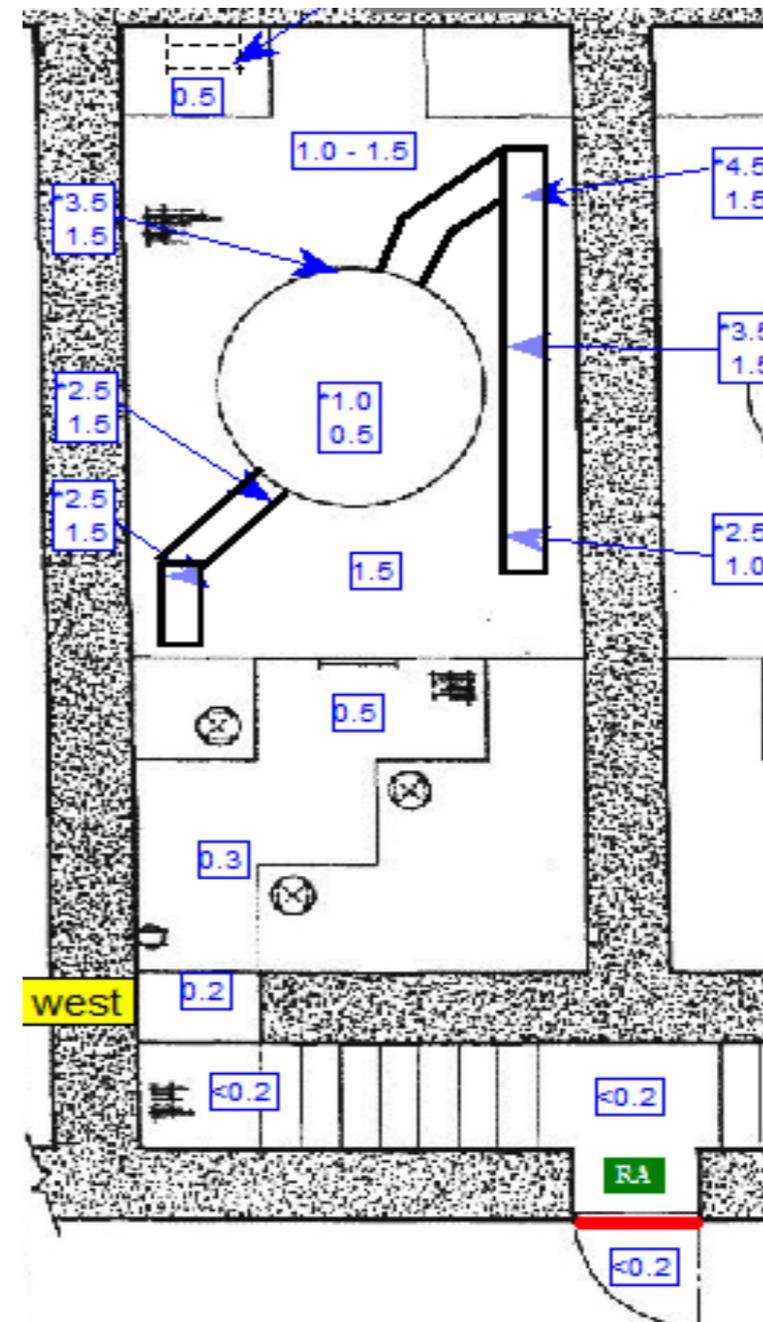
- On 11/6/2014 elevated dose rates were found in the U1 W Containment Spray (CTS) Hx Room
- Room already Radiation Area due to E CTS Hx

11/6 – Post Leak Testing

- Co-58 was primary contributor to increased dose rates.
- Dose Rates coming from line used for leak test
- Recommendation was made to decay system instead of flush system.

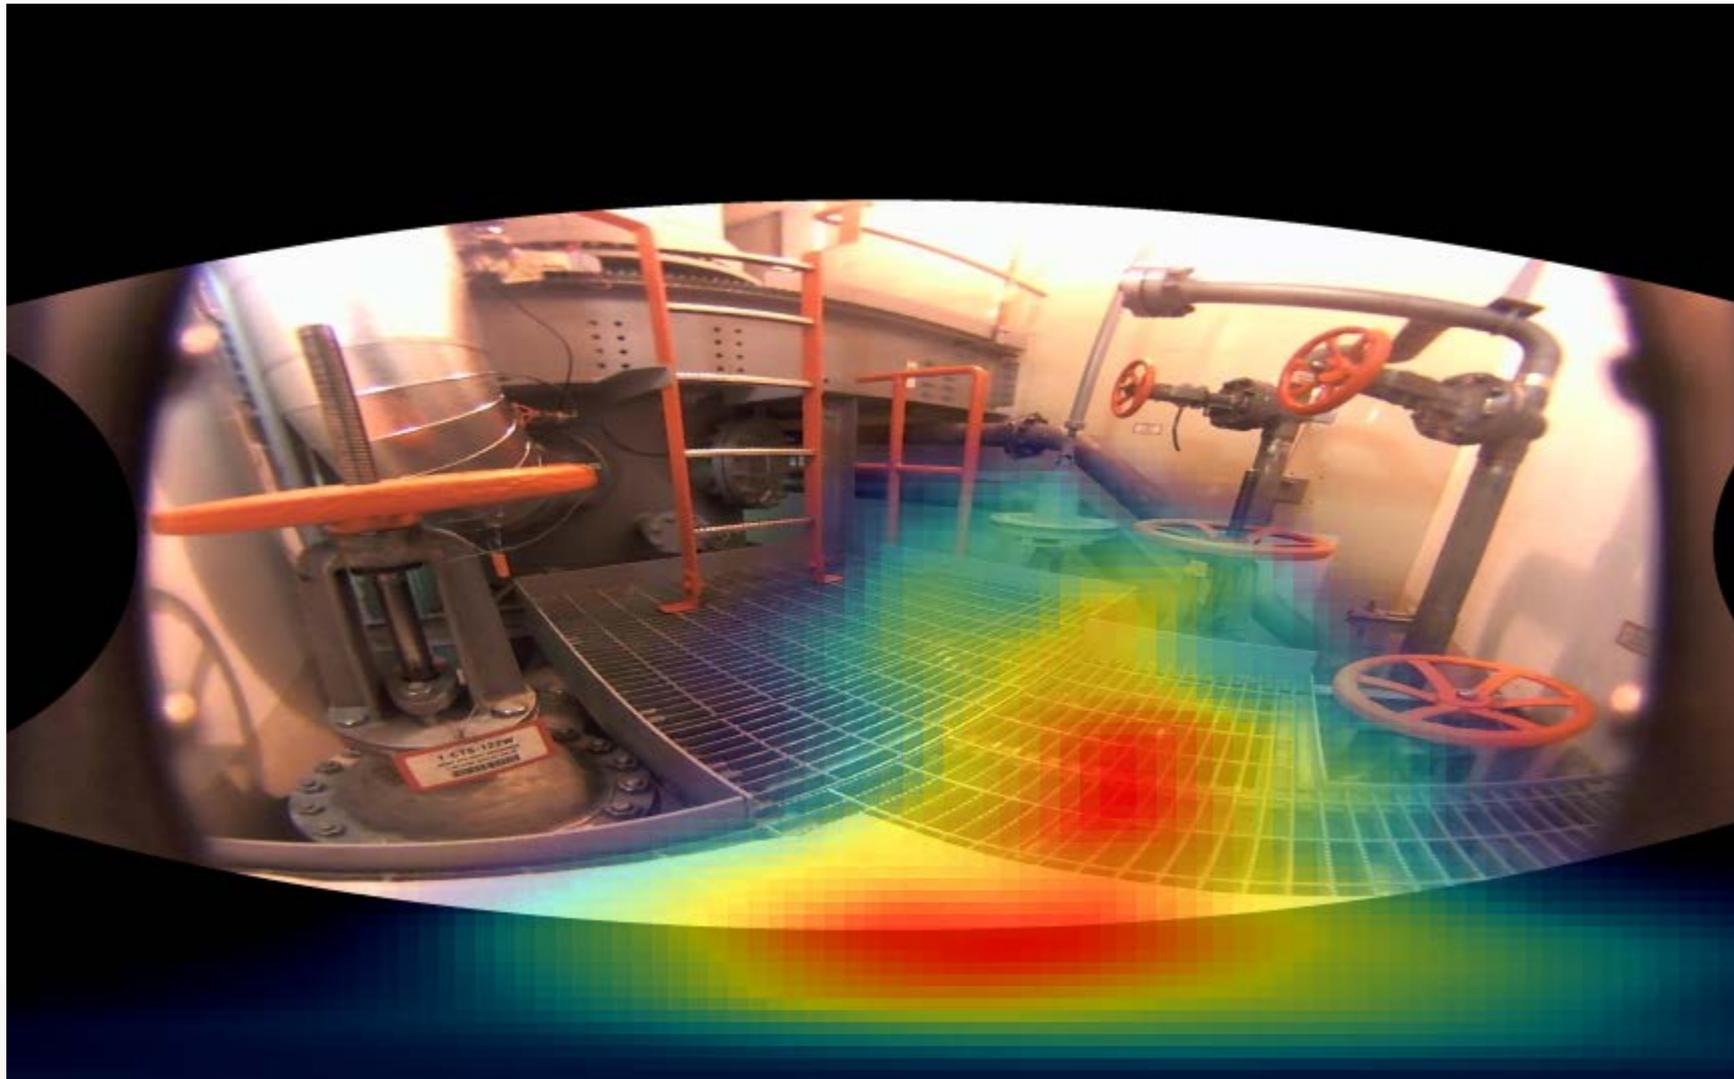
Co-58 – Highest contact DR: 2.1 mR/hr
– Highest GA DR: 0.5 mR/hr

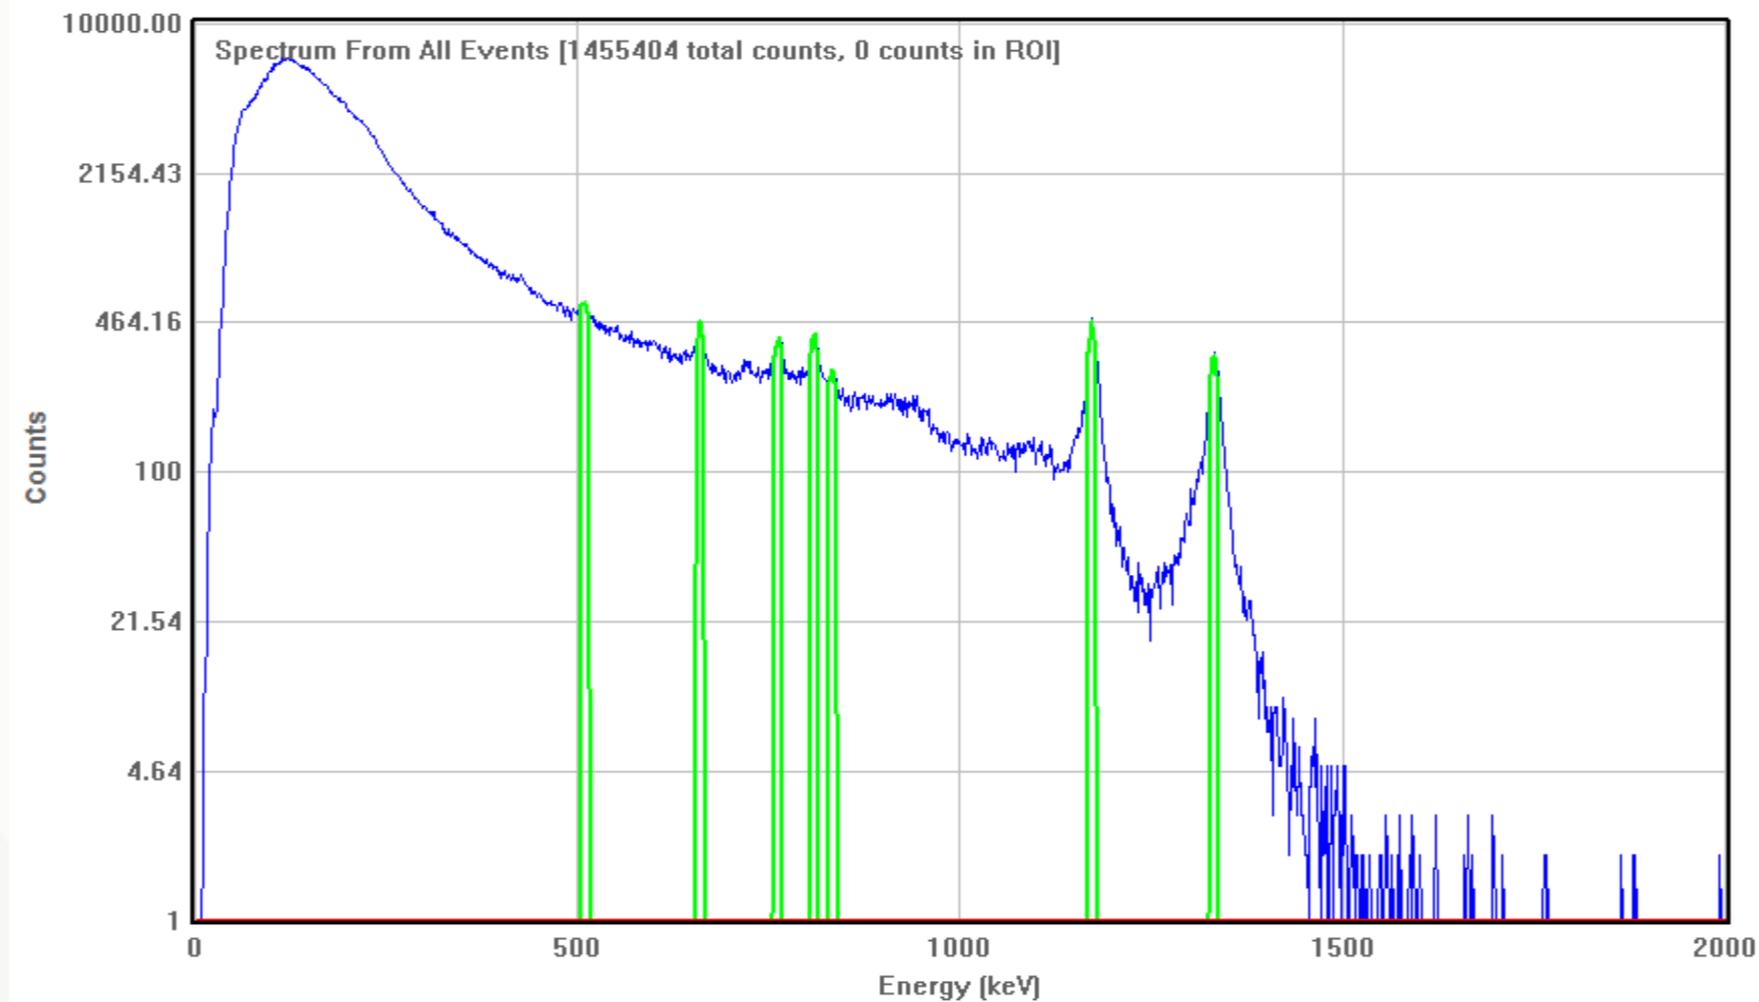
S. Waste Gas Compressor:

- Un-posted Radiation Area found on 609' in S. Waste Gas Compressor Room during routine surveys
- The small heat exchanger on gas compressor found reading 30 mR/hr on contact and 8 mR/hr at 30 cm.

Co-58, Co-60, Cs-137, Mn-54, Nb-95

Czt: 1mR/hr. Ro20 @ CZT: 0.8mR/hr

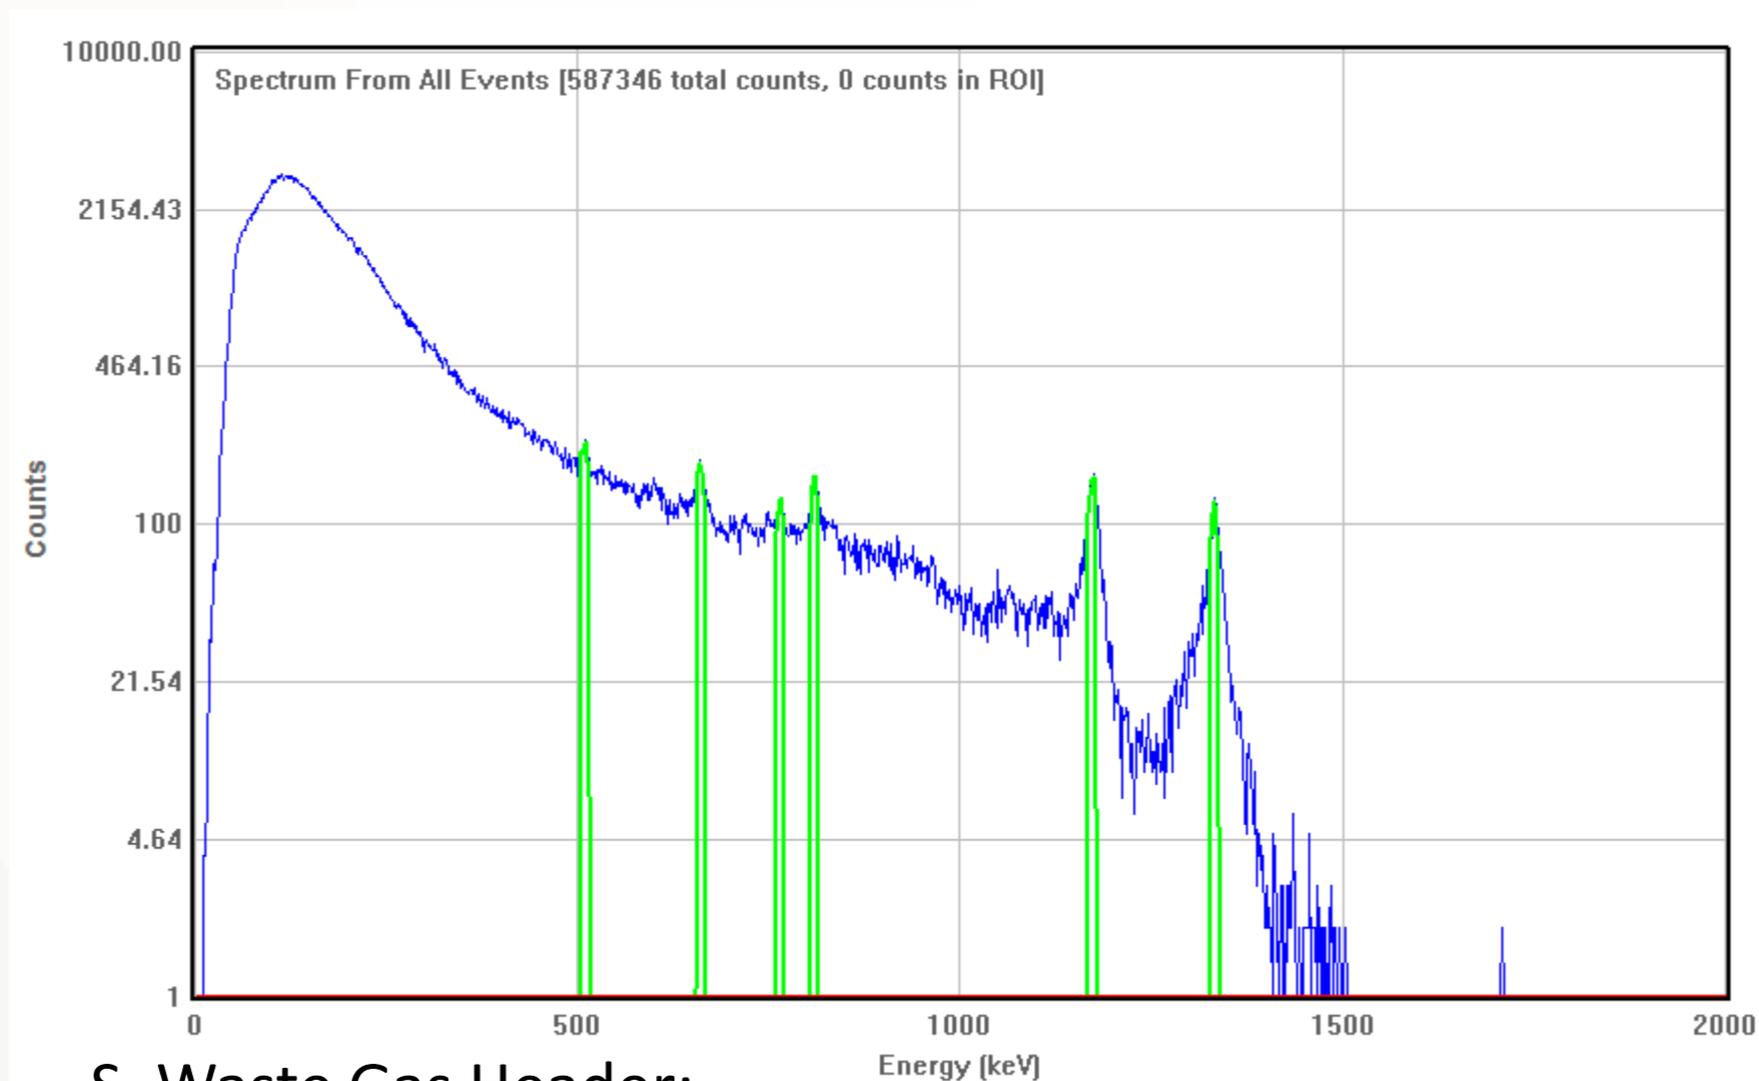
S. Waste Gas Header:
Co-58, Co-60, Cs-137, Nb-95

- When the spent resin storage tank was filled water solid due to clogged resin, the vent path allowed water to enter the plant vent header.
- This water cleared out particles entrained in the piping and flowed down to the drain tank.
- The gas / vapor with the radioactive particles was drawn into the south compressor suction.
