Inside and outside – A review of the RCA boundary

**Dr. Ivo Stalder,
RP Department**

**Andreas Ritter
Leibstadt NPP**

Kernkraftwerk Leibstadt

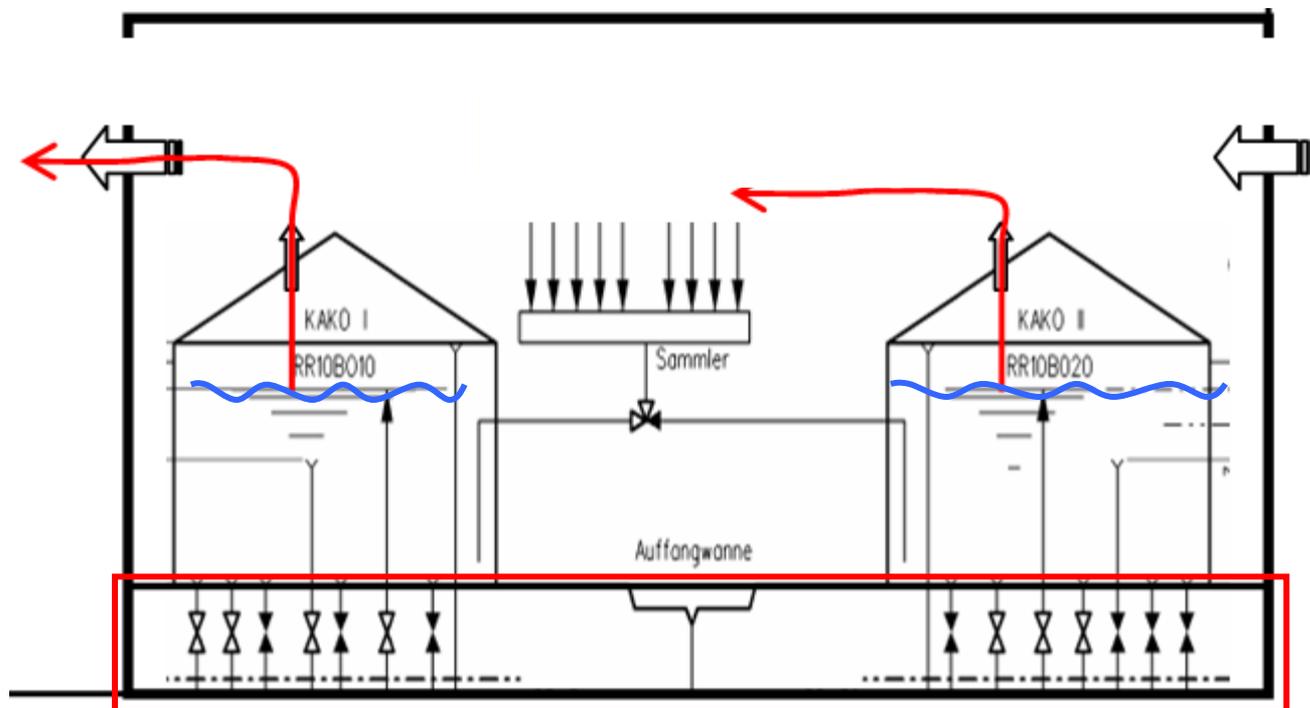
Initial event 2: Cold condensate storage tank vent

- Cold condensate containing I-131 after fuel failures
- Changes in water level push Iodine-air out of tank vents
- Contamination found outside RCA

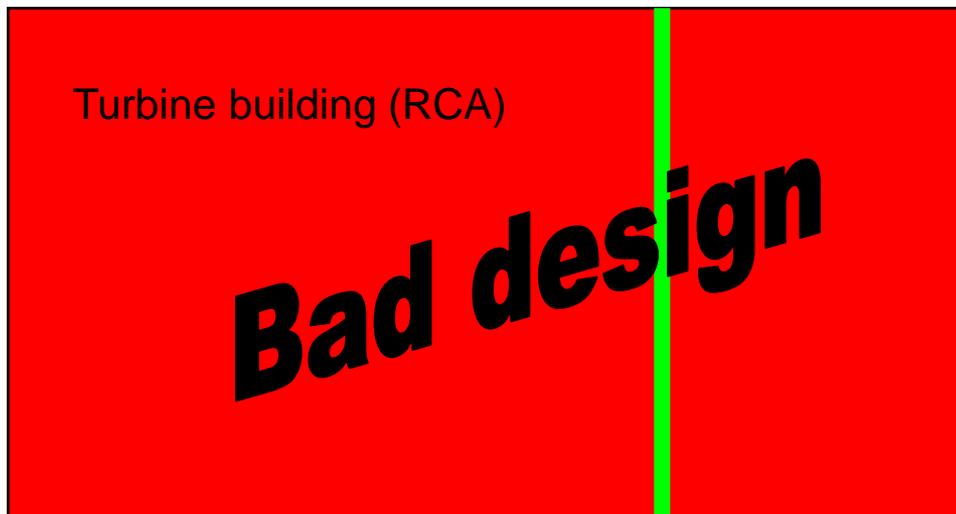
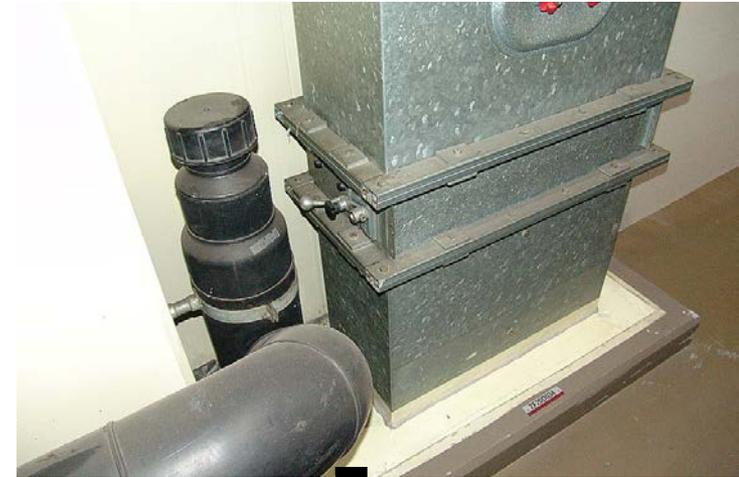
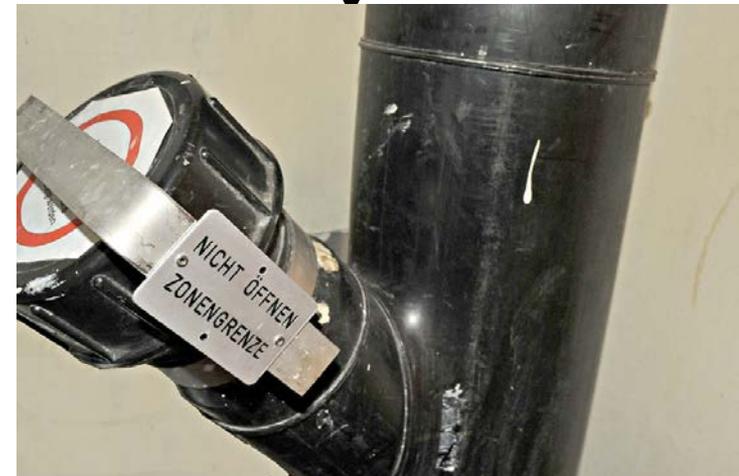
Penetrations: Turbine building findings

- A total of 205 penetrations were evaluated
- Rainwater drain lines crossing the RCA

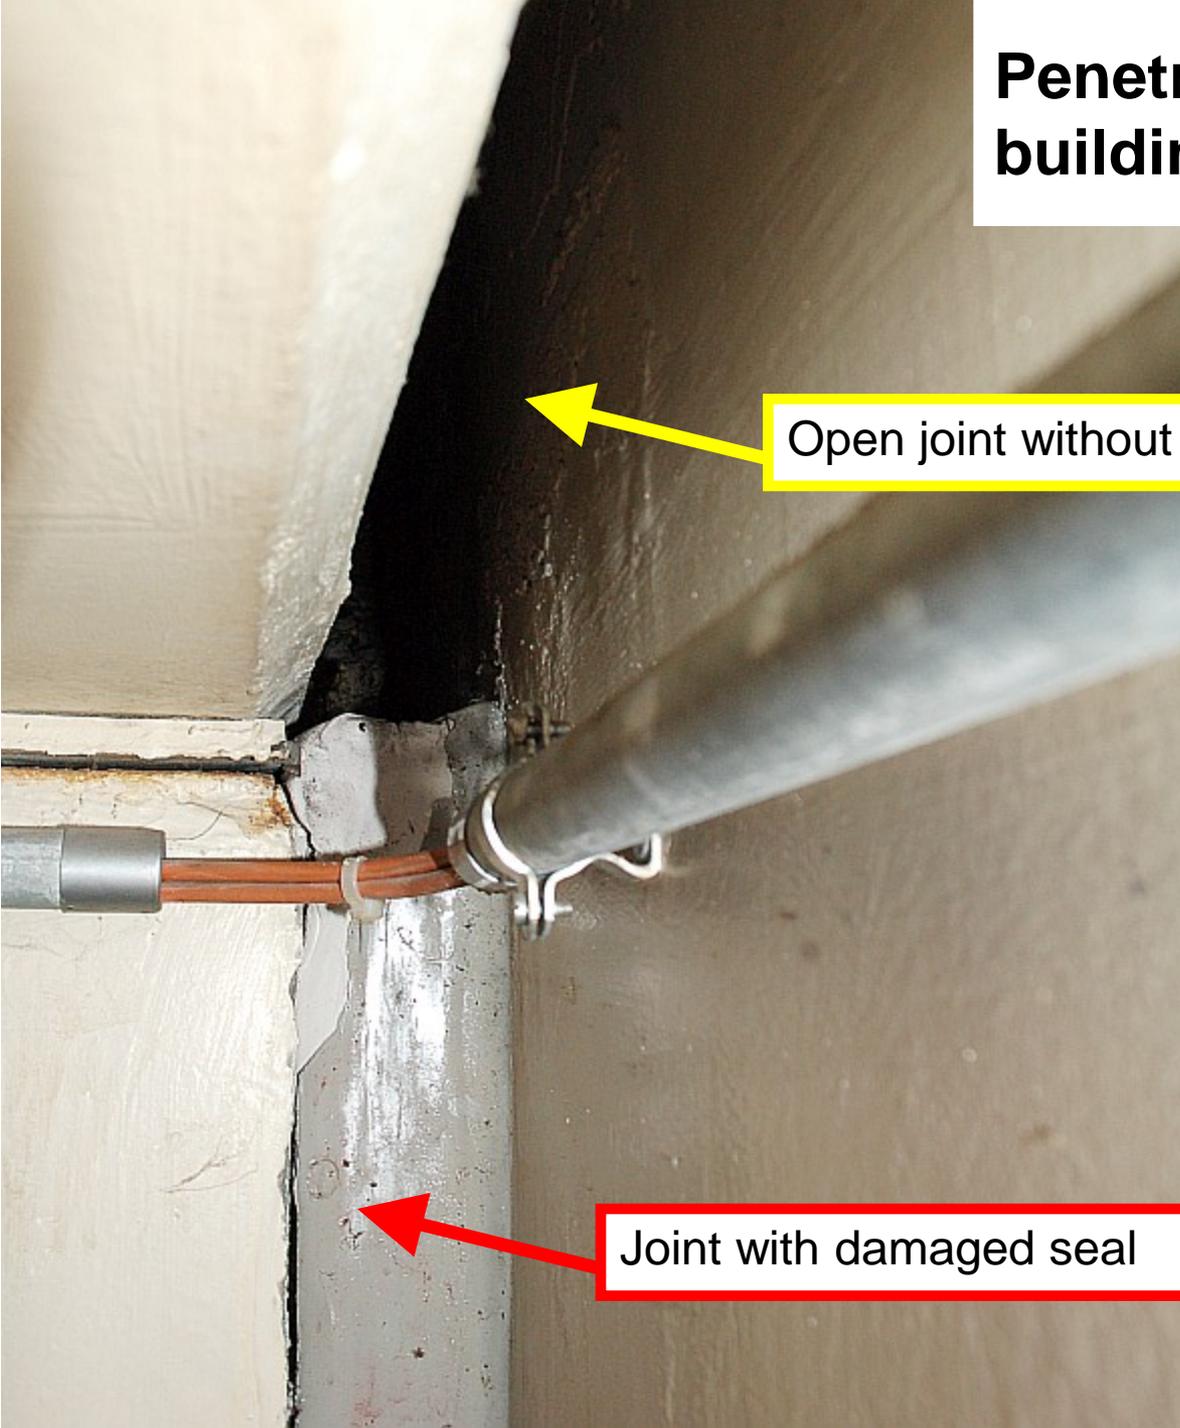
Penetrations: joint between buildings without seal

Open joint without seal

Joint with damaged seal

- Due to the negative pressure inside RCA an inward flow could be demonstrated
- Joints were repaired

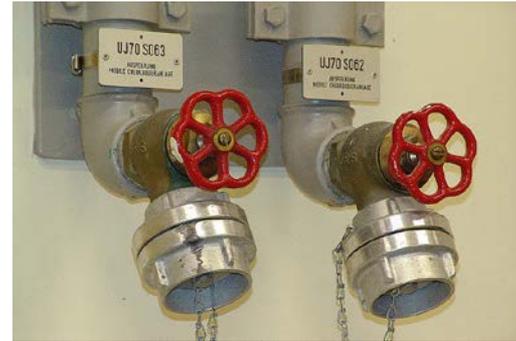
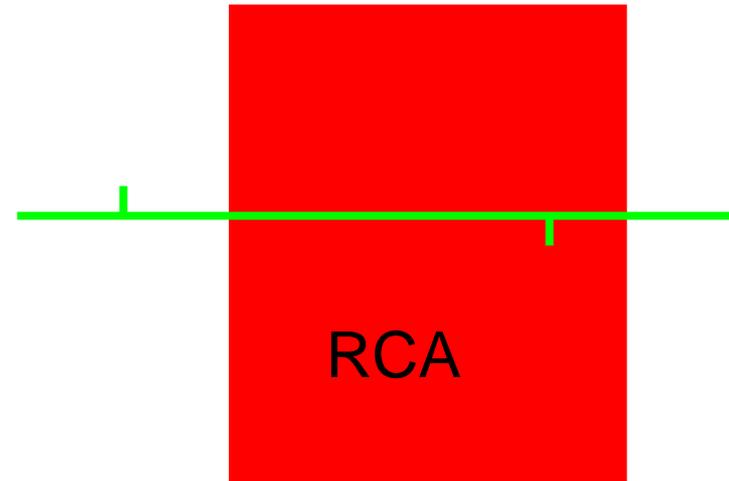
Interfaces: Findings in the turbine building

- **Make up water outlets:**

- Coupling fits to various types of hoses
- 1. Barrier = pressure difference
- 2. Barrier = non existent
- Possibility to inject contaminated water into the make up water system
- Solution: Additional check valve for each outlet

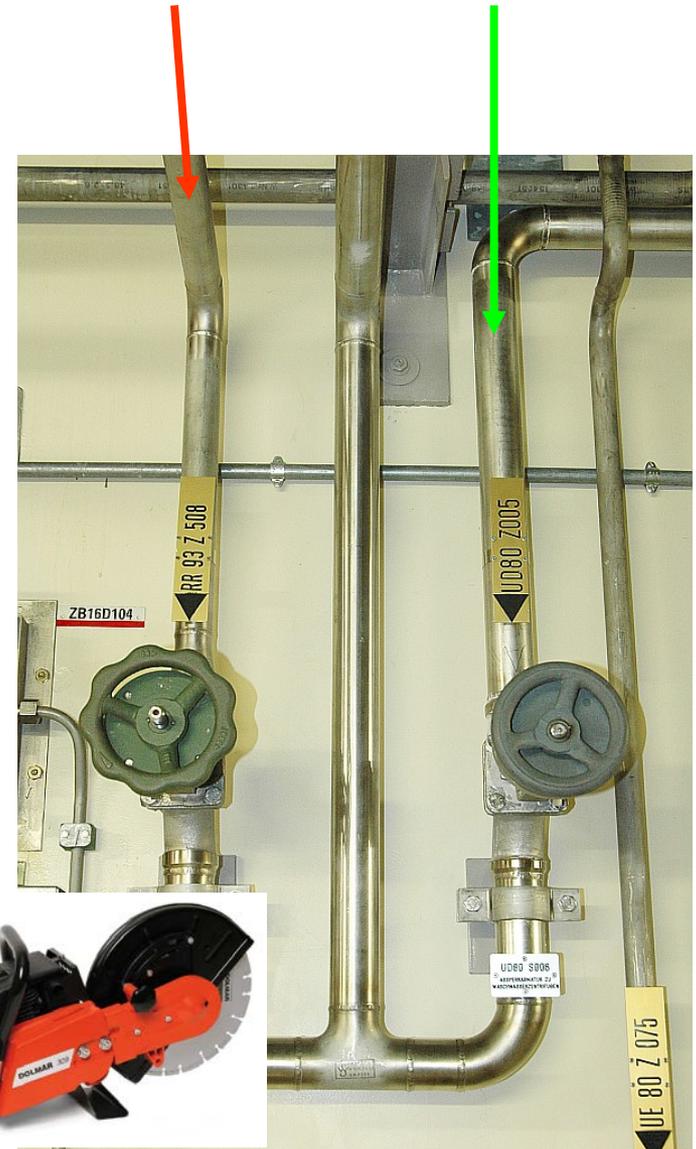
Interfaces: Findings in the Radwaste

- **Interface between cold condensate (radioactive) and make up water (non-radioactive):**
 - 1. barrier = non existent (similar system pressure)
 - 2. barrier = non existent
- **Valves are not considered to be a barrier, because their position can be „open“ or „closed“**

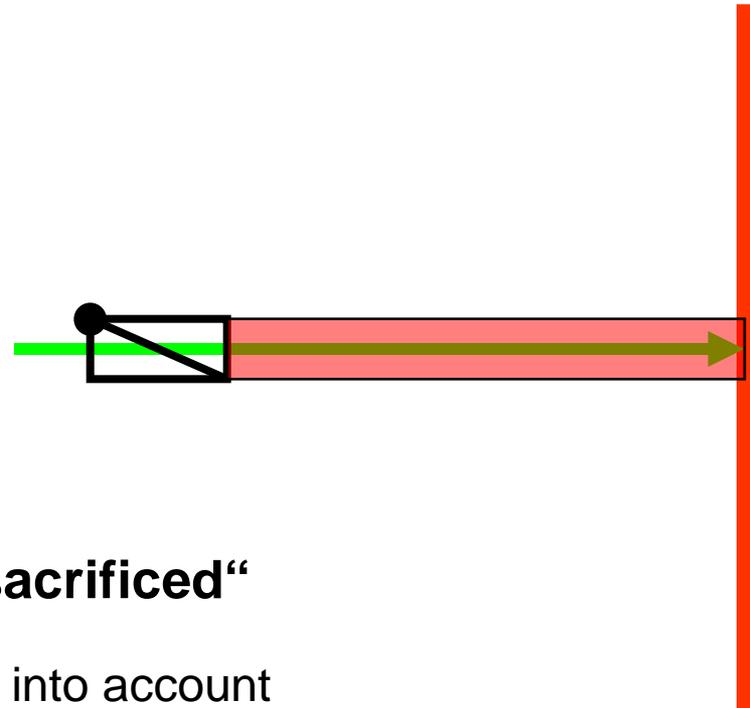
Interfaces: Special situations

- **Some parts of systems can't be protected with reasonable effort**
 - ⊗ Drinking water system inside Hot Lab
 - ⊗ Water supply of Hot Laundry
 - ⊗ Parts of Auxiliary steam system

- **Those parts of systems are „sacrificed“**
 - ⊗ Possible contamination is taken into account
 - ⊗ Documentation for future modifications and decommissioning

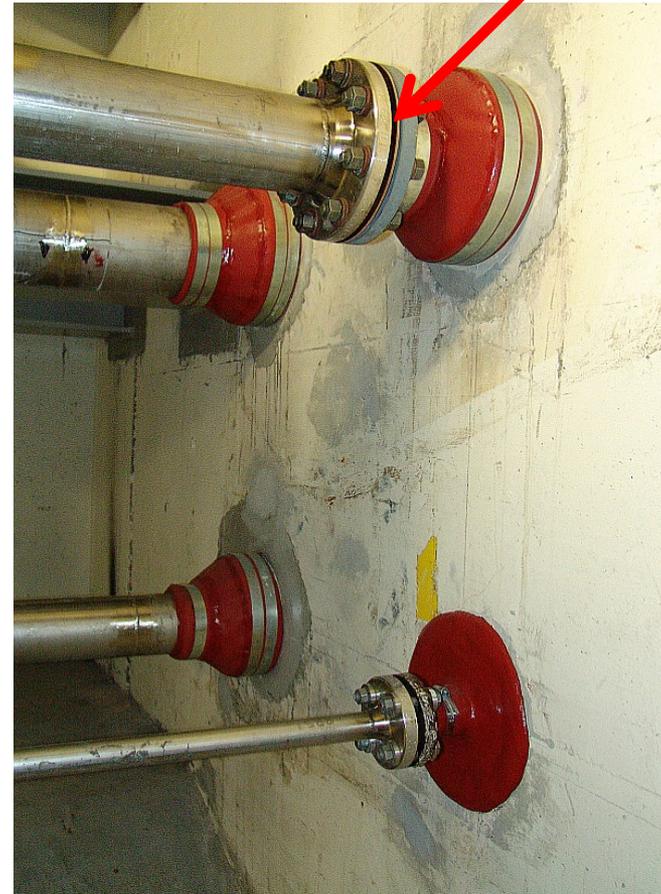
The next significant plant modification

- Piping with radioactive content outside RCA
- Flange = Risk for leakage
- Drain to river
- Solution: reroute ventilation and drain discharge towards RCA
