ALARA in Practice

Reactor internal parts repair at the Temelín NPP

- Temelín NPP, Unit 2 refuelling outage 2011
- damage of the reactor inner parts:
 - block of protective tubes – bottom plate surface
 - core barrel – inner and outer surface
 - reactor vessel dividing ring – inner surface
- cause: mutual seizing with foreign objects (stainless steel pin, nut)
- damage: scratches, grooves, pressure marks

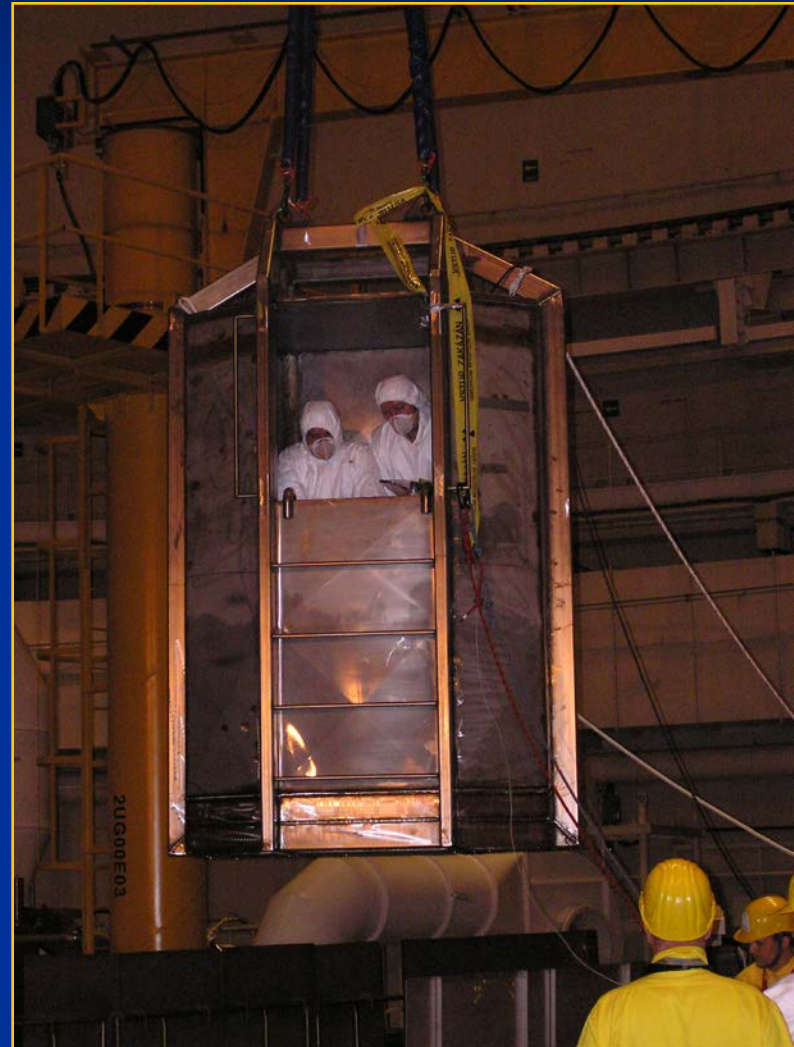
Core barrel repair preparation – inner surface

- the gondola
 - mass 7360 kg
 - max. load 300 kg
 - lead shielding 5 cm / 10 cm bottom
 - additional shielding
 - Radshield plate

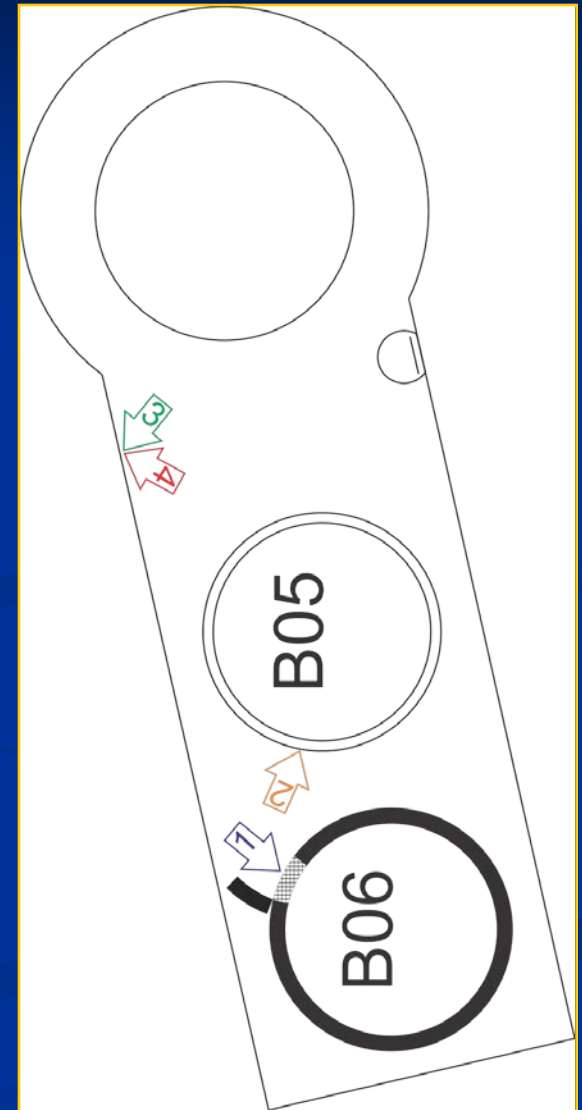
Block of protective tubes

- dose rate measurement
 - 4 top of the ladder
45 mSv/h
 - 3 mid of the ladder
87 mSv/h
 - 2 core barrel well (150 cm)
236 mSv/h
 - 1 supporting ring window
244 mSv/h (max 2682 mSv/h)
