Ringhals - Operational Experience on Silver and Antimony related to doses

ISOE International Symposium Brussels
1-3 June 2016
Madelene Johansson, Ringhals NPP

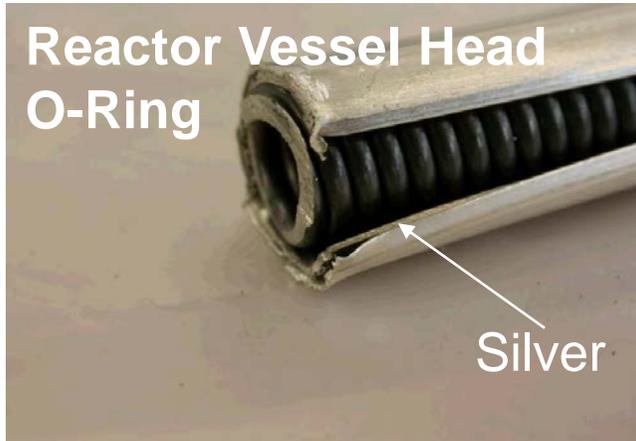
Refuel Outage Unit 3 in 2010

A piece from the O-ring was found with the weight of 0,15 gram. It could not alone had caused the elevated levels of silver in the coolant.

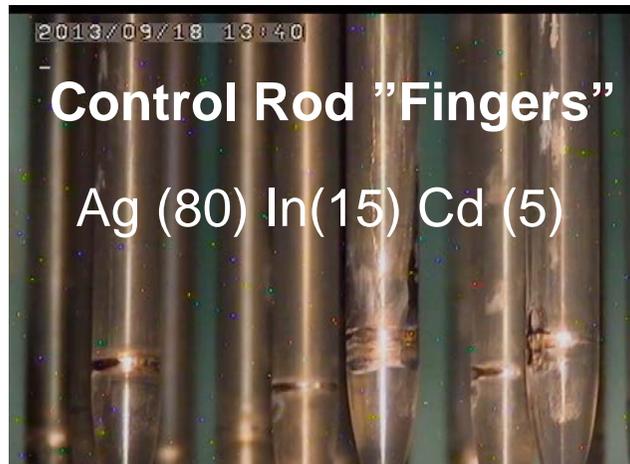
Refuel Outage Unit 3 in 2013

7 of 48 inspected control rods showed axial cracks on one or more fingers.

More likely the source

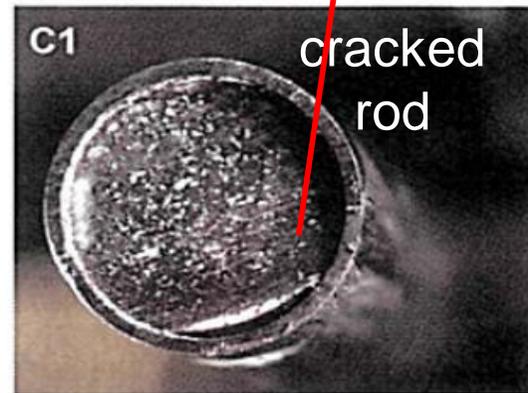
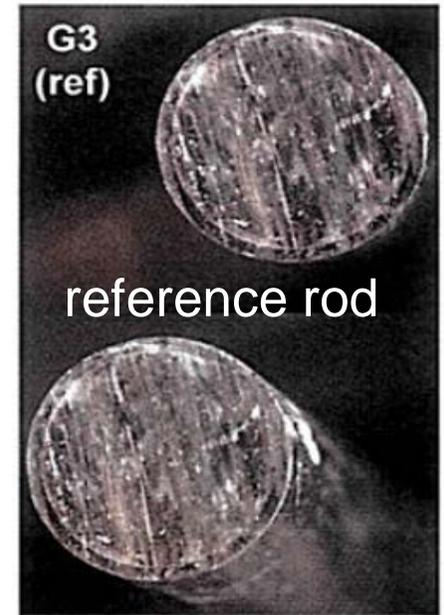
loss of absorber

Even rods with tiny cracks (hairline crack) can cause leakage of the absorber materials into the reactor water. These cracks occurs by radiation-induced stress corrosion cracking (IASCC). This type the damage does not affect the control rod function but must be replaced due to ALARA and radiation safety concerns.

Experience from inspected control rods with cracks indicates that number of cycles in the core should be reduced (17 for R3 and R4, 15 for R2) and that the following limits on the permitted neutron fluence shall apply: $42 \leq \emptyset \leq 54$

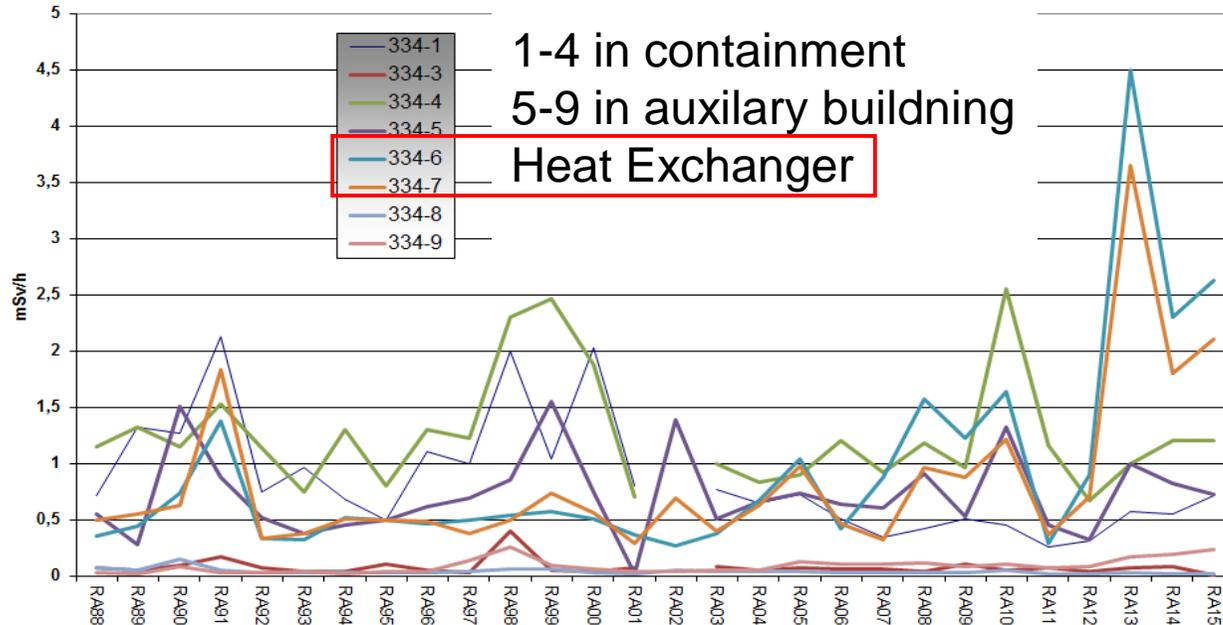
Silver and Antimony deposition Impact on radiation fields

Deposition of Ag-110m occurs mainly in CVCS where it locally can cause very high radiation fields.

Deposition of Sb-124 occurs mainly in RHR and CVCS
