Lessons Learned from Radiological Incidents in Switzerland

Franz Wallimann, AXPO AG Kernenergie
Swen-Gunnar Jahn, ENSI

Exceeding the Dose Limit in NPP Beznau (KKB 2)

Incident on 3 August 2009:

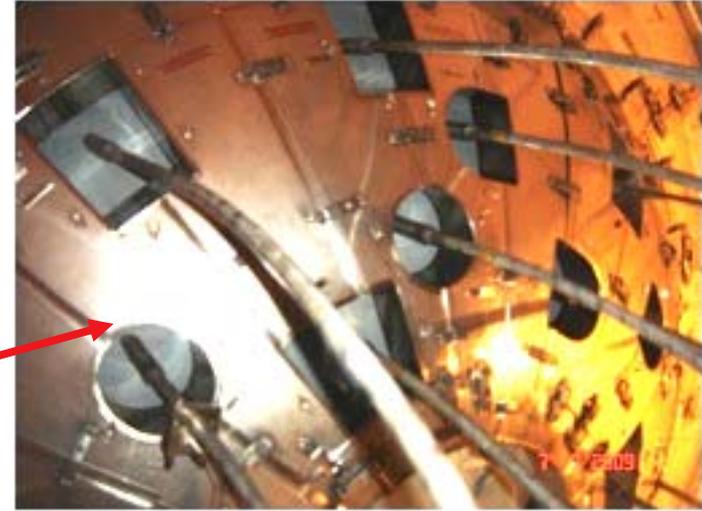
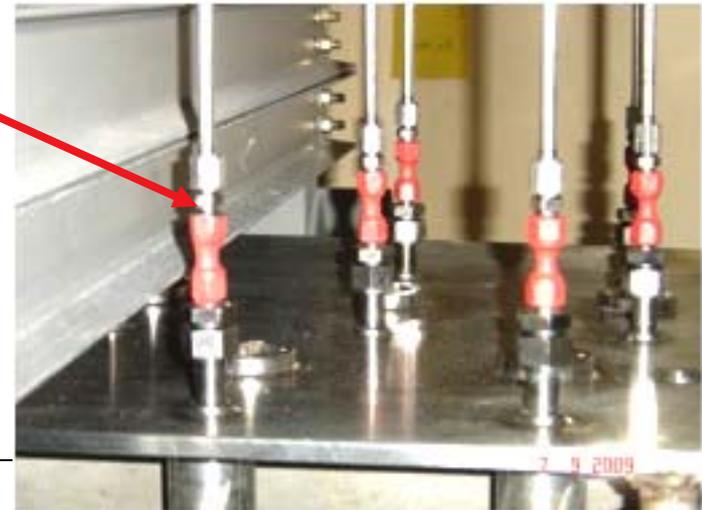
in-core
instrumentation
seal table

- On 31 July 2009, NPP Beznau Unit 2 shut down for annual outage
- In this outage it was scheduled to perform a 10-yearly pressure test of the primary circuit
- Preparation work for this test:
 - Installation of floodlight and camera rails in the room located under the reactor pressure vessel (reactor cavity room)
 - Withdrawing of inner-tubes of the highly activated in-core instrumentation system from the core and
 - sealing pressured-tight

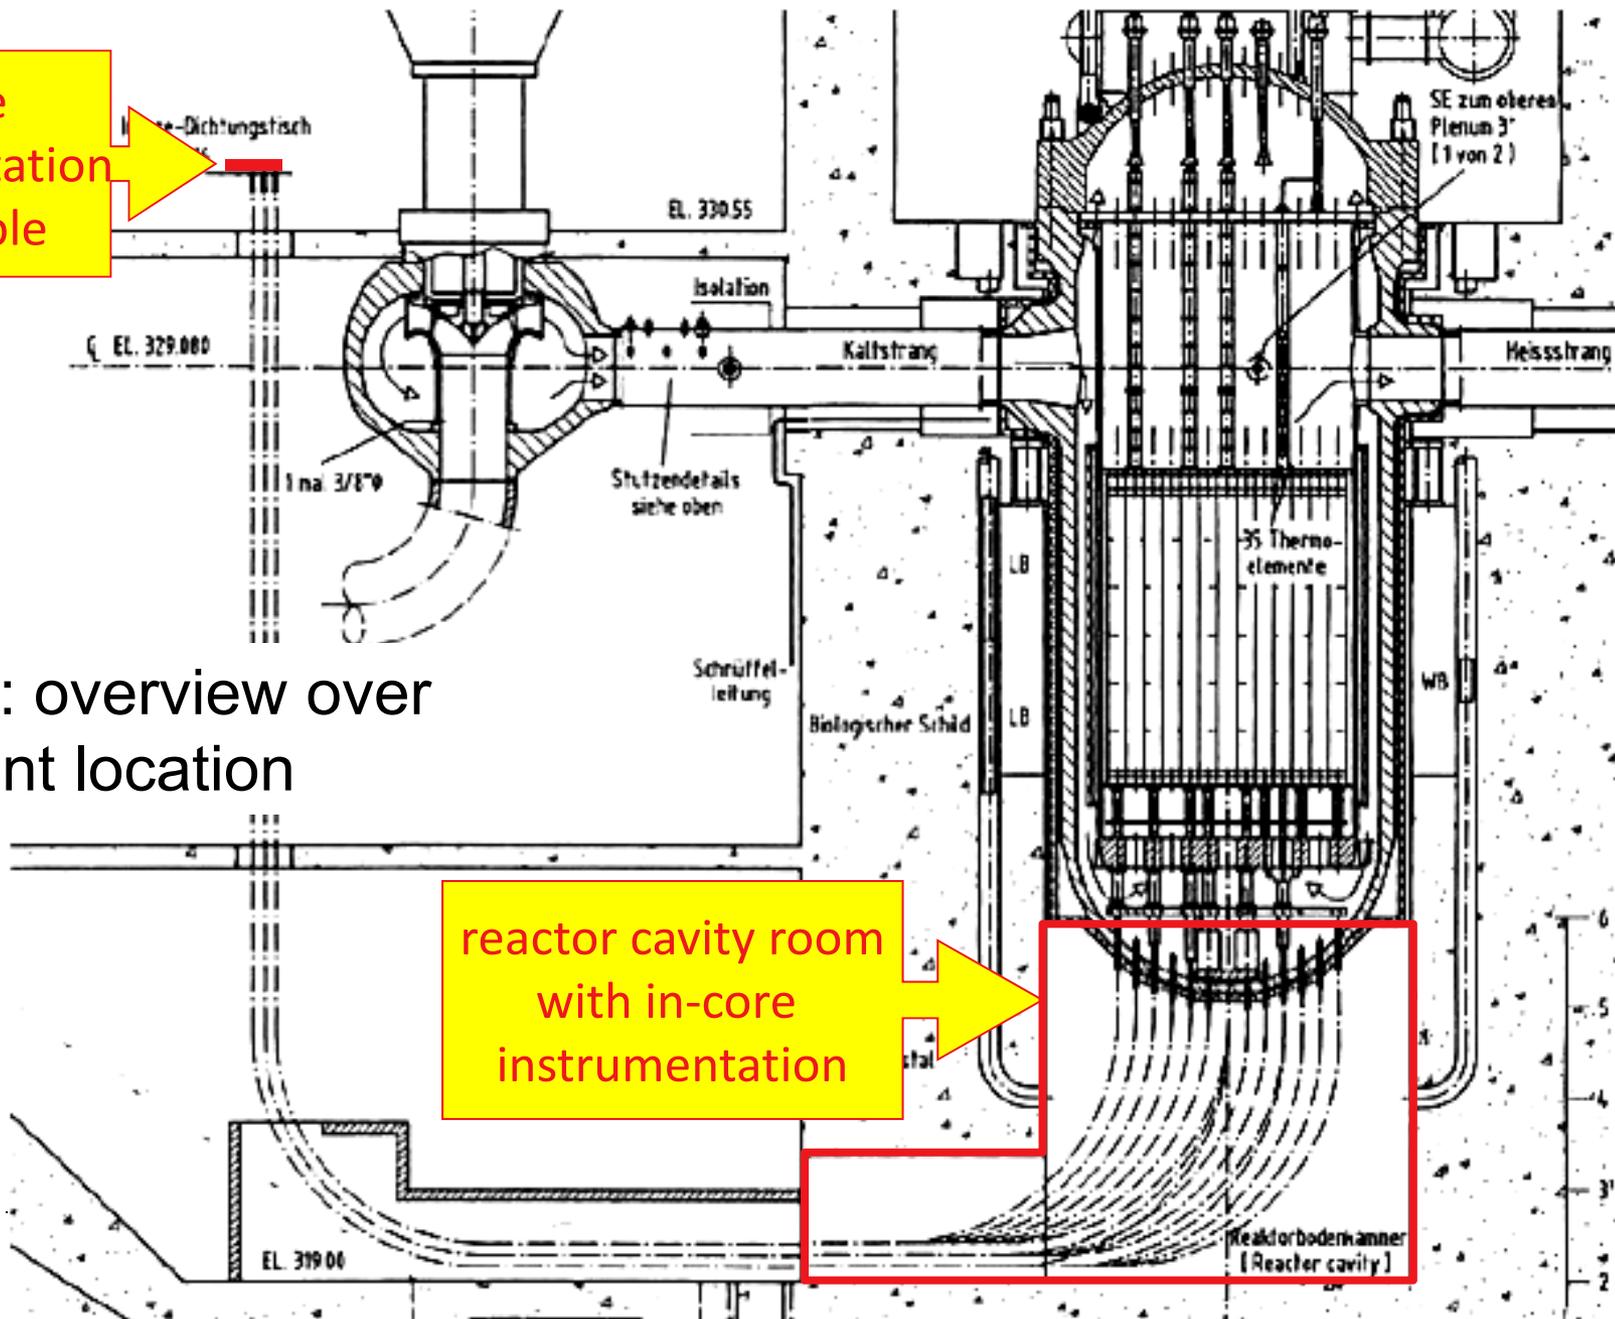
KKB2: overview over
incident location

reactor cavity room
with in-core
instrumentation

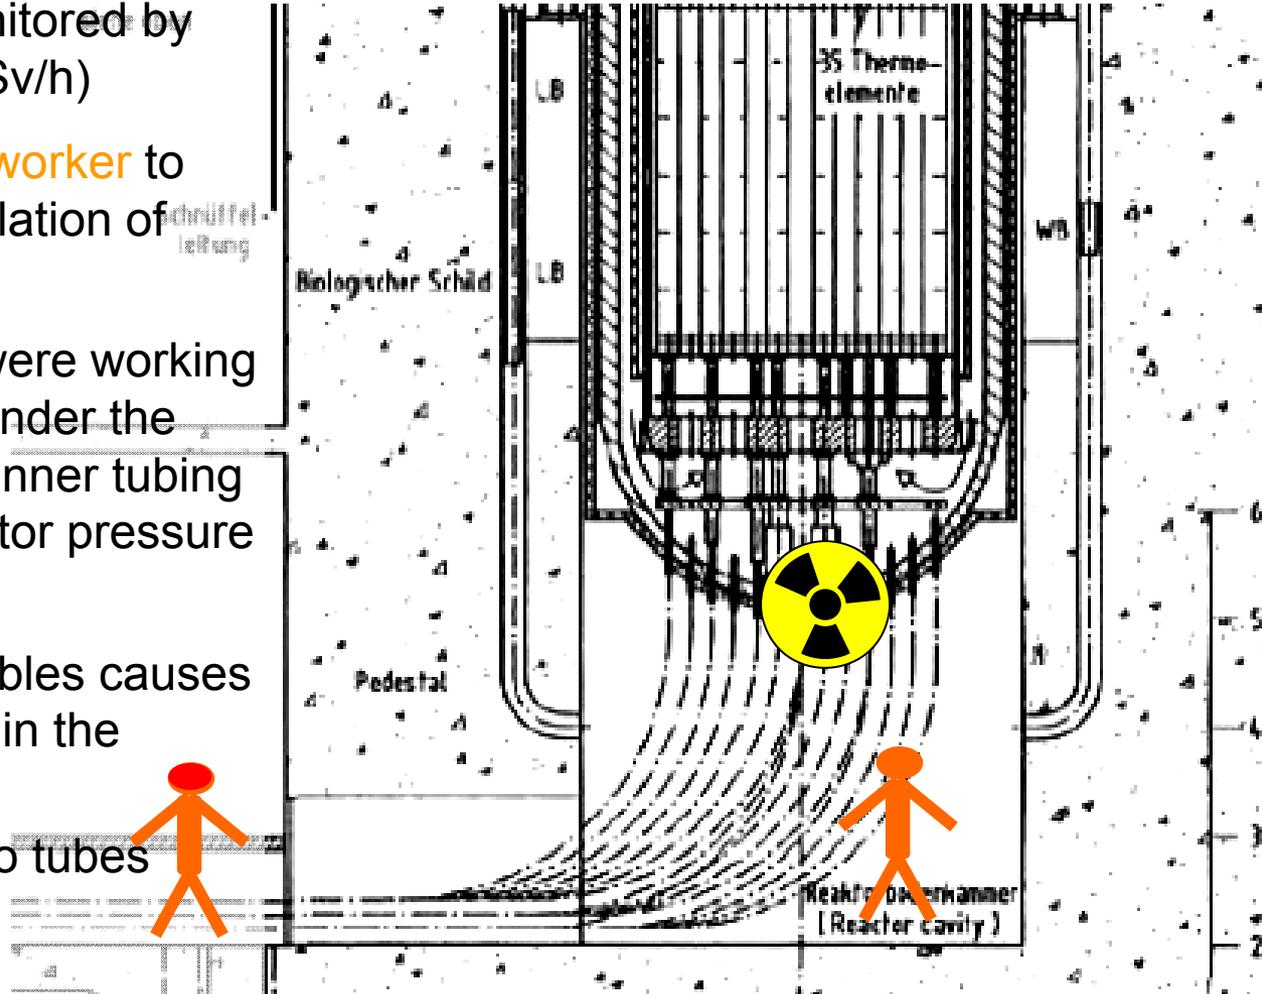
Incident History (3)

- Before starting the job inside reactor cavity the dose rate was monitored by **RP-controller** (around 1.5 mSv/h)
- RP-controller admitted the **worker** to enter the cavity to start installation of **schüttel-leitung**
- Whilst the two employees were working in resp. in front of the room under the reactor pressure vessel, the inner tubing was withdrawn from the reactor pressure vessel
- Withdrawing of in-core thimbles causes rapidly increase of dose rate in the reactor cavity room
- test shows 2.8 Sv/h with two tubes withdrawn

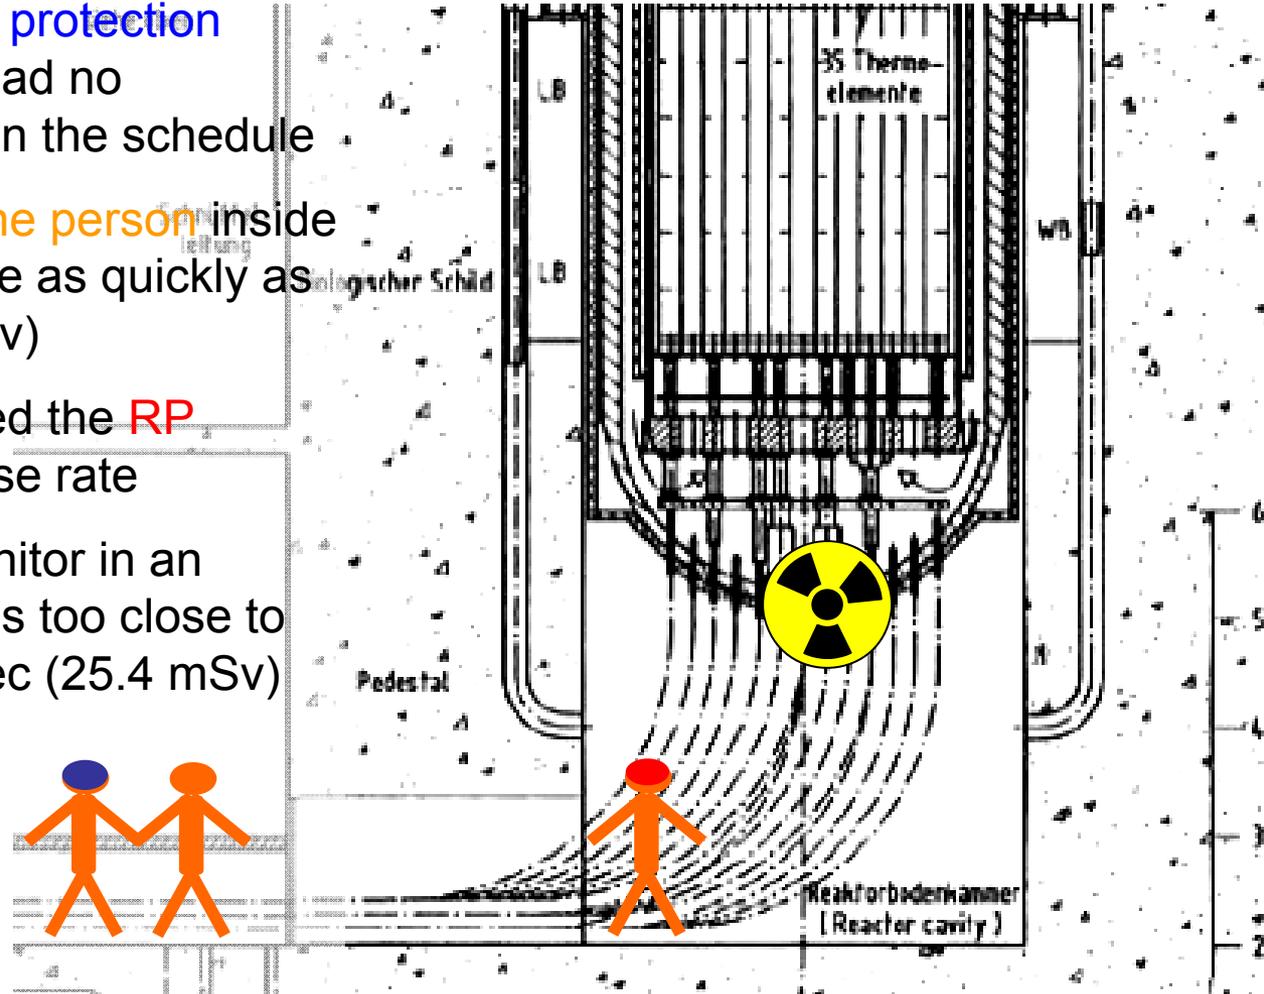
Incident History (4)

- Only by chance the conflict was recognized by the **radiation protection coordinator** on duty - who had no knowledge of the changes in the schedule

- **RP coordinator** alarmed **the person** inside the cavity who left the scene as quickly as possible (resulting 37.8 mSv)

- **RP coordinator** commanded the **RP controller** to monitor the dose rate

- **RP controller** used the monitor in an inadequate manner and was too close to the source for around 20 sec (25.4 mSv)

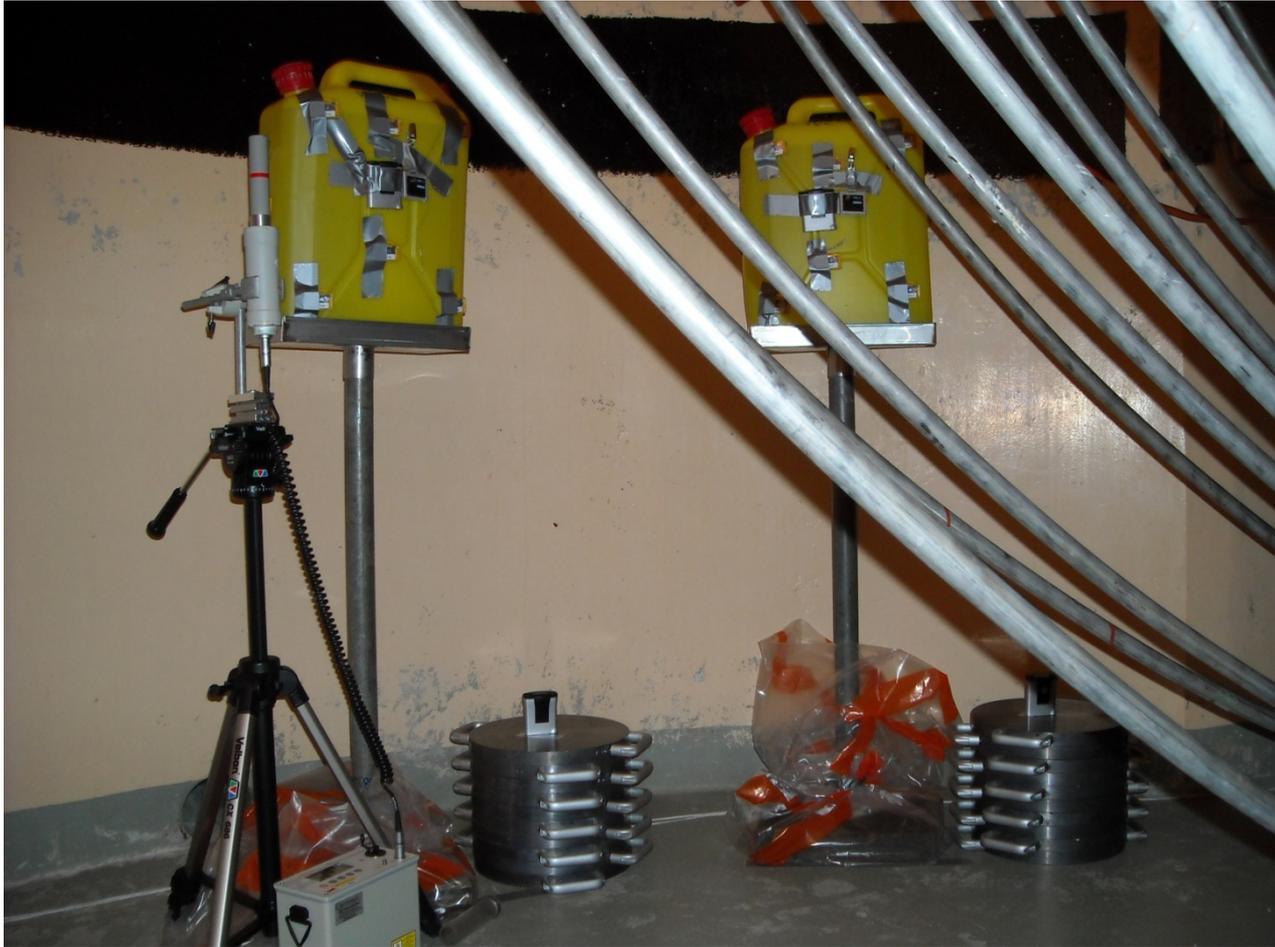
verification of dose rate and dose inside the reactor cavity room

- the preliminary finding (measured dose on electronic personal dosimeter > annual dose limit) **was reported internal to the RP-management and to the chief operator** in charge (Piketingenieur)
- The RP-Management took the necessary steps to analyse the thermoluminescence dosimeter → confirmation of exceeding the dose limit → **declaration of reportable incident**
- **The chief operator reported the incident to the authority ENSI** (within a few hours after the event occurred)
- NPP Beznau started to analyse the causes and send a **preliminary report** (at the some day)
- ENSI analyzed the root causes by interviews and started a verification of dose rate inside reactor cavity
- A **final report** with corrective actions was send by NPP Beznau
- ENSI asked other Swiss NPP to investigate the risk of high dose rates

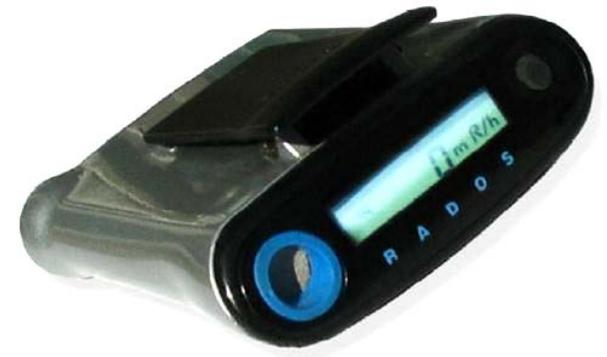
EPD - Signals

- **inadequate use of electronic personal dosimeter**
 - no adjusting of the alert level (normal setting 1 mSv/h) to actual dose rate (around 1.5 mSv/h)
 - the dosimeter alerts from beginning of work
 - no reaction on emergency signal
- **missing technical measure** to avoid withdrawing whilst the cavity room is open
- **missing permanent dose rate sensor** with optical and acoustical signalisation of high dose rate
- **inadequat use of handheld dose rate monitor to verify radiological situation** → RP Controller went with handheld dose rate monitor into radiation area instead of using a telescopic dosimeter.
(maybe wrong human reaction under stress condition)

- Dose Rate Warning: 1 Beep per 0.1 $\mu\text{Sv/h}$

- Dose Rate Alert: In KKB 2 set on 1 mSv/h

→ ‚Normal‘ dose rate under reactor pressure vessel is around 1.5 mSv/h, so the Dose Rate Alert sounds from the beginning of work. There was no procedure to set the alert on a higher threshold

- Dose Alert: In KKB 2 individual up to 18 mSv

→ Dose Rate Alert override Dose Alert, so there was no alarm signal change when reaching preset dose limit.
