Pressurizer Heater Nozzle Replacement at San Onofre

Kelli Gallion

NATC ALARA Symposium

January 2005

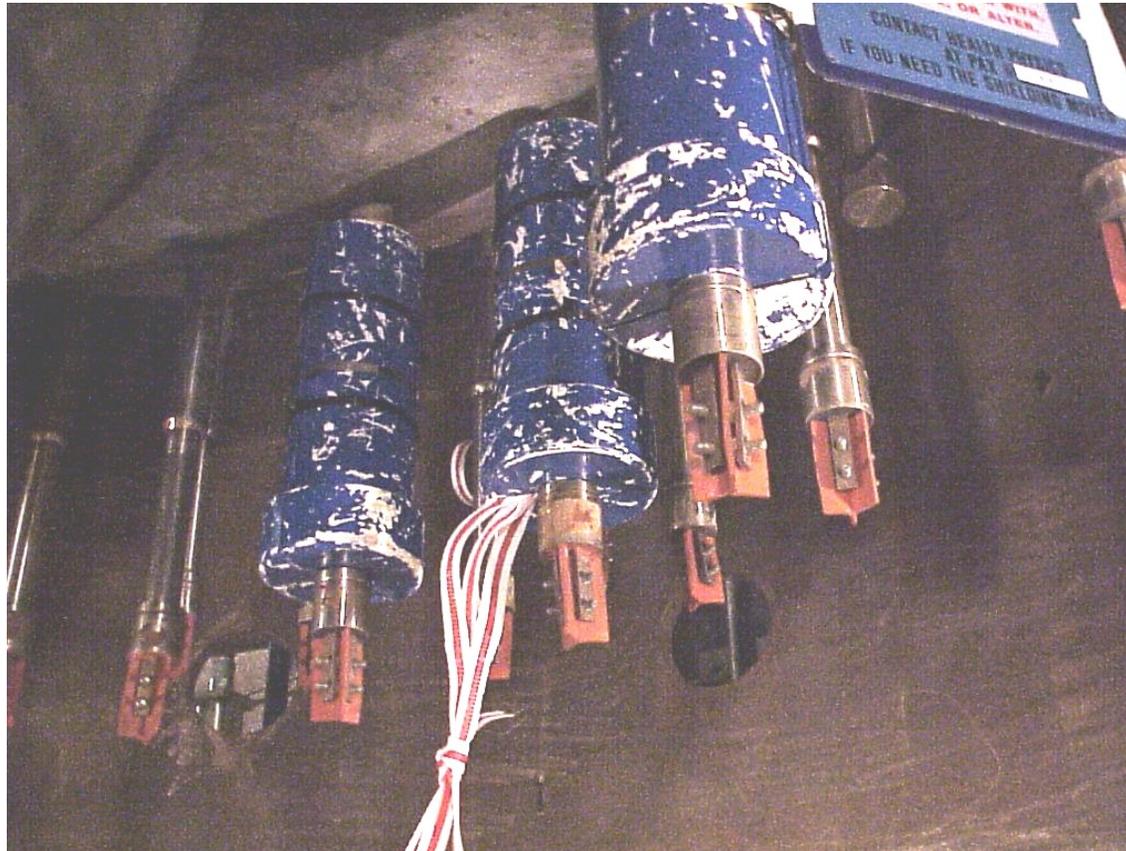
Heater Shielding

☛ Sleeve Shields

- ~300 mR/hr contact, 180 mR/hr at 30 cm to
- ~120 mR/hr contact, 80 mR/hr at 30 cm

- Clam Shell Shield Over Heater Sleeves Until Heater Removed
- Lead Blankets Placed Around Surge Line
- Lead Blankets On Work Platform To Lower Exposure Rate In Area Used To Change PCs, and Control Work
