Browns Ferry Unit 1 Restart Cobalt Reduction Plan Update

John Underwood
TVA-Browns Ferry Nuclear Plant
1/12/2005

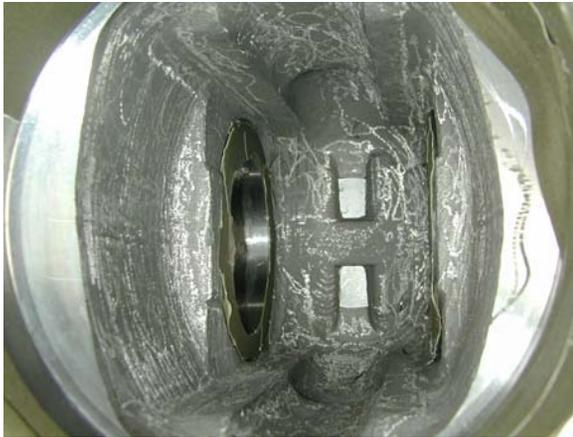
As Received

6 inch RWCU inlet valve body

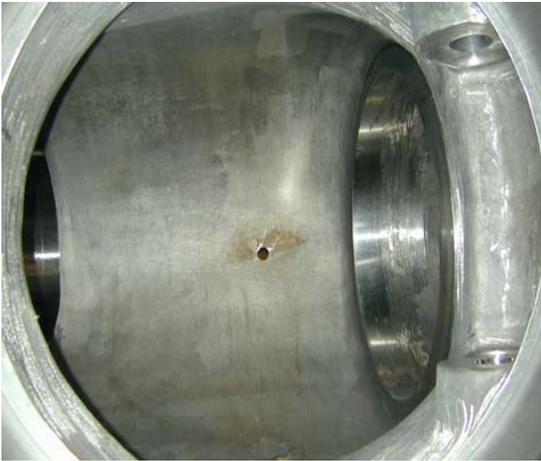
As Received

24 inch RHR testable check valve

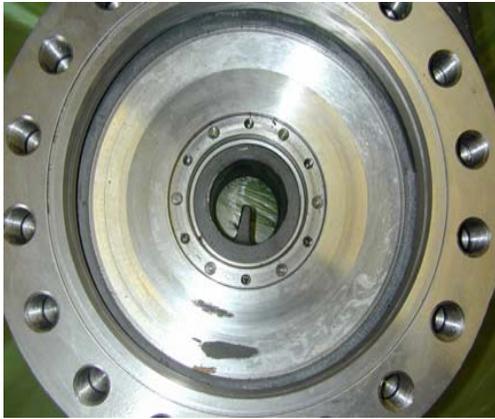
As Received

RWCU Pump

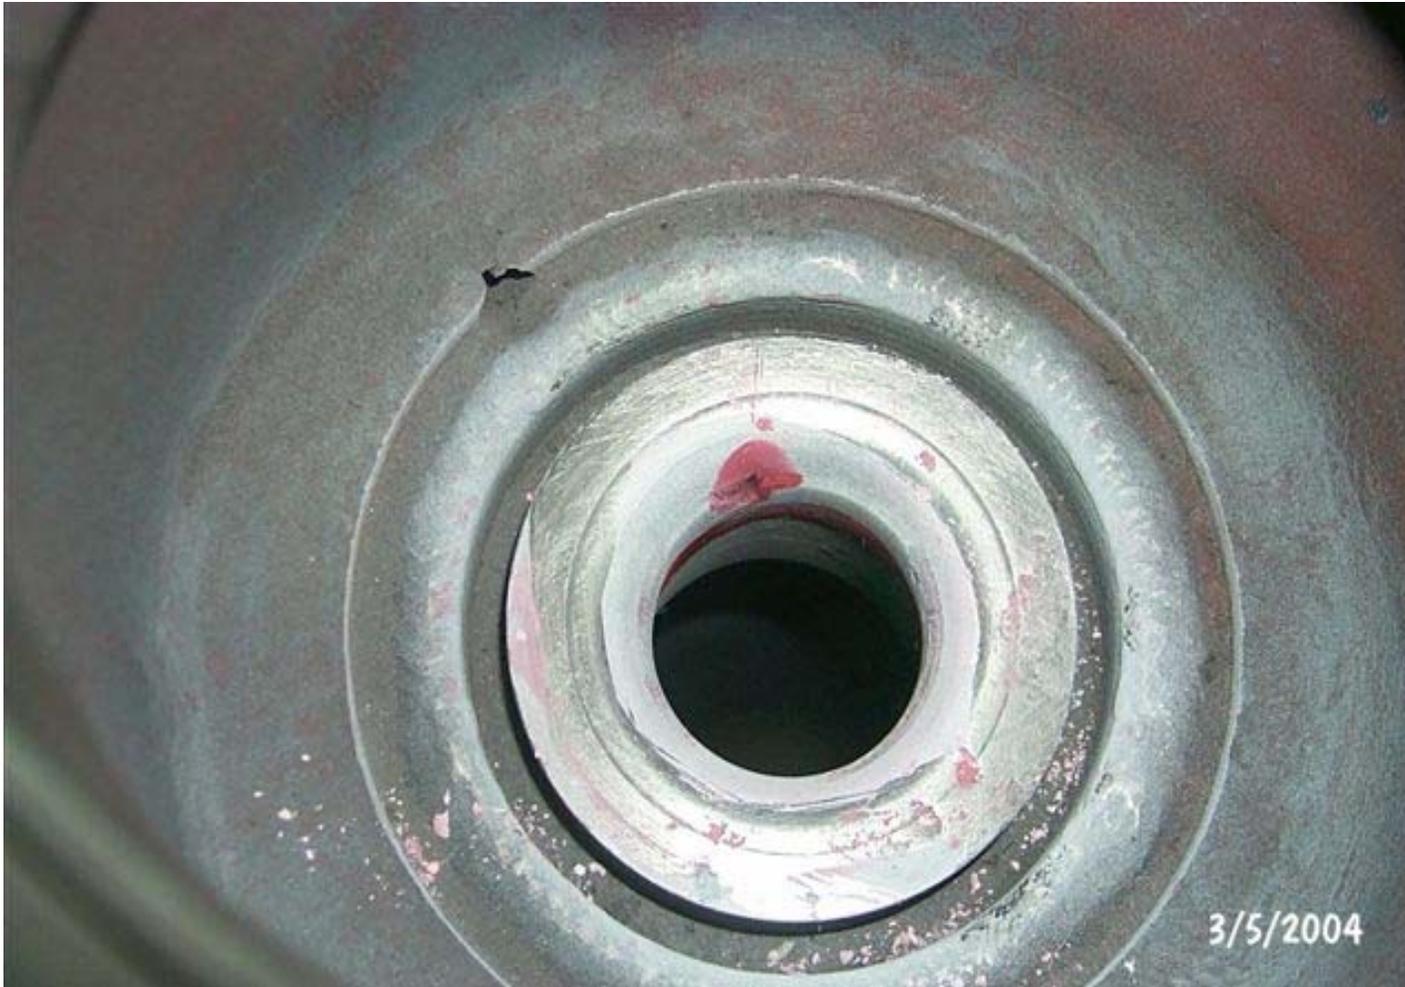
Stellite® 21 vs. Stellite® 6

The valve below was worked during BFN unit 3 cycle 11 outage. The “flaked” off portion of this valve is made up of Stellite® 6 which has been found to be more brittle than Stellite® 21.
