Improvements of ADR System

August 30, 2010

Ulchin NPP units 5&6

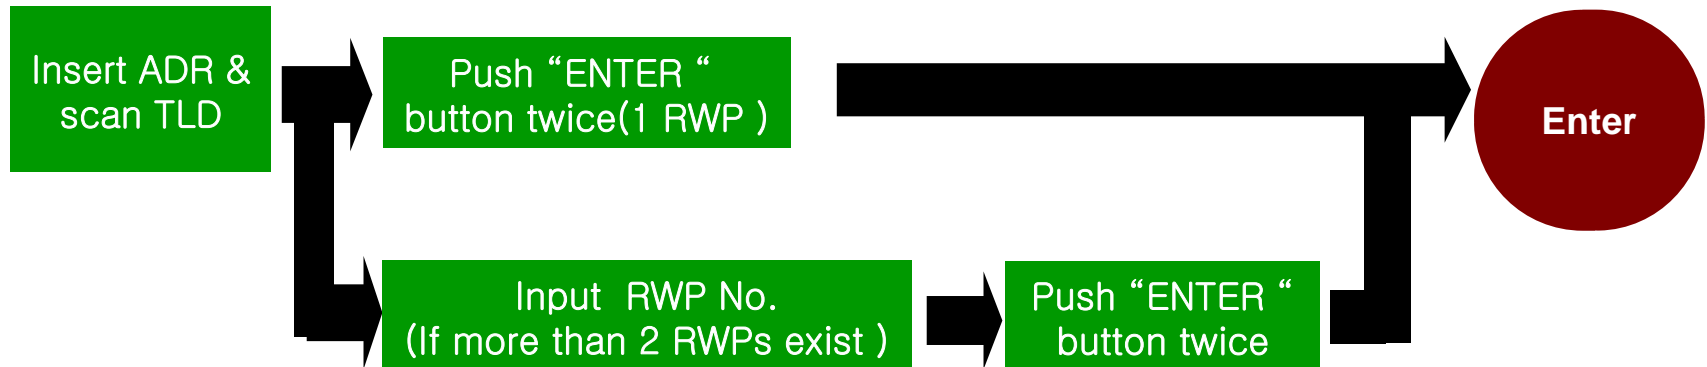
1. Inconvenience and confusions due to **multi-access steps** for entrance

Before	After
<ul style="list-style-type: none">● Scan ADR & TLD● Push “ENTER” button twice● Confirm RWP No. and input RWP No. (if more than 2 RWPs exist)● Enter radiological controlled area	<ul style="list-style-type: none">● Same as “Before”● None● Select the RWP shown on the touch screen● Enter radiological controlled area

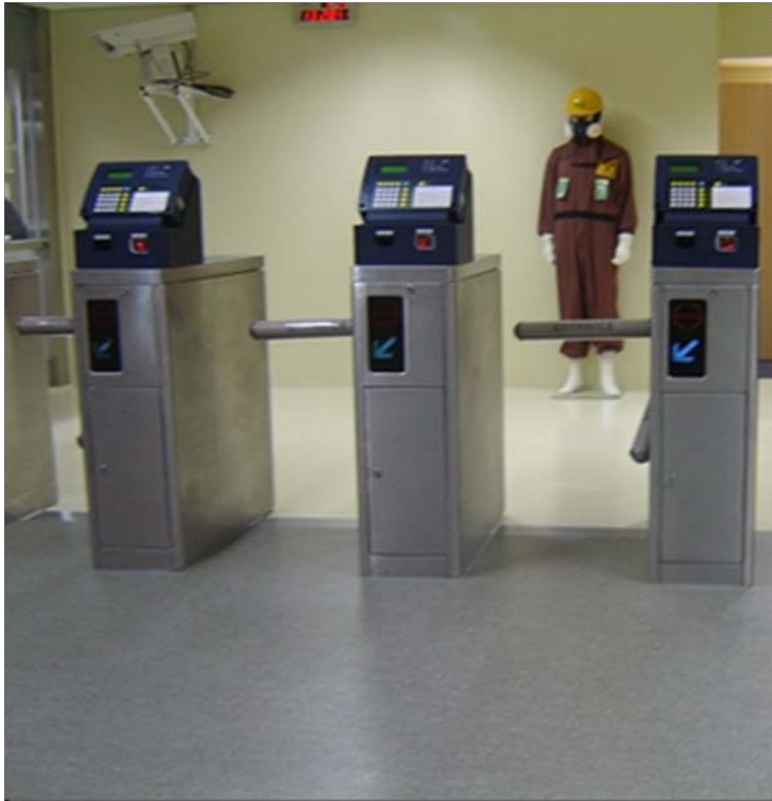
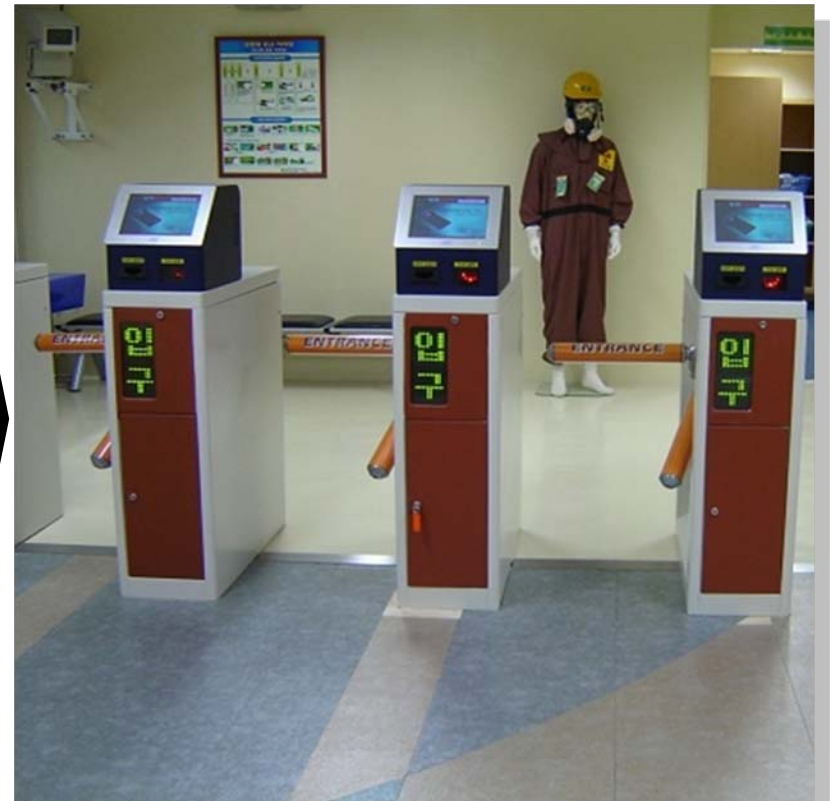
Redesign small LCD to the wide touch screen

Before

After

Before	After
<ul style="list-style-type: none">● None. but worker's RWP No.	<ul style="list-style-type: none">● Developed program to display most of information on the wide LCD screen<ul style="list-style-type: none">– Worker's radiation dose history– Protective equipments requirement– RWP, WBC, etc.

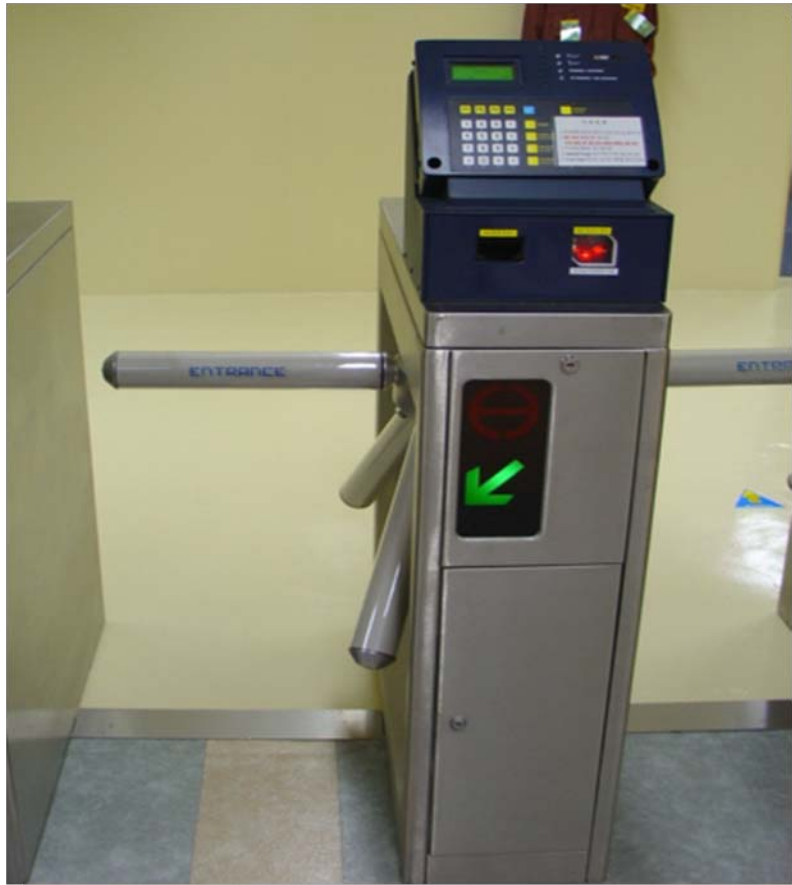
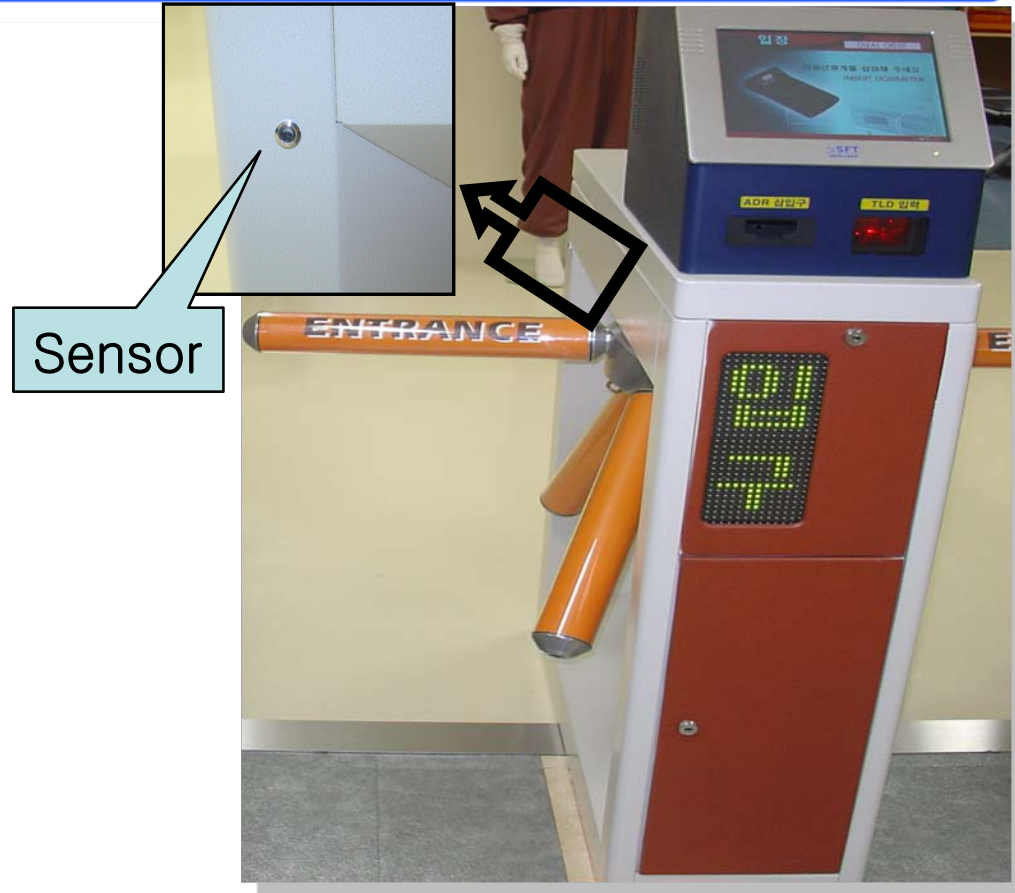
- Turnstile sensors sometimes were not recognized exactly.
- Using the hardwire cable between PC and Reader caused many data transmission errors.

No access errors after adding photo sensors

Before

After

Before	After
<ul style="list-style-type: none">● 4 sensors inside turnstile● Use of a hardwire cable between PC and Reader	<ul style="list-style-type: none">● Added 2 photo sensors for exact acknowledge● Changed to LAN
