2013 INTERNATIONAL ISOE ALARA SYMPOSIUM

Lessons Learned from the Fukushima Daiichi NPP's Accidents for Achievement of the First Class Safety in the world

Dr. Tadashi NARABAYASHI Nuclear and Environmental Systems Hokkaido University

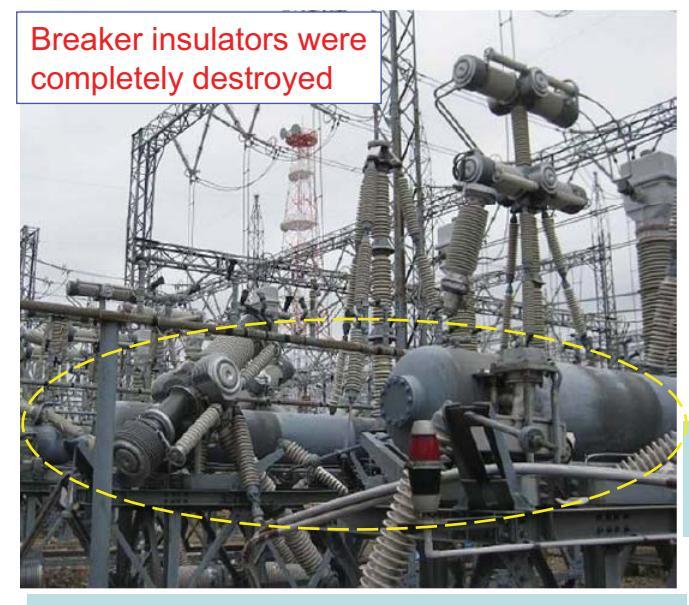
Damaged External Power

External AC Power was lost in Fukushima Daiichi

Damaged ABB(Air Blast Breaker) Fukushima Daiichi Unit 1-4

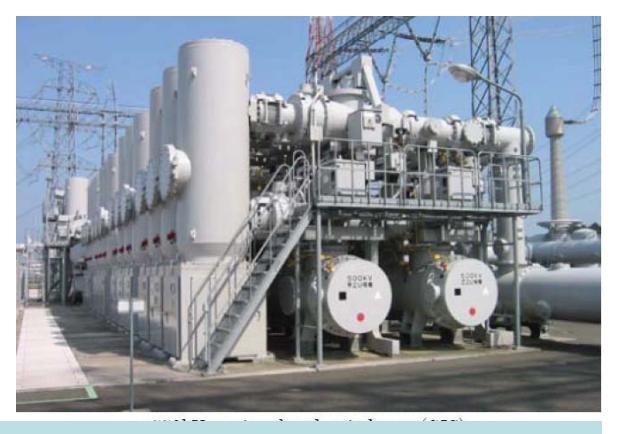
GIS: Gas Insulated Switchgear Onagawa Unit 1-3 were OK

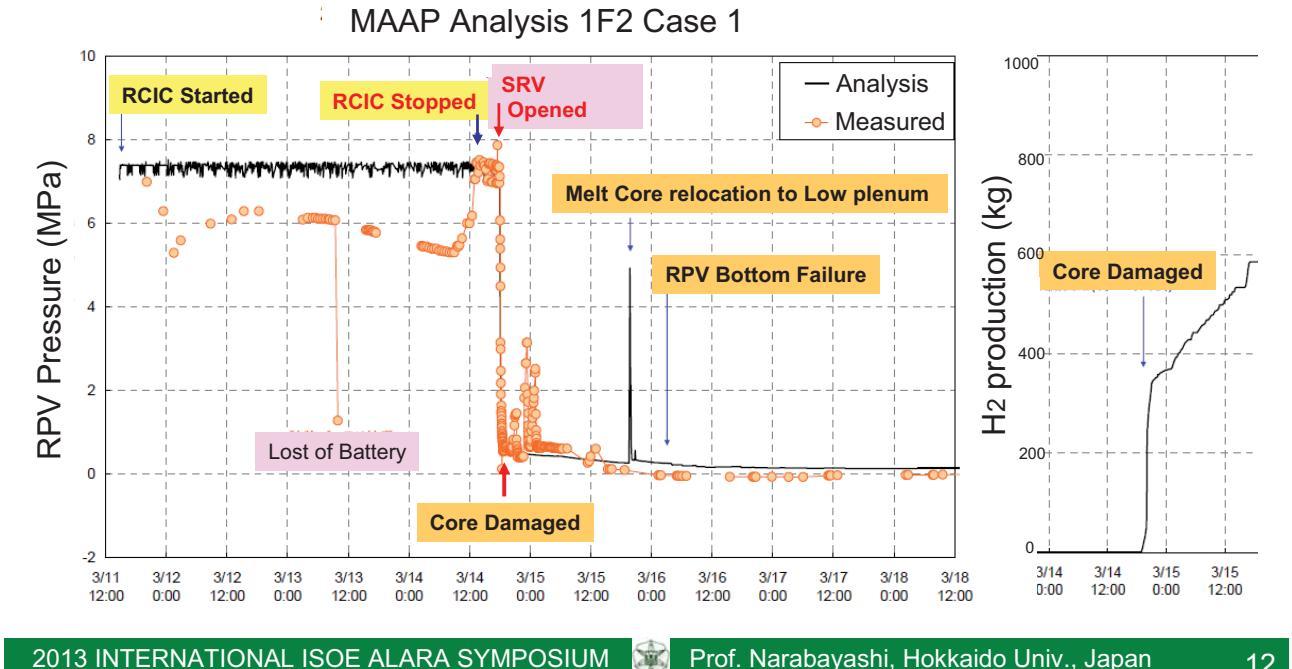
Failure of prompt water injection in #2

- Failure of prompt water injection after RCIC stopped in unit #2 caused the core damage and H2 generation started.
 High-pressure discharge pump driven by diesel engine should
 - be used.

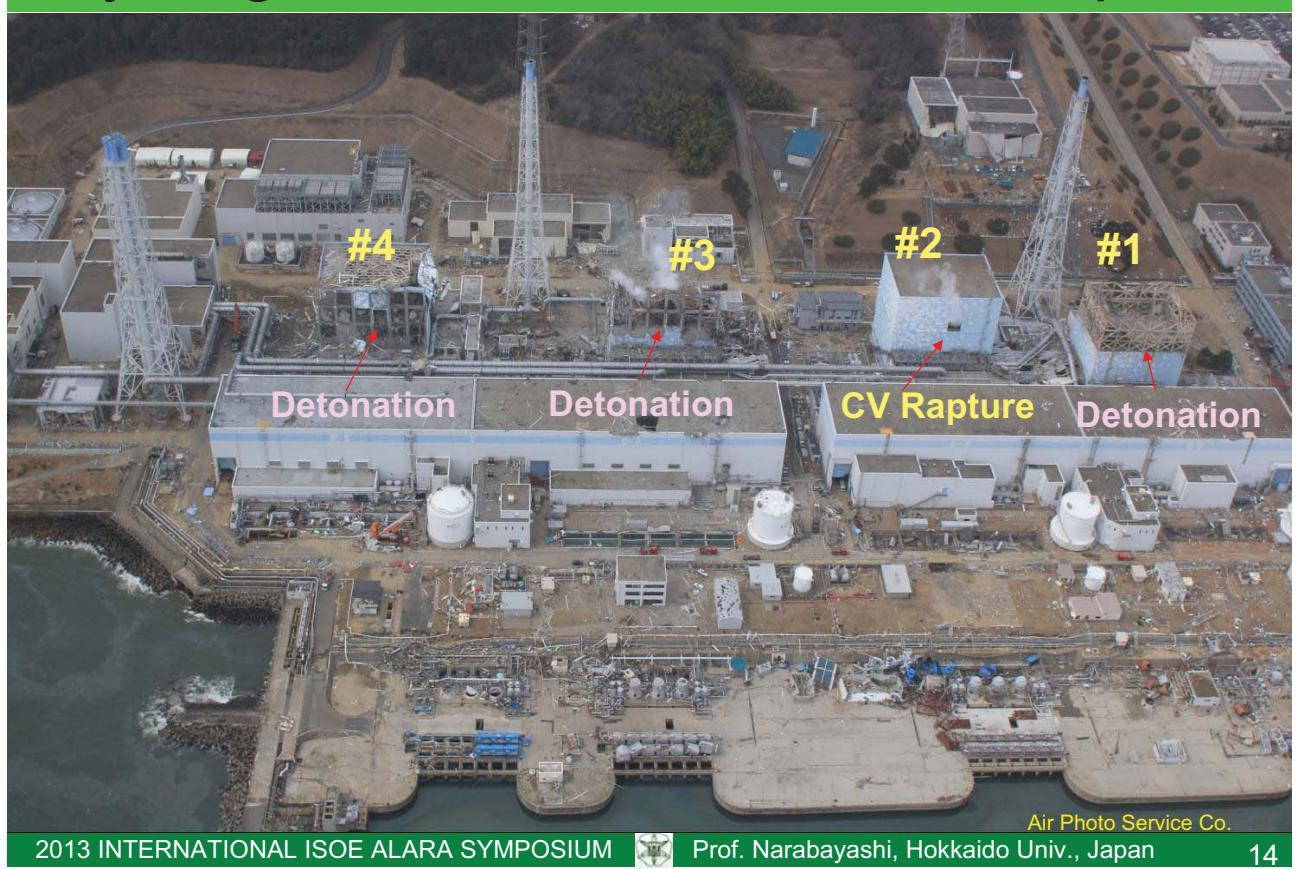
Hydrogen Detonation and CV Rapture

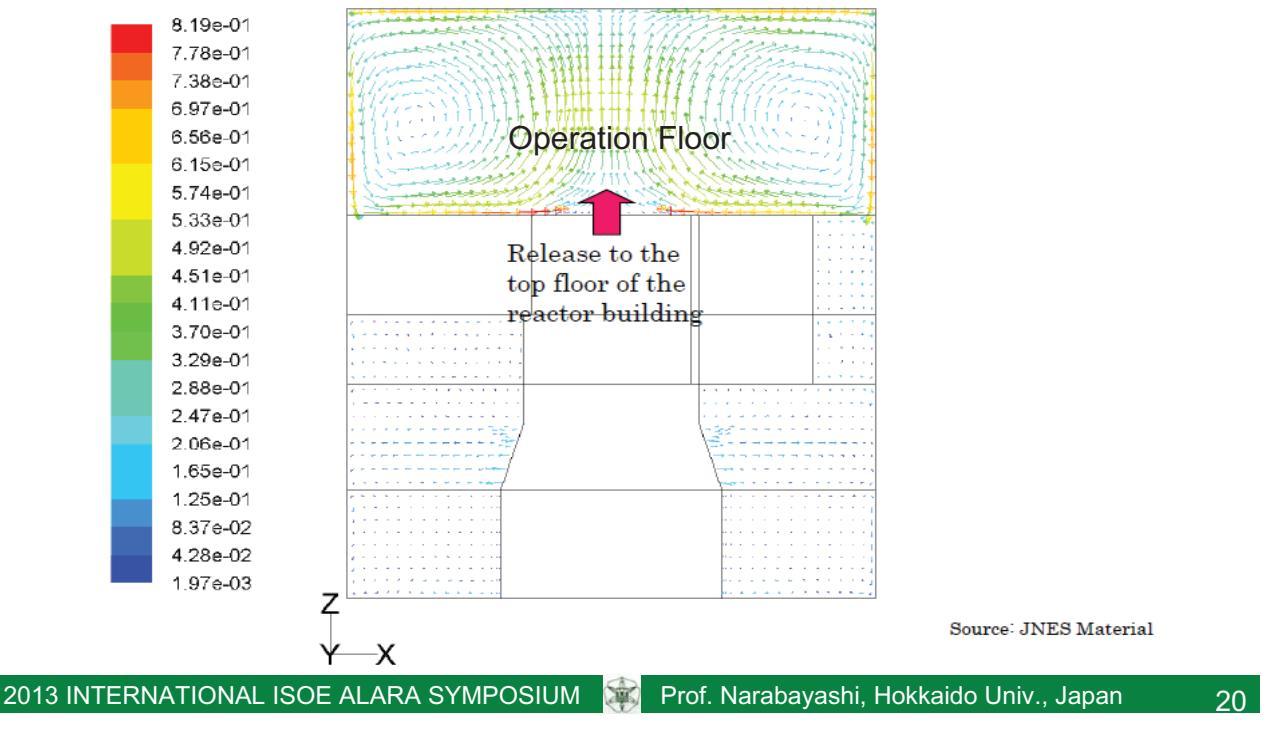
Hydrogen gas accumulation

Analytical result of hydrogen gas accumulation, assuming the release of hydrogen of 400kg from the surface of operating floor.
