Conditioning of intermediate level waste resin by dewatering

ISOE European Symposium 2014 - Bern, Switzerland

Intermediate Level Waste at Sizewell B

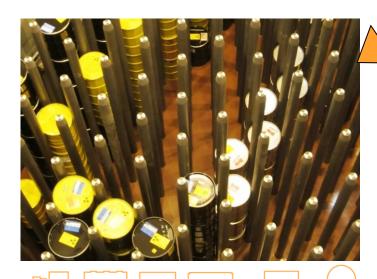
- High doserate compactable waste
 - Accumulated for 18 years
 - 500 bags in 40 x 1m³ cages & IBC's
 - -2-50 mSv/h in contact
 - General area ~300μSv/h.

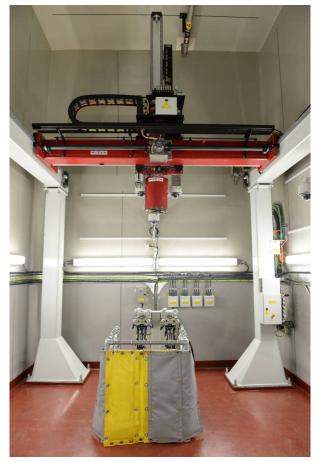
- Benchmarking at Ringhals identified robotic manipulator for ILW processing
- 3-axis gantry+ manipulator arms
 - Intermeshing jaws & parallel acting jaws

- Sentencing based upon external doserate
 - Bags were not opened
 - L/ILW doserate limit reduced to 1mSv/h i/c
 - Manipulator VRF <2, cf. Shredder-compactor VRF
 ~5
- 45 x LLW drums: 0.75 mSv/h i/c (0.002 3 mSv/h)
- 22 x ILW drums: 6.1 mSv/h i/c (0.18 25 mSv/h)
- Collective Dose: 1.9 man.mSv over 14 days.

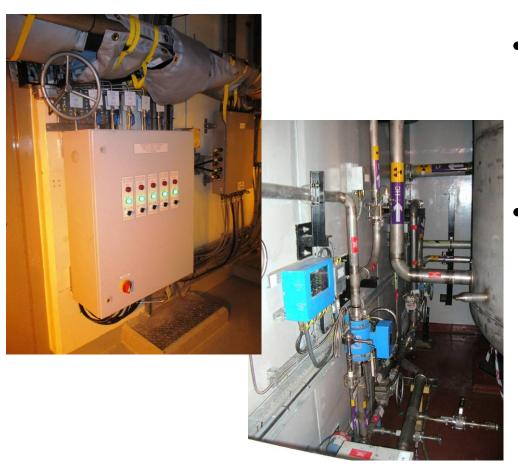
- Existing water tank contaminated with ILW resins and crud – no filters had been installed
- New pneumatic actuators & local control panel for existing valves next to motive water storage tank

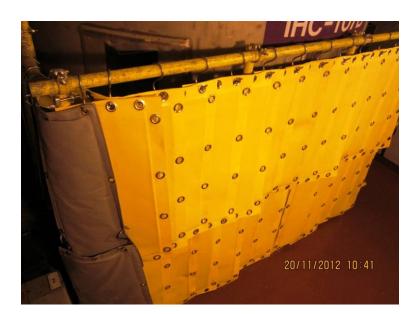
Shielding plan developed to create low doserate area for installation of new actuators

$80 - 100 \mu Sv/h$

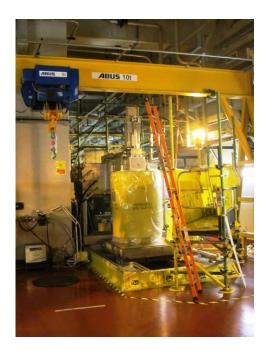
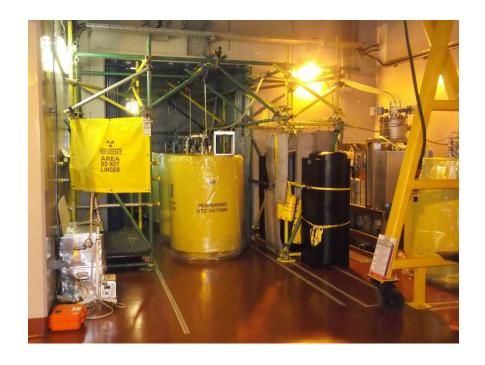
- MOSAIK II-15
 - IP-2 ductile cast iron cask (no lead liners fitted)
- FAFNIR V & NEWA
 - Resin dosing & MOSAIK dewatering equipment

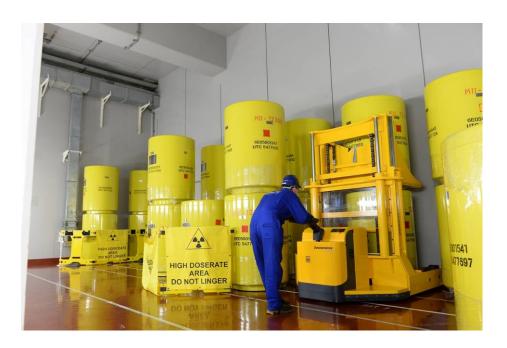
- Lessons from bench-marking visits to Biblis & Grohnde
 - Plastic strakes fitted to Cask Lifter to protect MOSAIK paint
 - MOSAIK movement plan developed
