2012 INTERNATIONAL ISOE ALARA SYMPOSIUM

Fukushima Severe Accident Dose Management &
Global Lessons Learned in Occupational Dose Reduction

Lessons of Fukushima-Daiichi NPP's Accidents for Achievement of the 1st Class Safety in the World

Dr. Tadashi NARABAYASHI

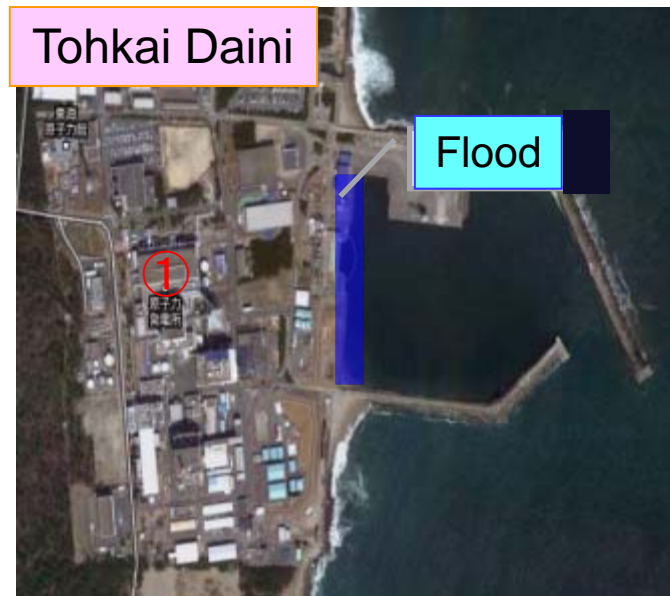
Tsunami Flooding Area in each NPP

Fukushima Daiichi

Fukushima Daini

Onagawa

Tohoku Daini

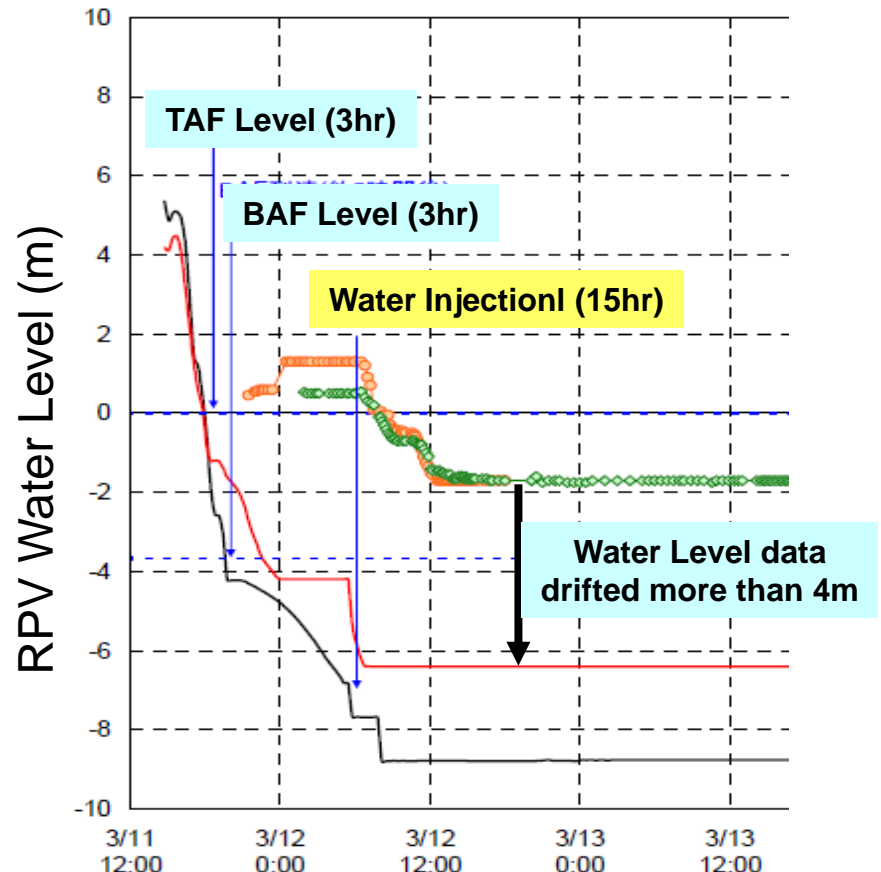
Pressure and Water Level in #1 RPV

- Analysis results show the RPV depressurization started before RPV bottom failure. **It might be caused through melted TIP tubes in the core.**
- Water level measurement was drifted by the loss of water in a reference leg by high-temperature superheated core.

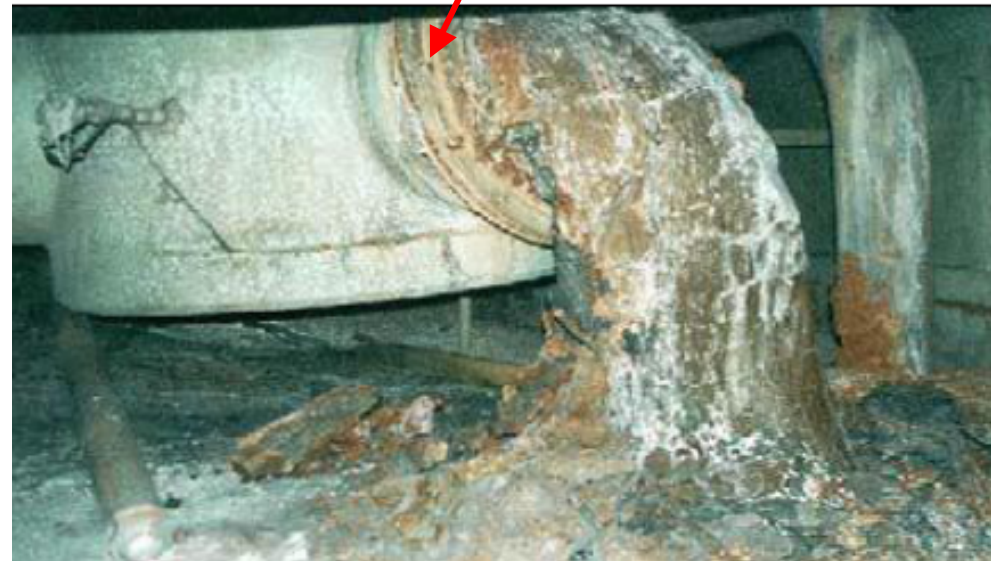
Large Egg and Elephant's Leg

TMI-2: Large Egg in core Chernobyl: Elephant's Leg

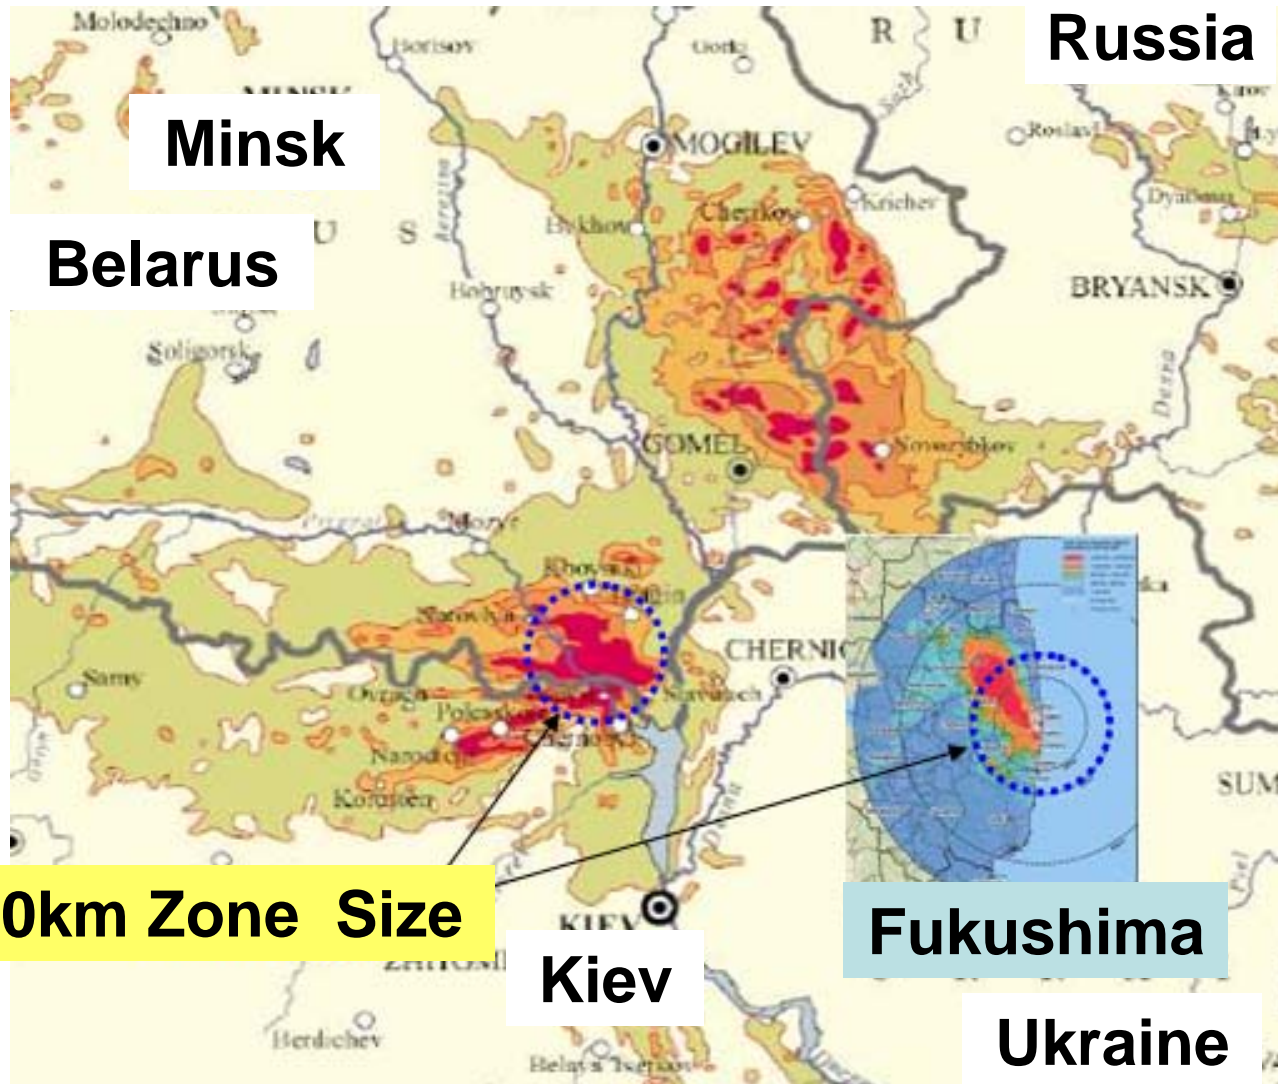
Comparison between Chernobyl and Fukushima

Released FP		
	Cher-nobyl	Fuku-shima
Cs,I	1	1/13
Total	1	1/50

Core thermal output		
TMI-2	Cher-nobyl	Fuku-shima
1	100	~0.01

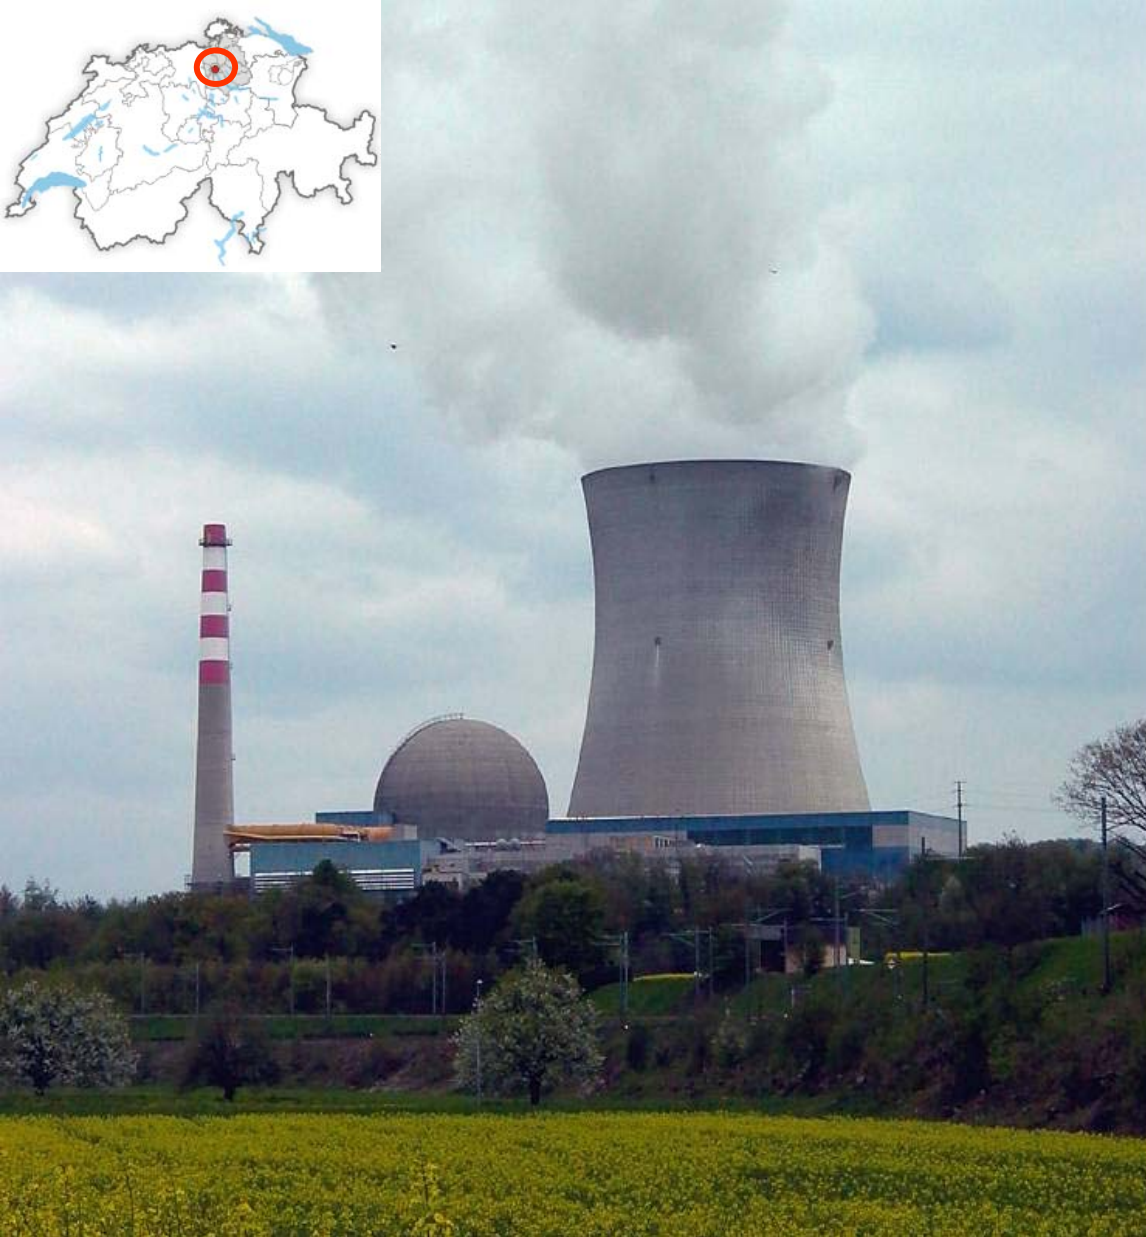
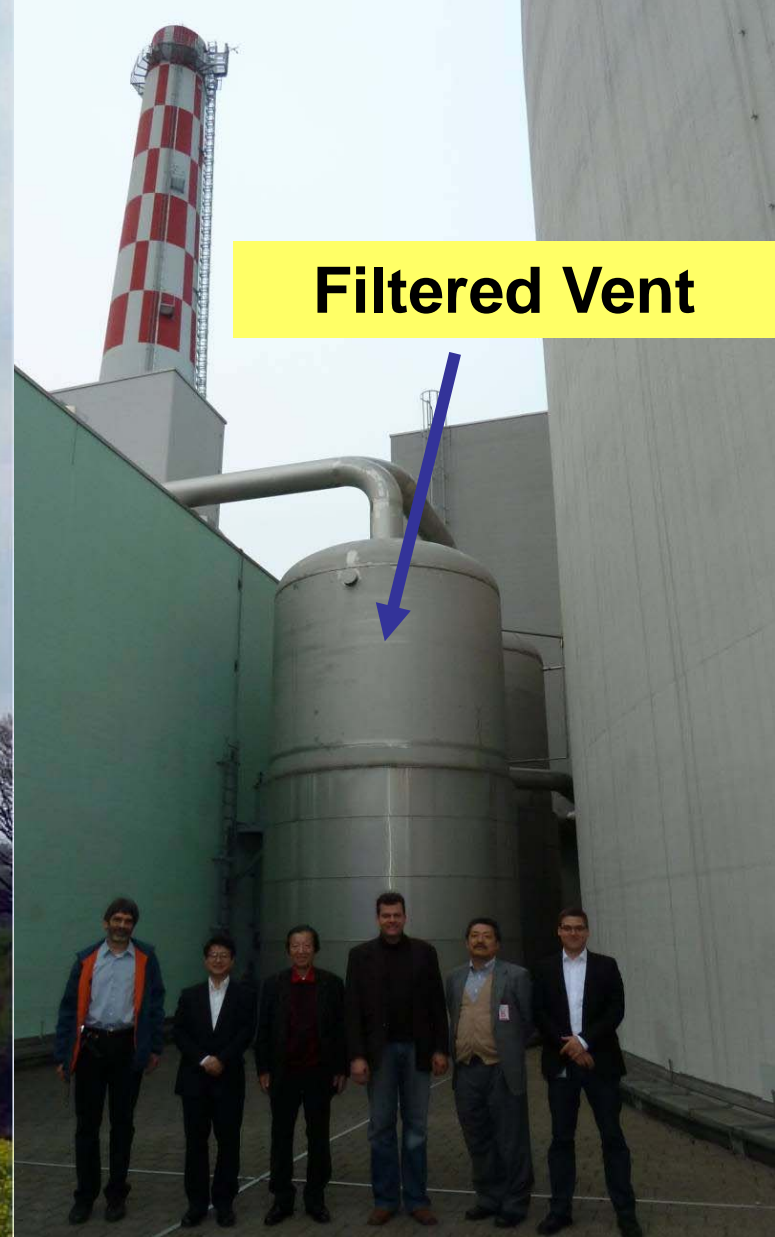
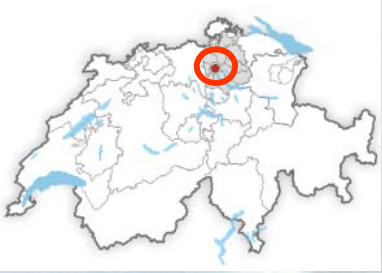
Visit Leibstadt NPP, KKL, Switzerland

FCVS: Filtered Containment Venting System

■ Vent valve will be open by manual shaft when SBO

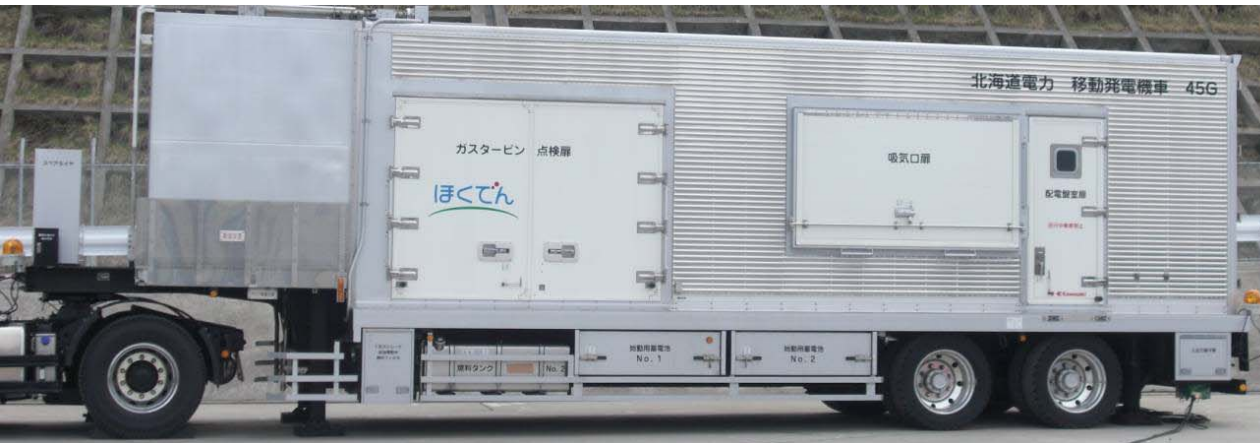
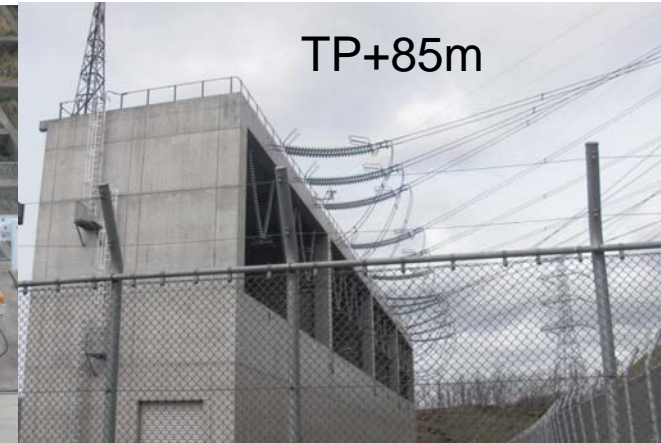
Special Power Generator on Height

- 4000kVA mobile gas-turbine generator at 31m parking (Hepco)

Gas-Turbine Generator
4000kVA, 3.2MW
3.3kV-6.6KV
Start within 40sec
