ANGRA 1 STEAM GENERATOR REPLACEMENT

MARCOS ANTONIO DO AMARAL
RADIOLOGICAL PROTECTION DIVISION MANAGER

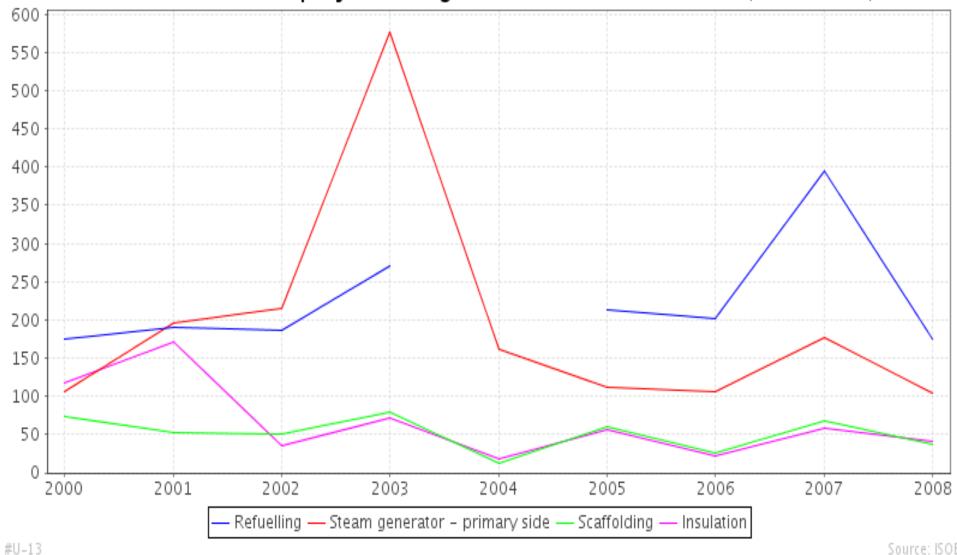
- 2003 1P12 High Primary to Secondary Leak Rate
- 2041 man.mSv
- 2004 1P12A 100% ECT 607 man.mSv No Refueling
- 2005 1P13 1,157 man.mSv
- 2006 1P13A + 1P14 938 man.mSv
- 2007 1P14A + 1P15 1,827 man.mSv FM in RCS
- + RCP burned + spent resin in RCS + waste evap.
- 2008 1P15A N-1 Outage 1,109 man.mSv

Evolution of the dose per job for Angra 1 between 2000 and 2008 (in man.mSv)

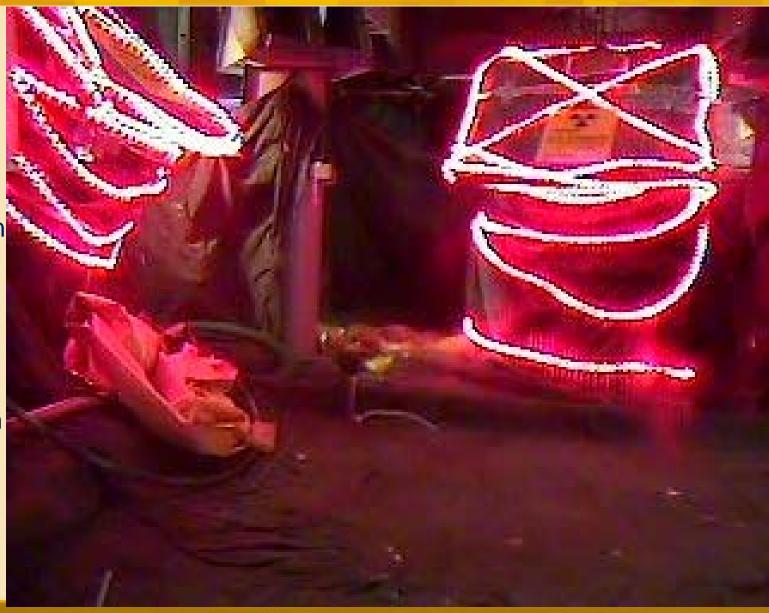
Emergency lights - red lights were used during high risk evolutions, blinking to warn the workers about the risks in the area, like in the job of radiography, "sand boxes" in the reactor cavity, primary legs cutting out and others.

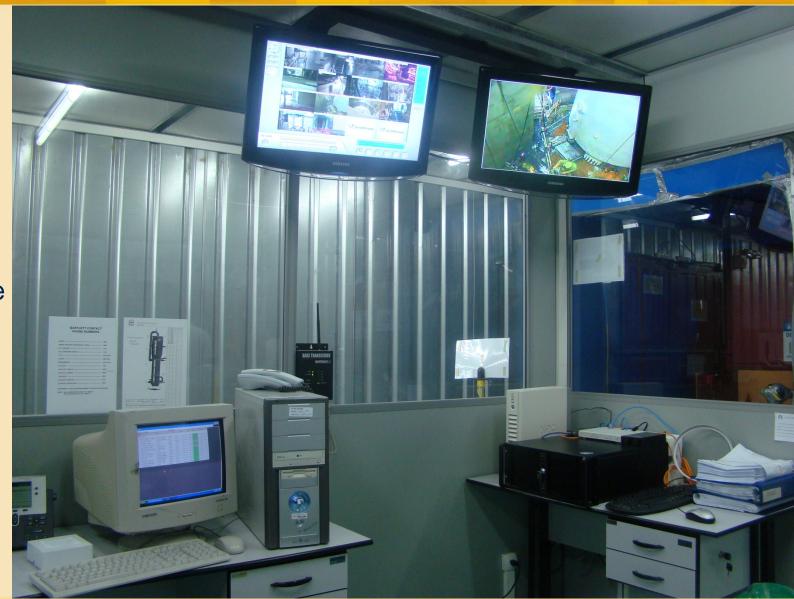
CCTV and Teledosimetry, with radio system and pager, made a powerful combination for the online coverage of the jobs in field.

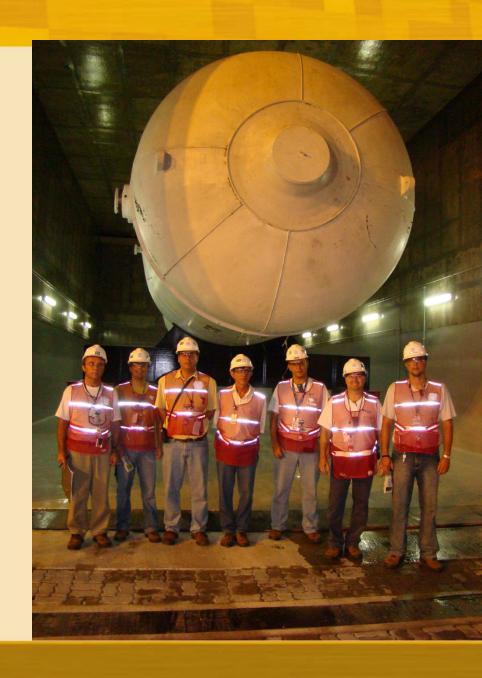
The OSG were stored in a mausoleum, with the low level radwaste produced directly from the SGR.

The RP Team provide the radiological safety for the transportation and secured the route to avoid any unplanned exposure.

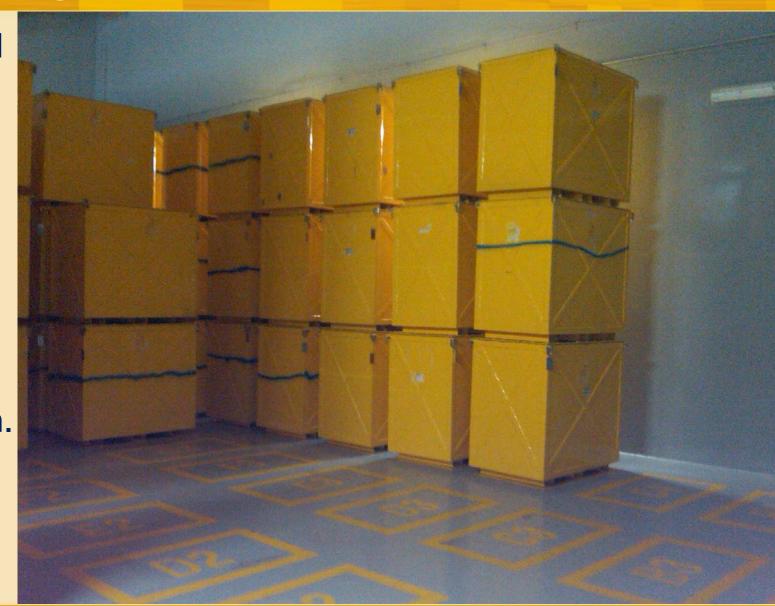
A total of 51 Metallic Boxes with thermal insulation containing asbestos are stored in the mausoleum.

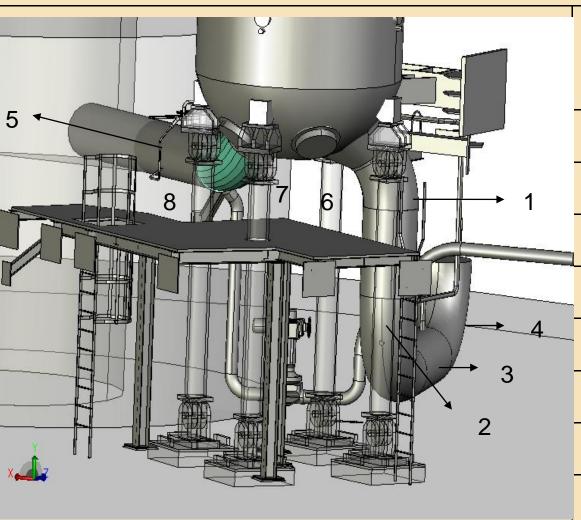
RCS loop 1 – Measurements for shielding efficiency (μSv/h)

Place	W/O Shielding	With Shielding
1	325,0	154,0
2	1950,0	480,0
3	1400,0	449,0
4	330,0	170,0
5	1115,0	520,0
6	55,0	25,0
7	20,0	10,0
8	90,0	20,0

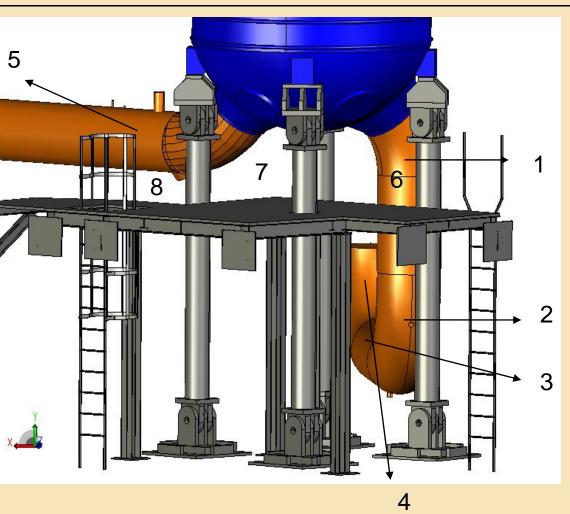
RCS loop 2 – Measurements for shielding efficiency (μ Sv/h)

Place	W/O Shielding	With Shielding
1	420,0	210,0
2	1220,0	220,0
3	460,0	280,0
4	300,0	248,0
5	735,0	400,0
6	25,0	16,0
7	15,0	7,0
8	65,0	30,0
