RADIATION PROTECTION MEASURES DURING THE STEAM GENERATOR HEAT EXCHANGER TUBES CLEANING

JAN NOVAK, RADEK SVOBODA

ISOE INTERNATIONAL SYMPOSIUM, TOURS, 2022

DUKOVANY NPP

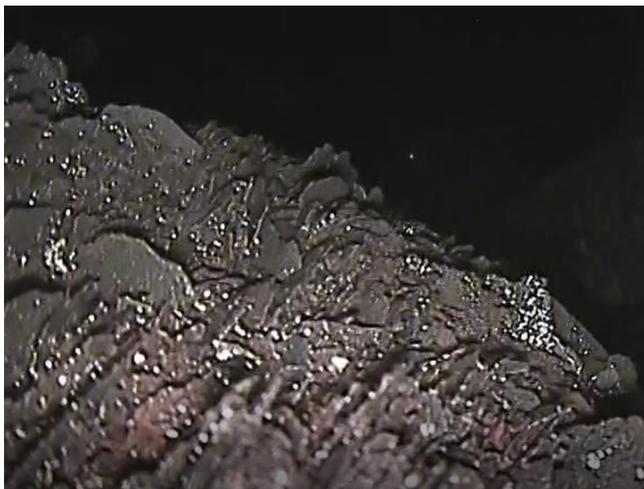
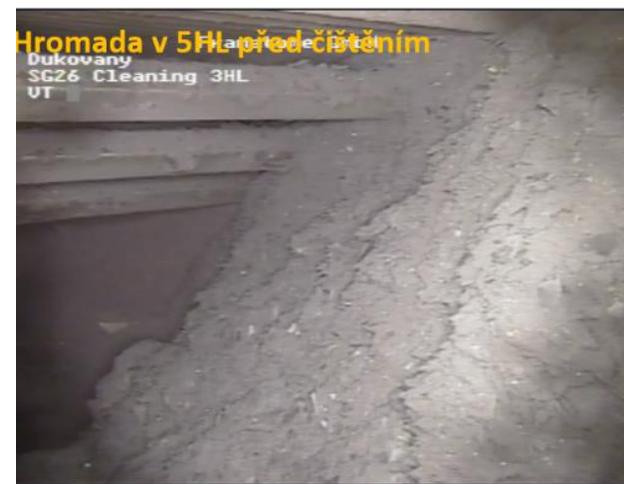
- during visual control, a sediment in the secondary part of the steam generator was detected
- 1) bottom of the steam generator covered by corrosive products

REASONS FOR CLEANING: INCREASED EFFICIENCY OF THE STEAM GENERATOR, EXTENDED EQUIPMENT LIFE

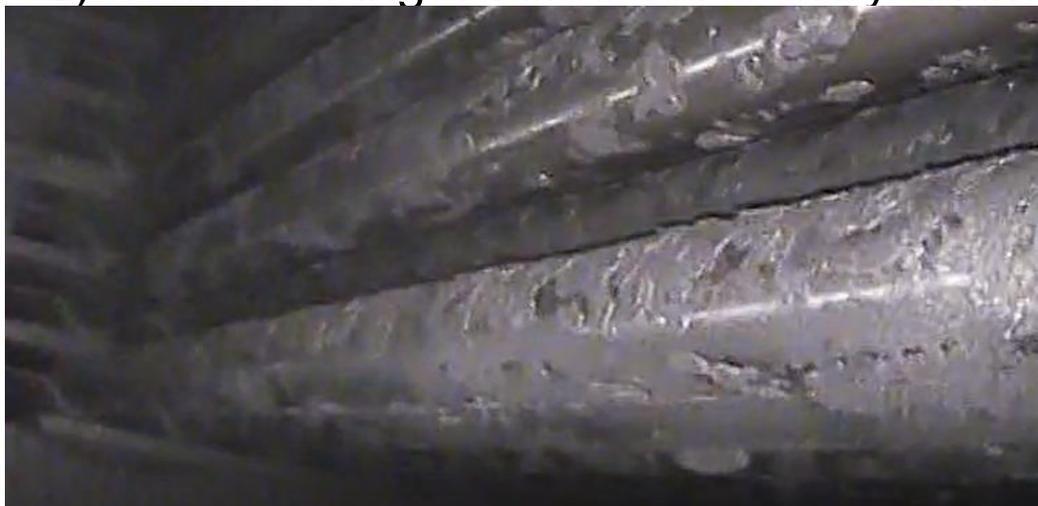
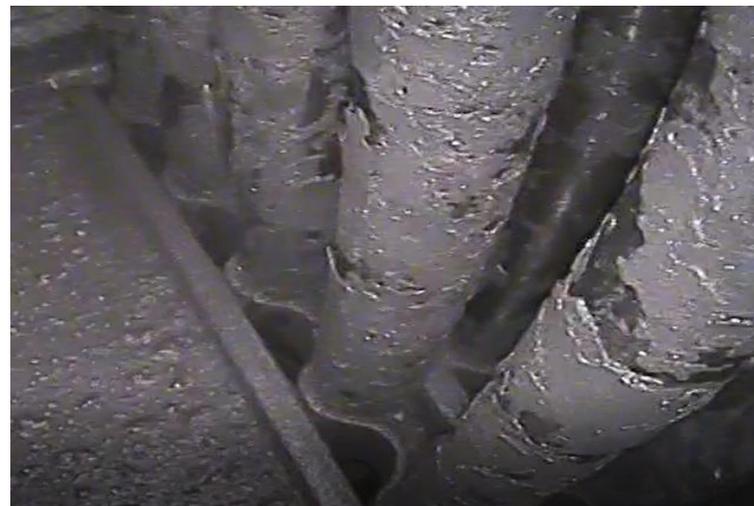
- during visual control, a sediment in the secondary part of the steam generator was detected

2) heat exchanger tubes covered by an impurities

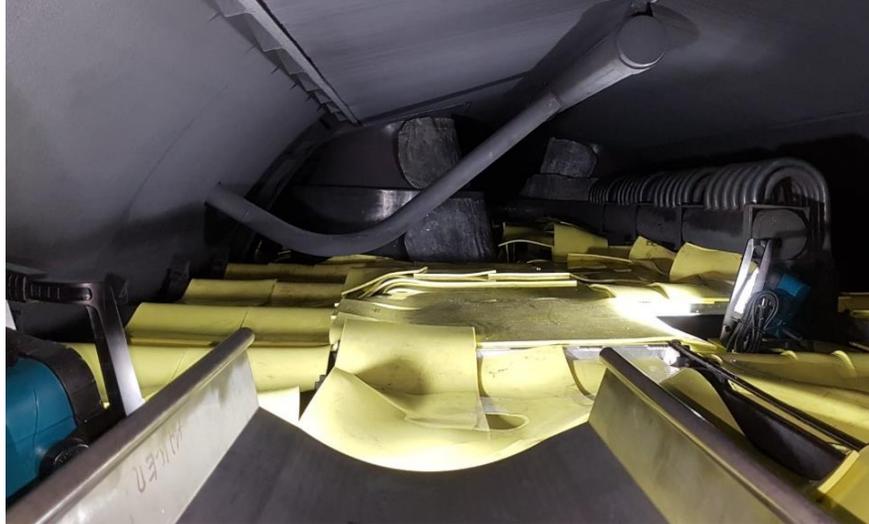
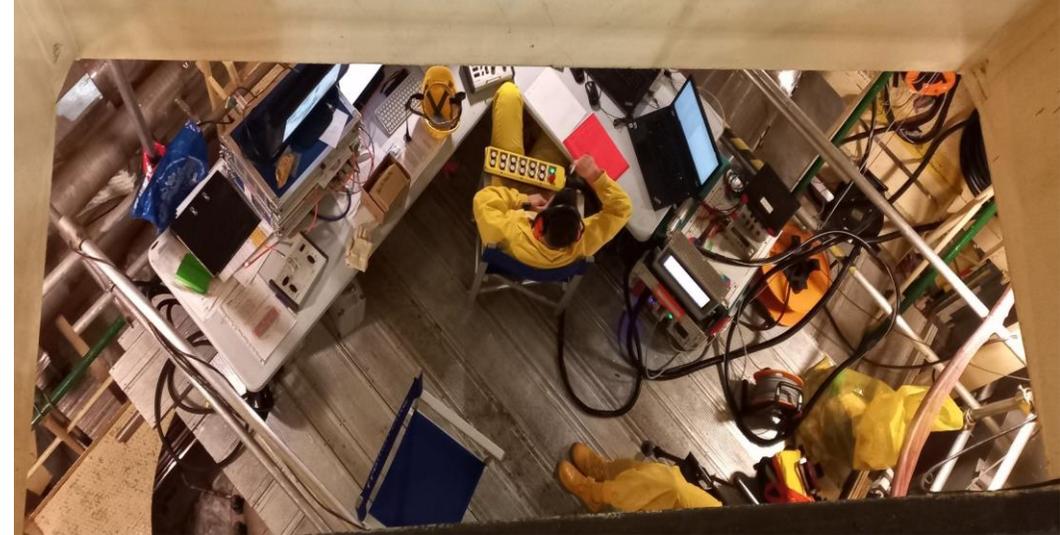
1st part – PREPARATION

- shielding, electric lightening, ventilation, cutting out struts and installation new ones, designated „radiation safe“ workspace for operators

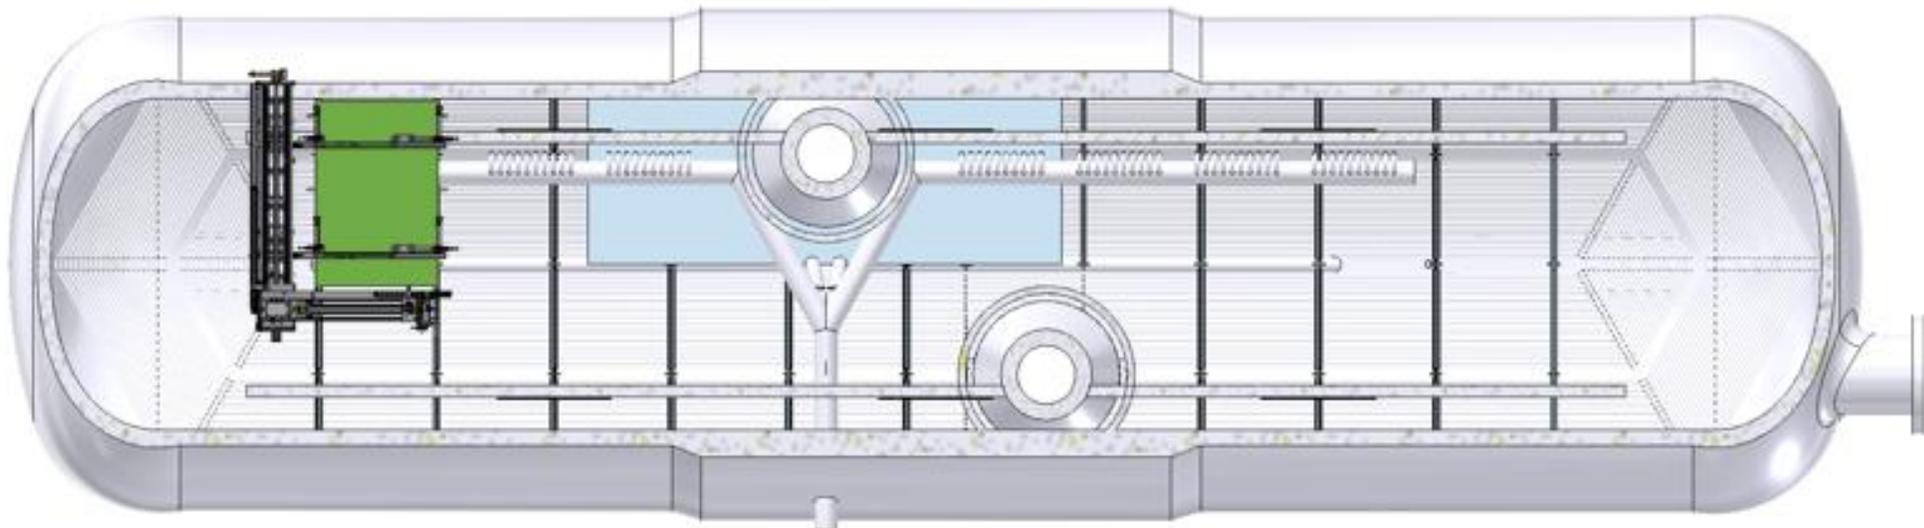
2nd part – EXPERIMENTAL CLEANING

- Is it effective? Should it continue?
- reason for choosing this segment: the largest sediment site

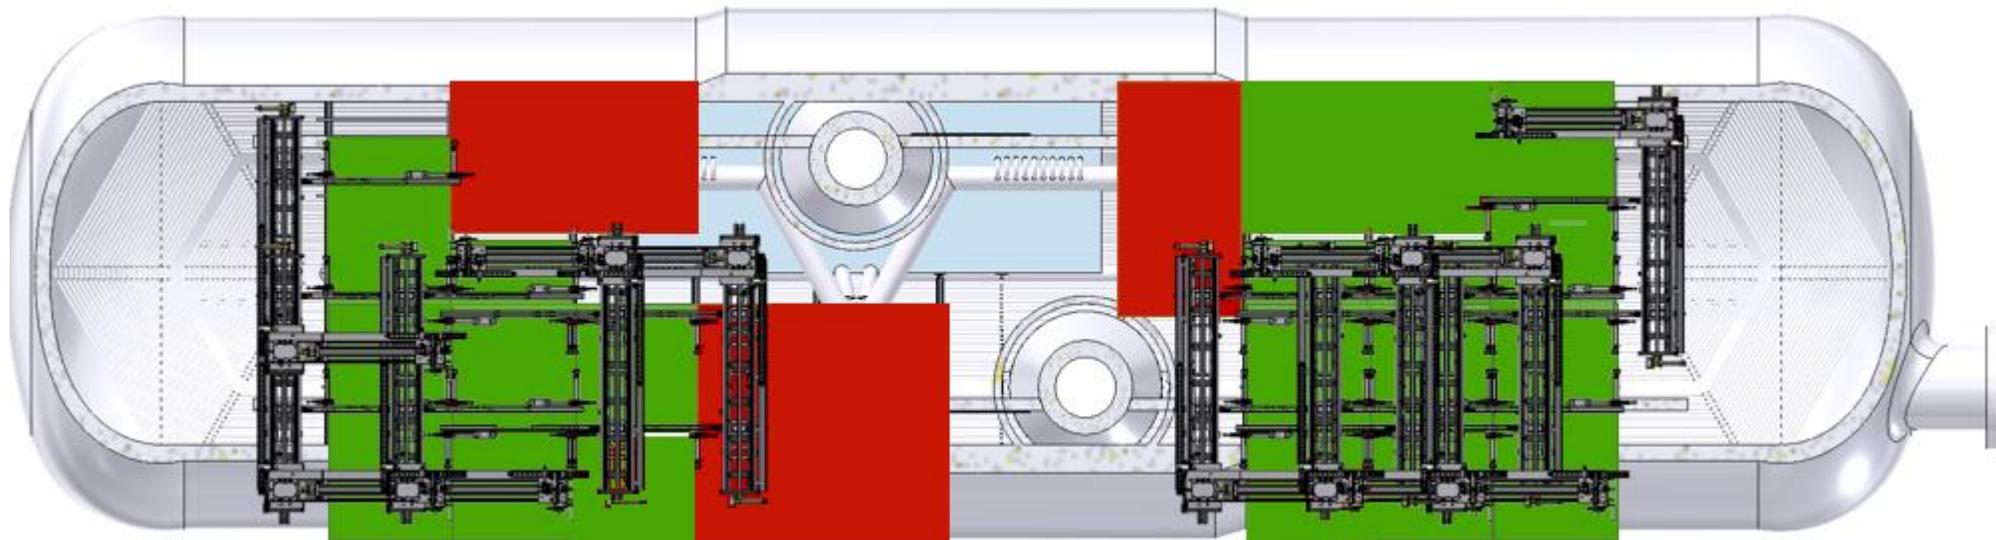
3rd part – CONTINUE OF CLEANING

- result of the experimental cleaning: YES – it is effective
- green parts - cleaned
- red parts - not cleaned – difficult access for the cleaning machine

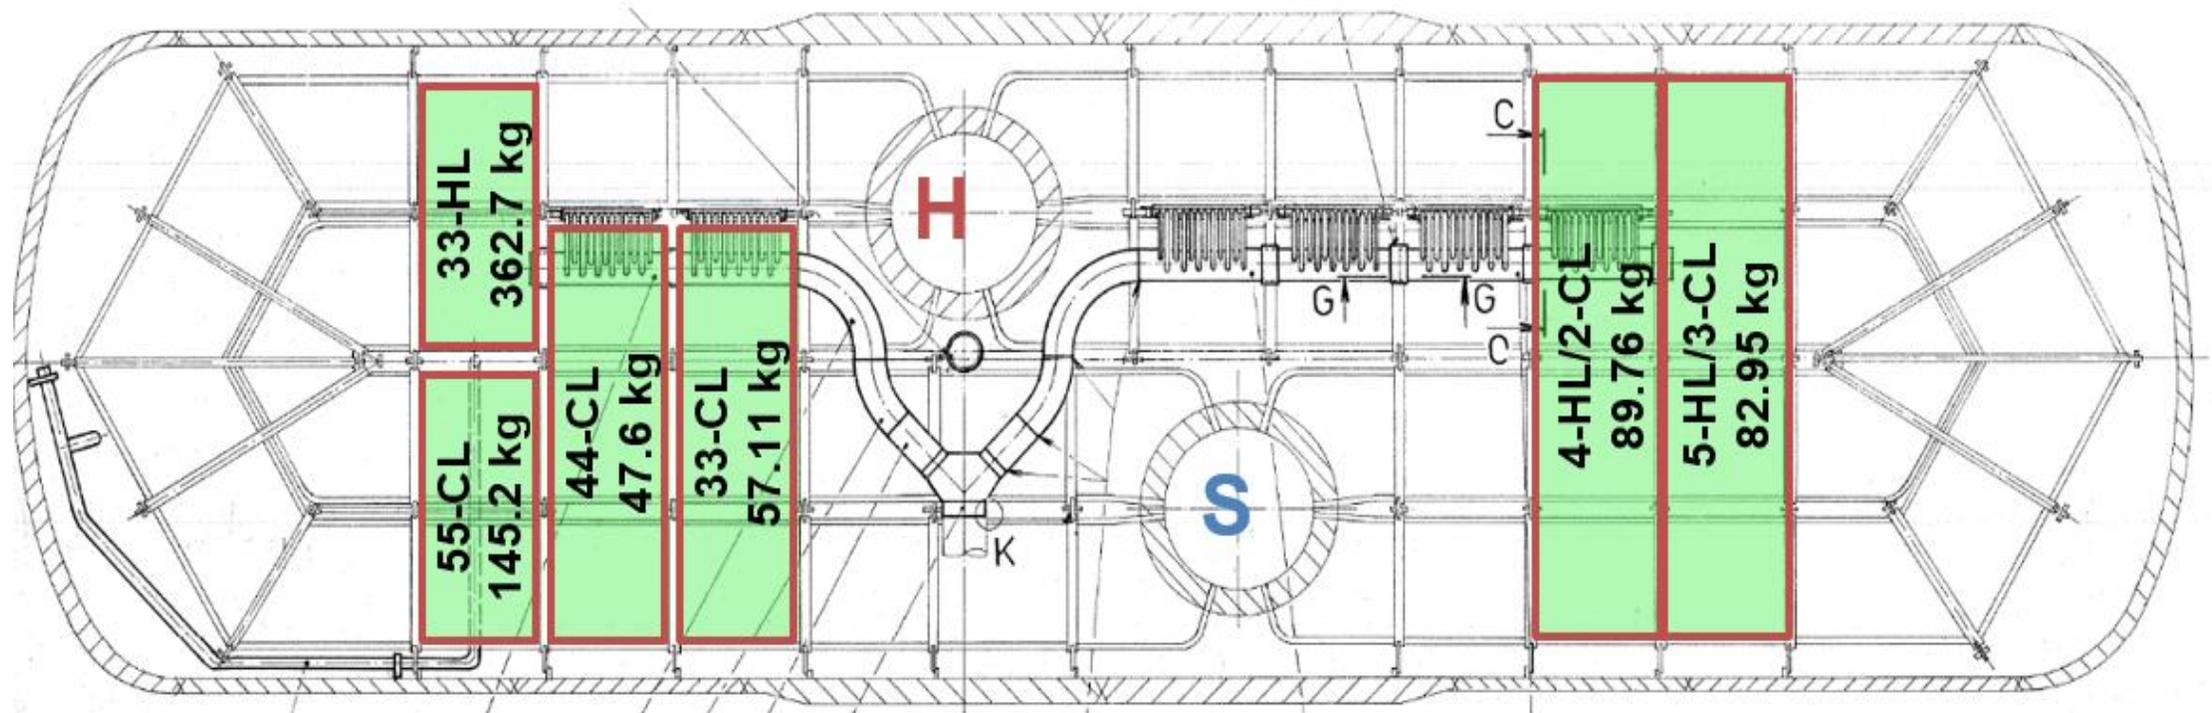
CLEANING RESULTS

Total amount of cleaned waste: 785 kg

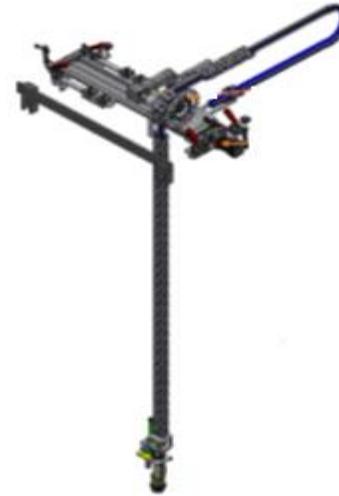
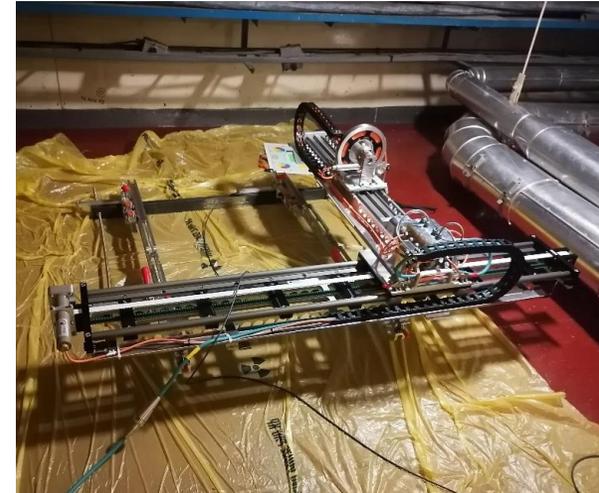
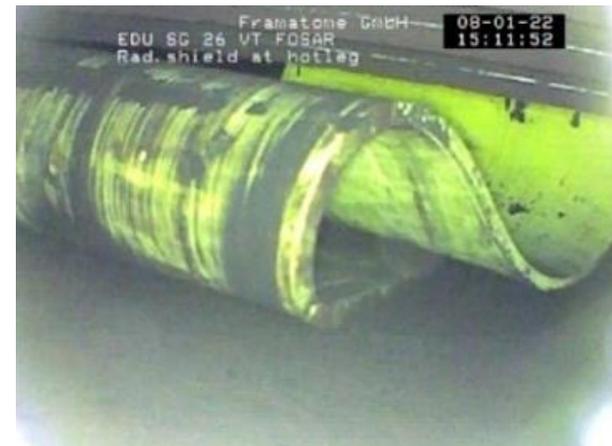
OBSTACLES DURING THE CLEANING

- cleaning equipment failure
 - loosening screws
 - cleaning head failure
- curvature of heat exchanger tube – complicated access
- fall of shielding on the bottom of the SG

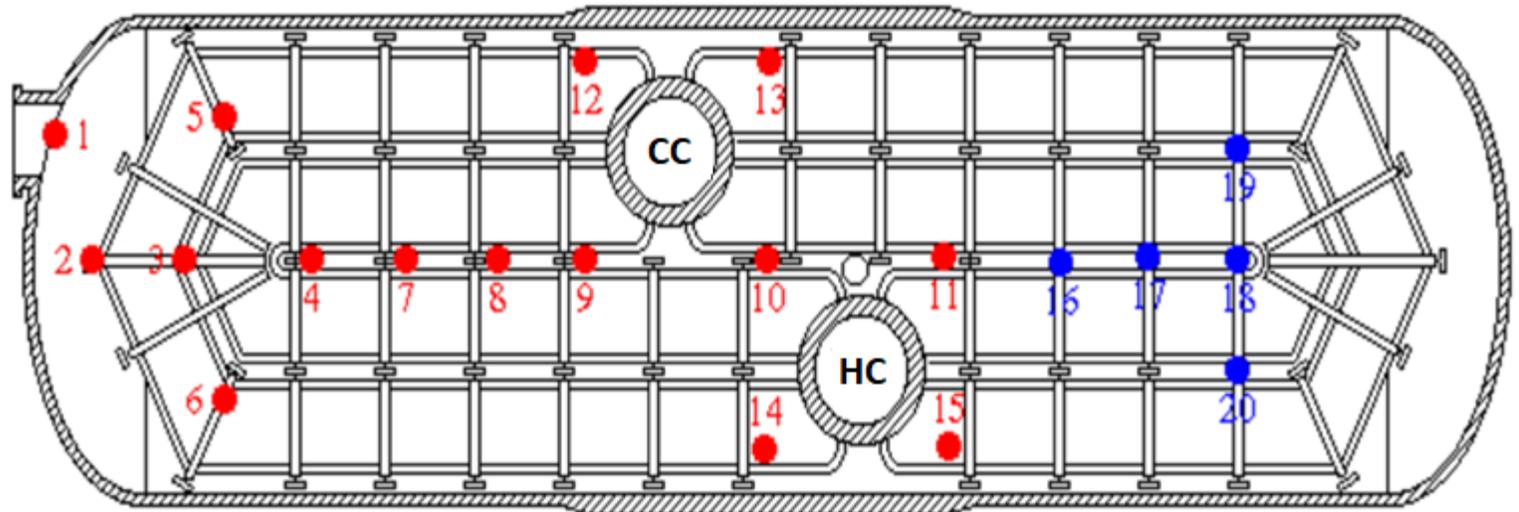
Radiation situation inside the secondary part of the steam generator:

Measuring points	Dose rate [$\mu\text{Sv/h}$]	
	without shielding and water	with shielding and water
1	2000	750
2	3500	1800
3	4500	1800
4	4800	2000
5	5500	5000
6	6000	2000
7	5300	2000
8	5400	1800
9	5000	1000
10		2000
11		1300
12		5000
13		4200
14		800
15		800
16		2000
17		2000
18		1500
19		1800
20		1200
Average	4666,7	2037,5

- filling a secondary part of a steam generator with water
- shielding installation (80 pcs)
- assessment of exposure situations - optimisation - designated radiation work permit
- dose plan – individual and collective
- individual doses daily check

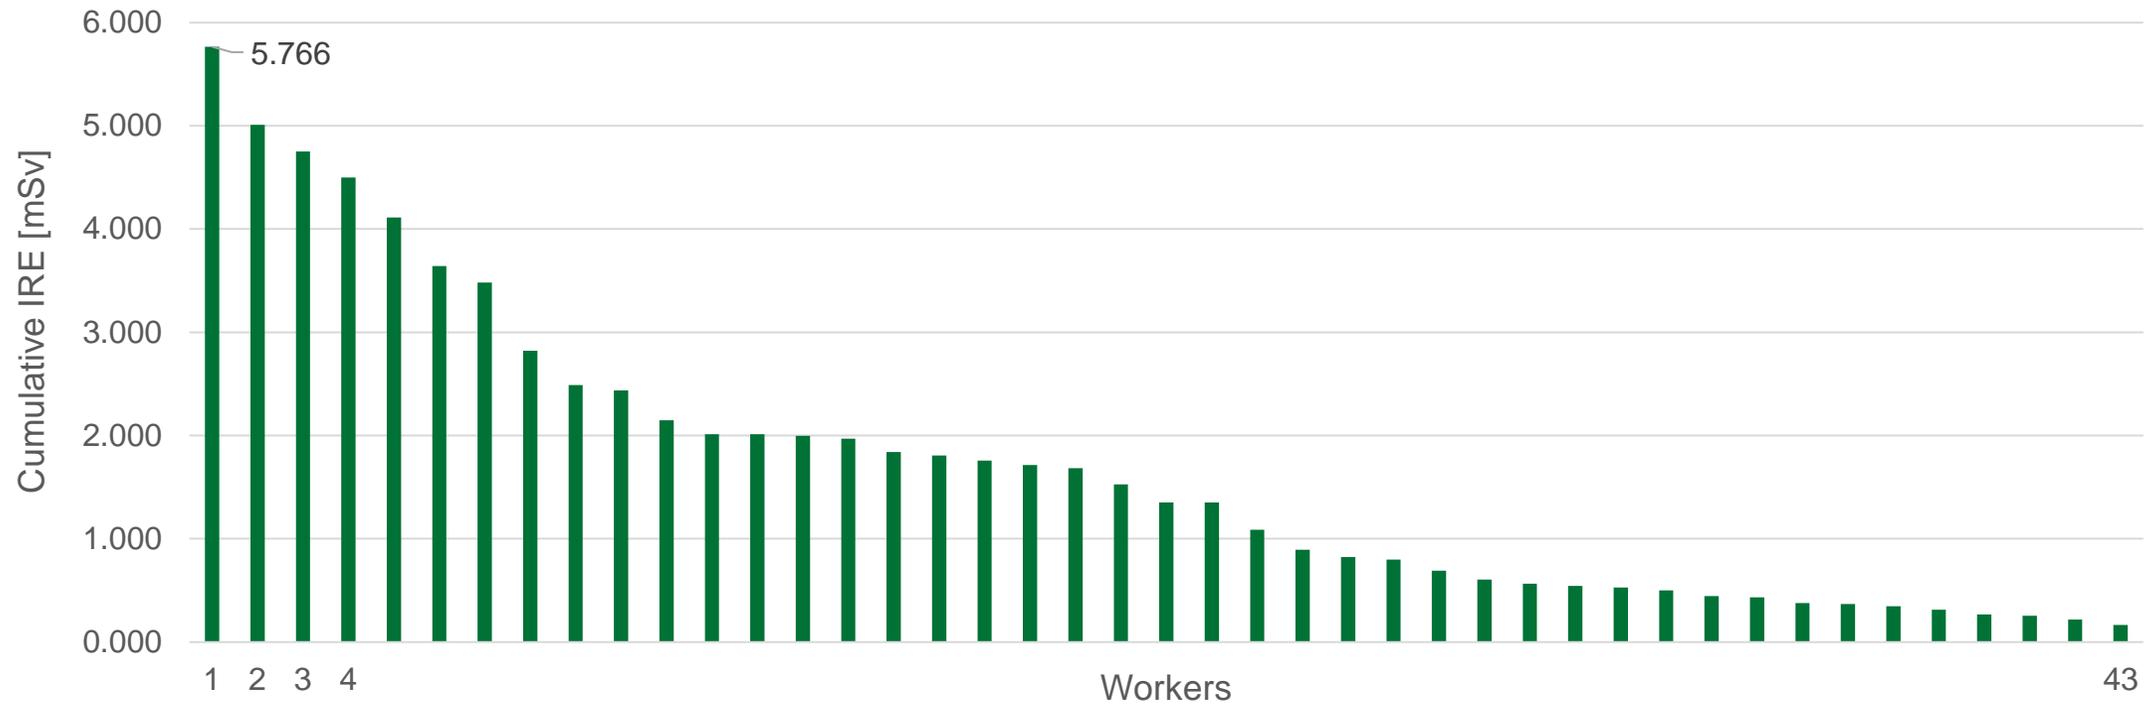
Cumulative IED

- 70% IEDs < 2 mSv

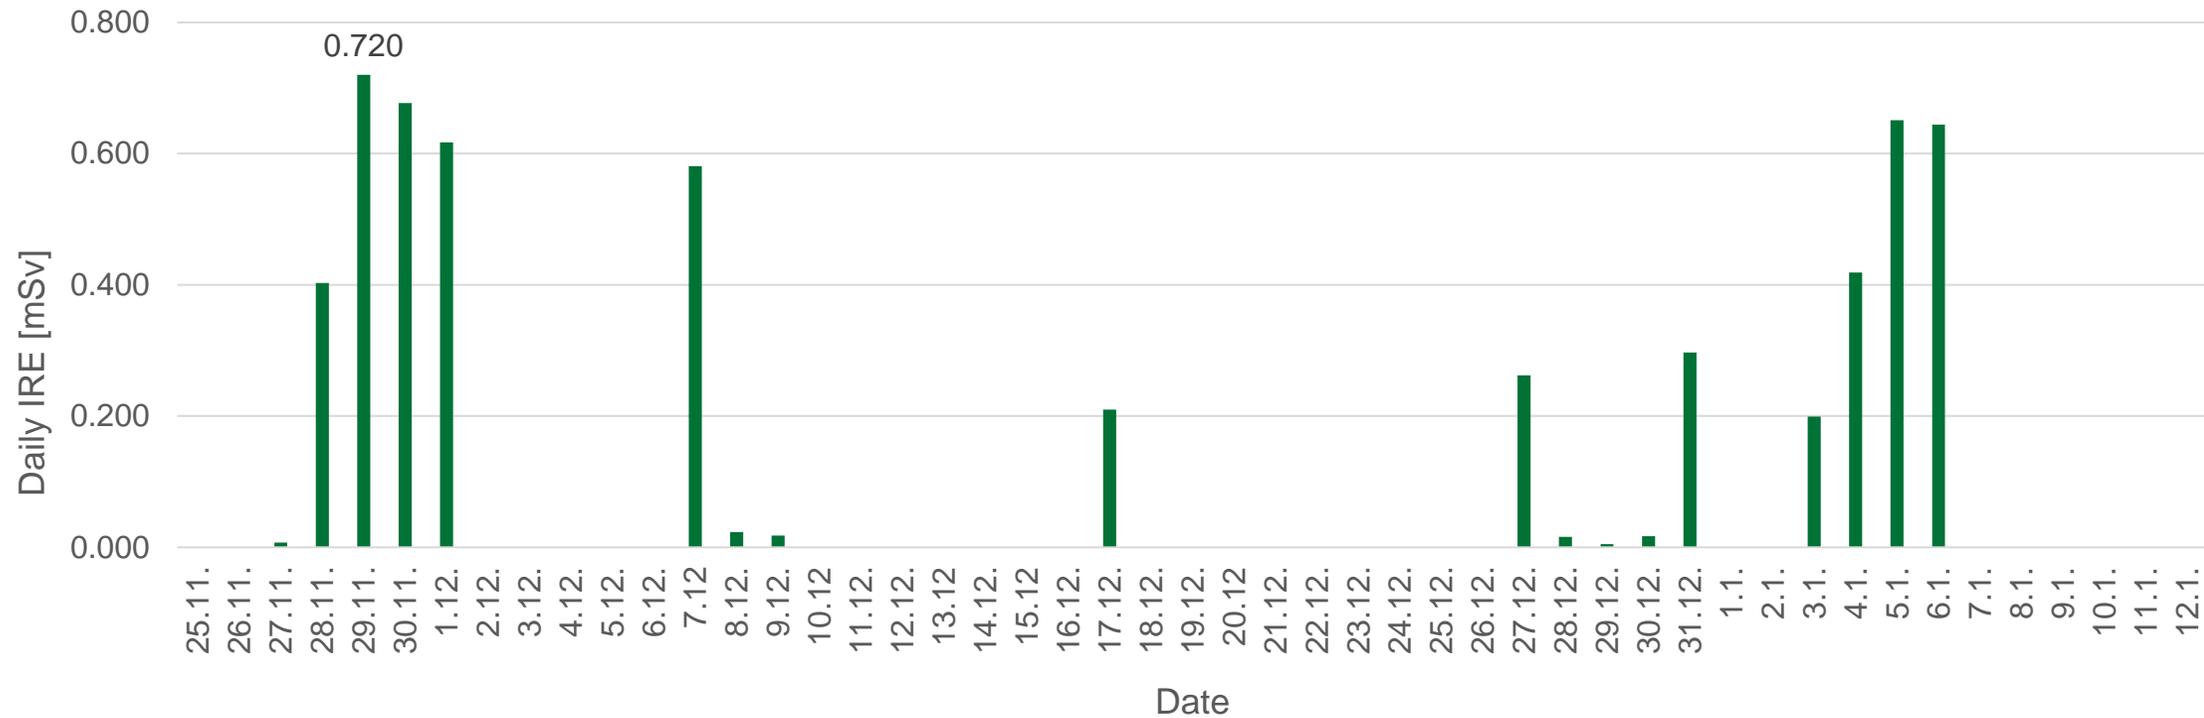
Daily IED - most exposed worker

- maximum daily dose was 720 μ Sv
- the total dose for the whole period was 5,8 mSv
