# Lessons Learned from the Fukushima Daiichi Accident to Establish Resilience Technology for Nuclear Power Plants Based on the Defense in Depth Philosophy

Jan. 12 , 2015

Dr. Tadashi NARABAYASHI

President of Japan Society of Maintenology

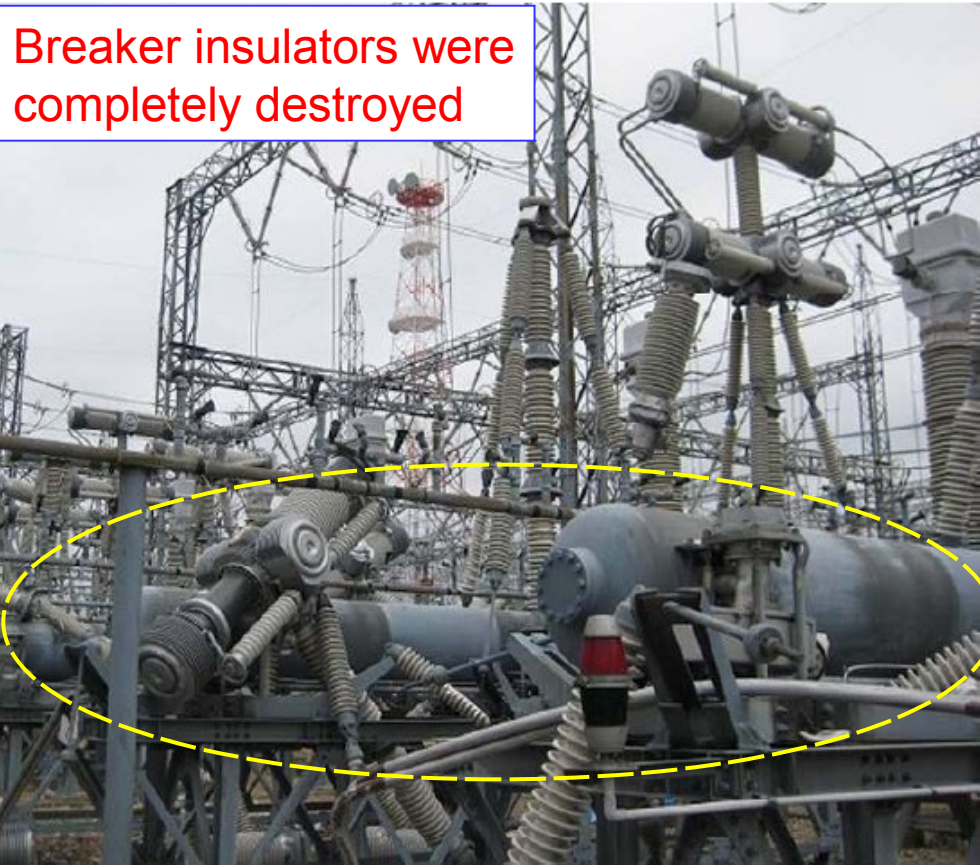
■ External AC Power was lost in Fukushima Daiichi

Breaker insulators were completely destroyed

Damaged ABB(Air Blast Breaker)  
Fukushima Daiichi Unit 1-4

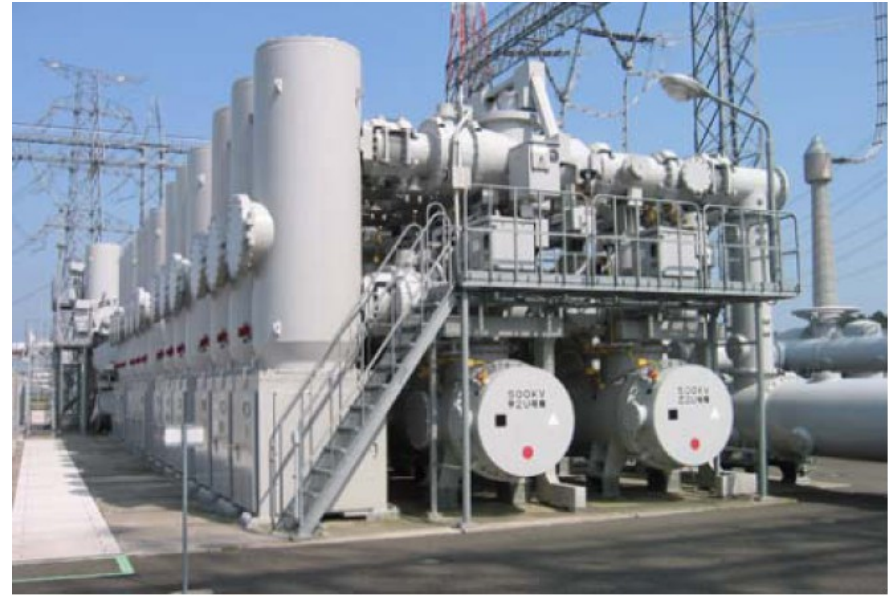
GIS : Gas Insulated Switchgear  
Onagawa Unit 1-3 were OK

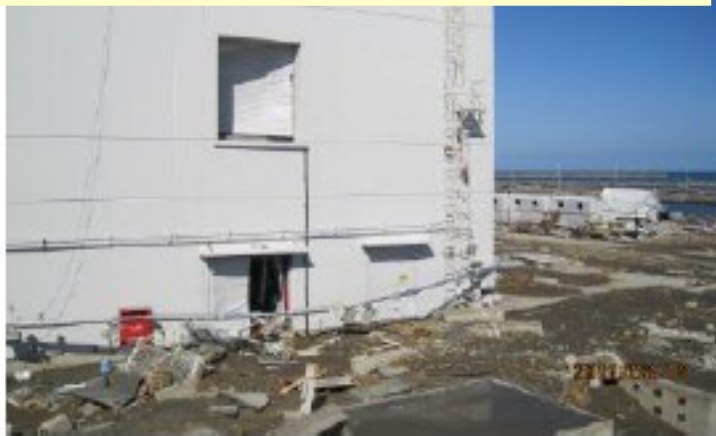
Sea water heat exchanger room

Damages of heat exchanger room and heat exchanger (Unit 1)

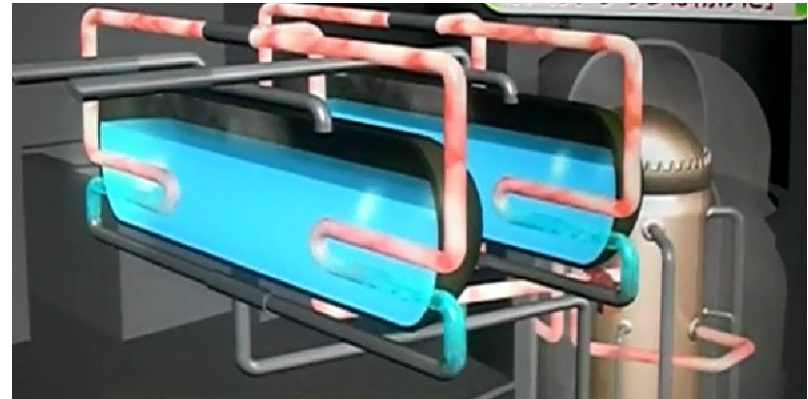
# ICs in unit 1 were tripped by FC

- Loss of battery power for main control room caused the **fail-close action** to MO isolation valves to cut off the IC cooling.
- **It was act as a fail-dangerous system under the loss of DC.**
- If the IC continue to operate, the accident would be terminated.

- RCIC steam turbine also stopped by loss of battery power in Unit 3.
- S/P temperature and pressure were so high that AM water injection took a lot of times.

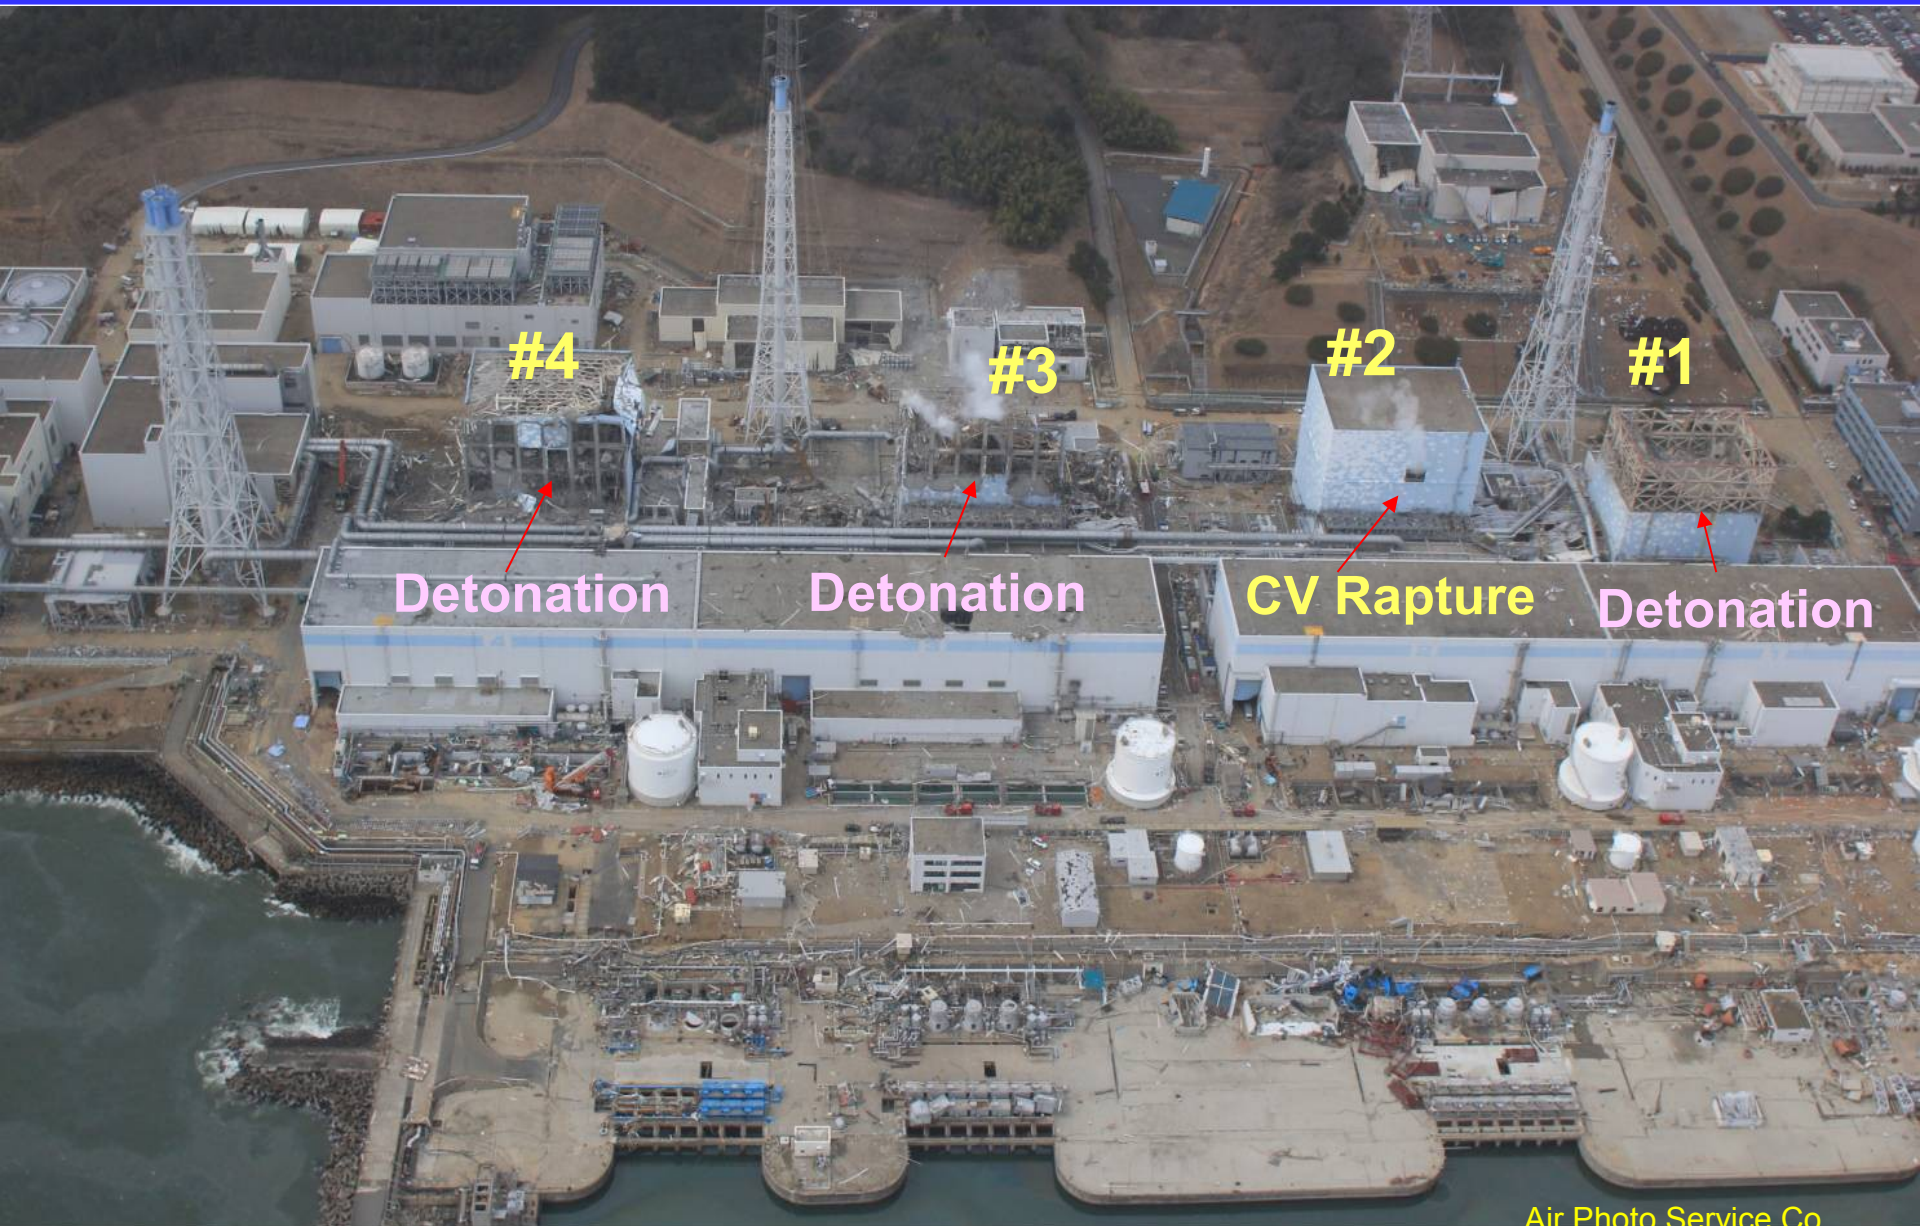
# Hydrogen Detonation and CV Rapture

- H2 detonation were occurred after vent operation (#1, #3, #4)
- Radiation level increased soon after #2 CV rapture

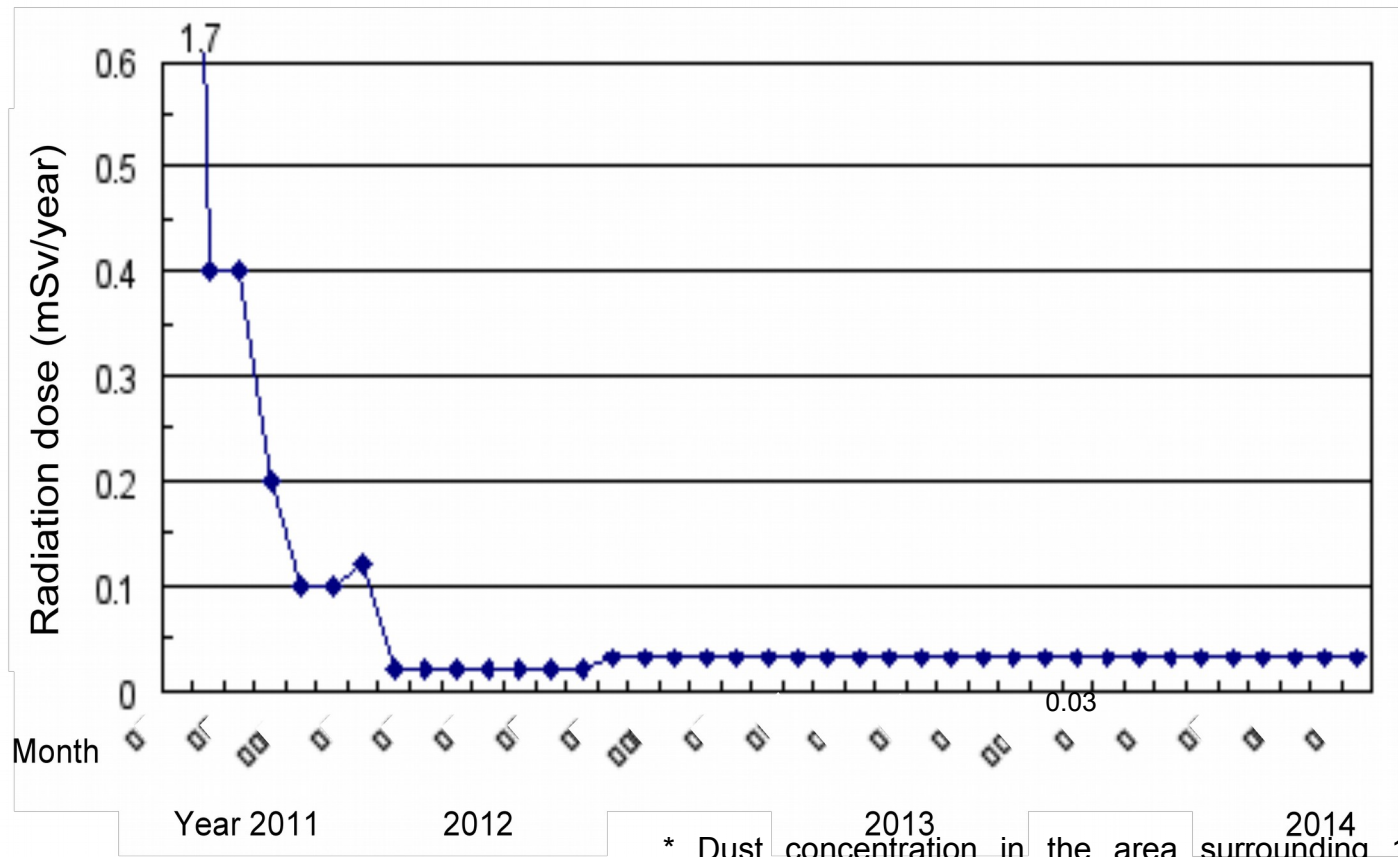
## Annual dose on the site boundary by radioactive materials (cesium) released from R/B in Units 1 to 4

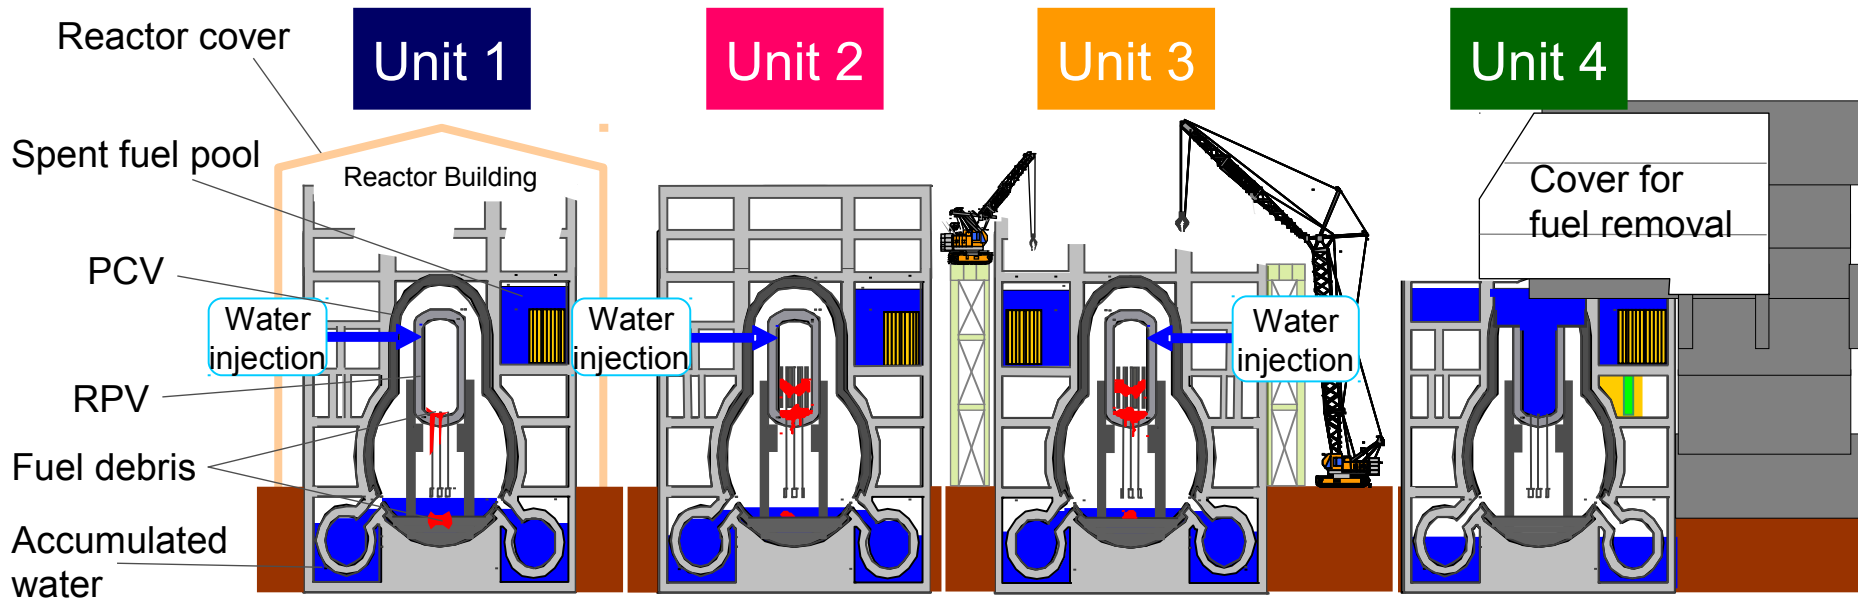
**Cold shutdown is being maintained at all reactors**

Unit 1	Unit 2	Unit 3	Unit 4
RPV bottom temp.	About 29°C	About 36°C	About 34°C	-
PCV internal temp.	About 29°C	About 37°C	About 34°C	-
Fuel pool temp.	About 26°C	About 22°C	About 21°C	About 22°C
Reactor cooling water injection volume	About 4.6m <sup>3</sup> /h	About 4.5 m <sup>3</sup> /h	About 4.3 m <sup>3</sup> /h	-

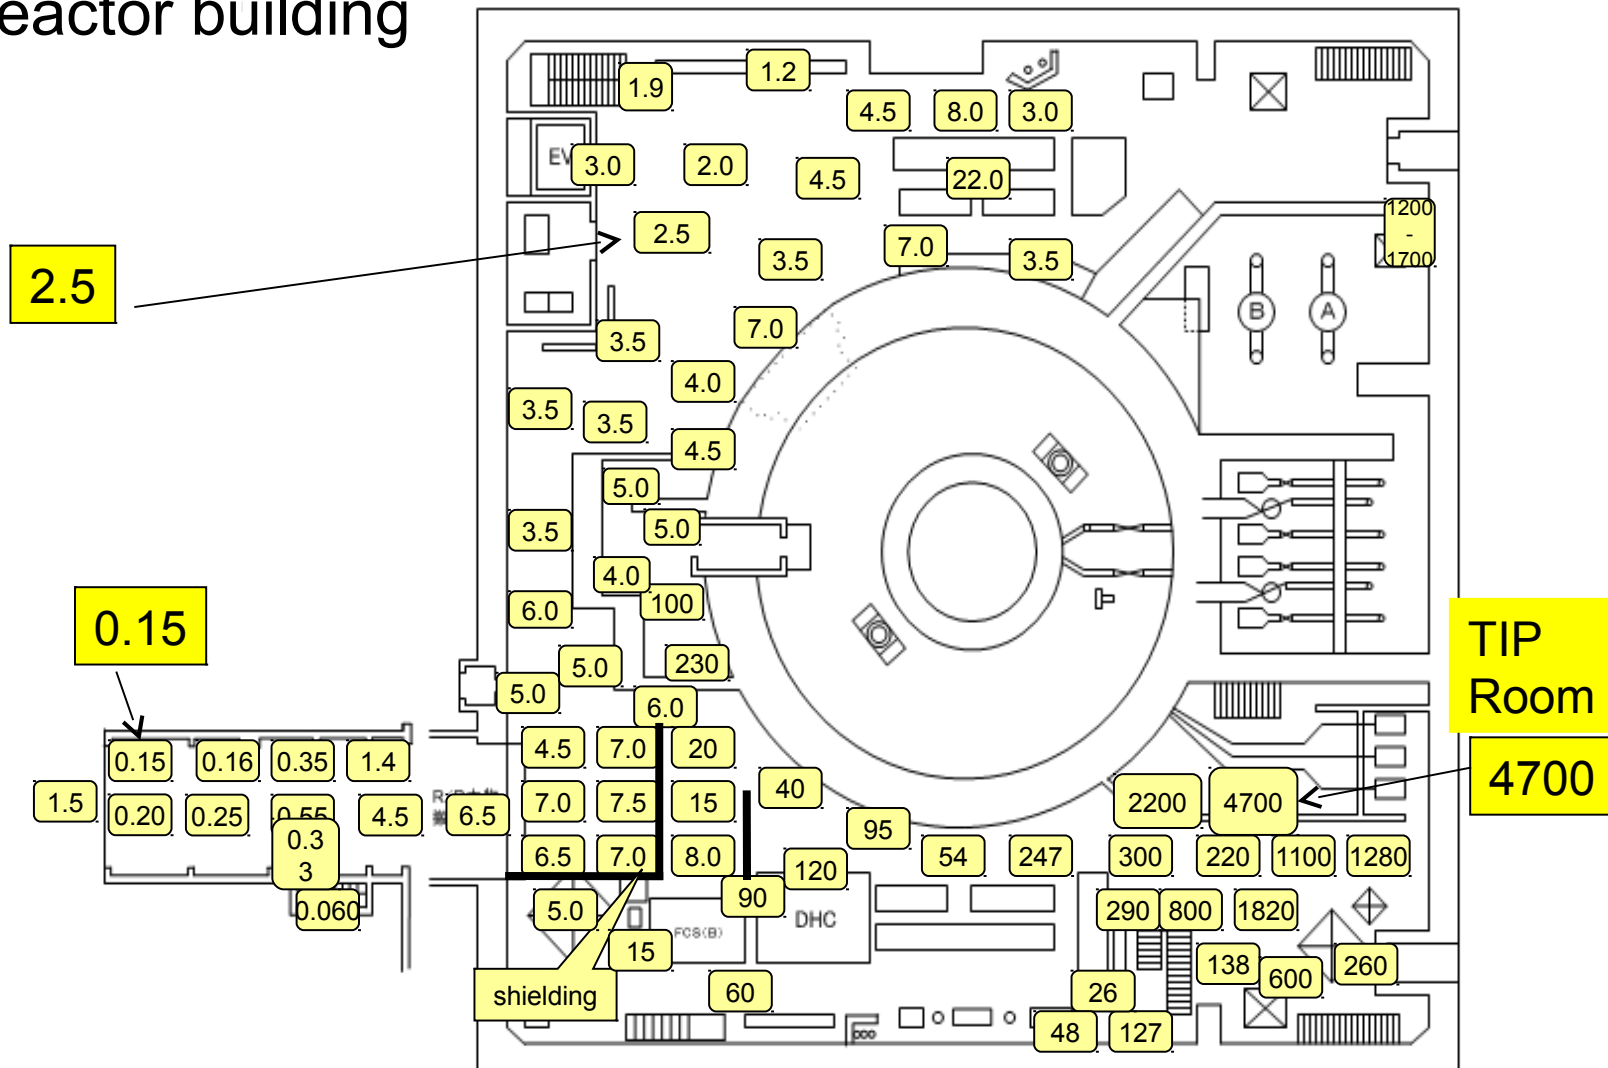
Unit 1: Reactor building  
1<sup>st</sup> Floor

# Radiation Dose Map in Unit 1 Building

Unit : mSv/h

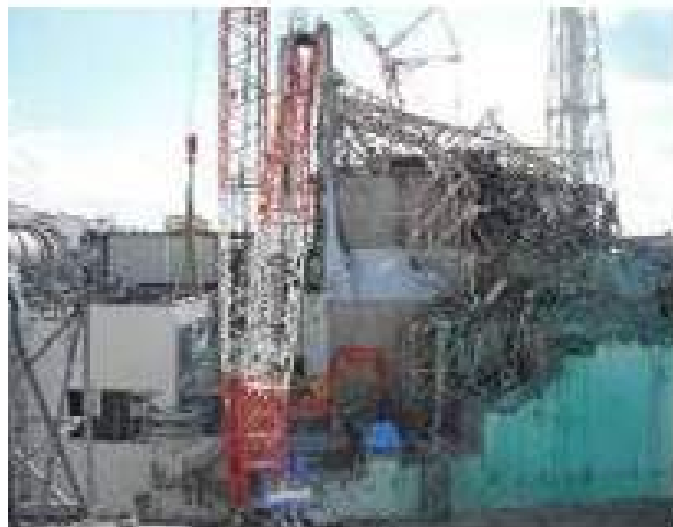
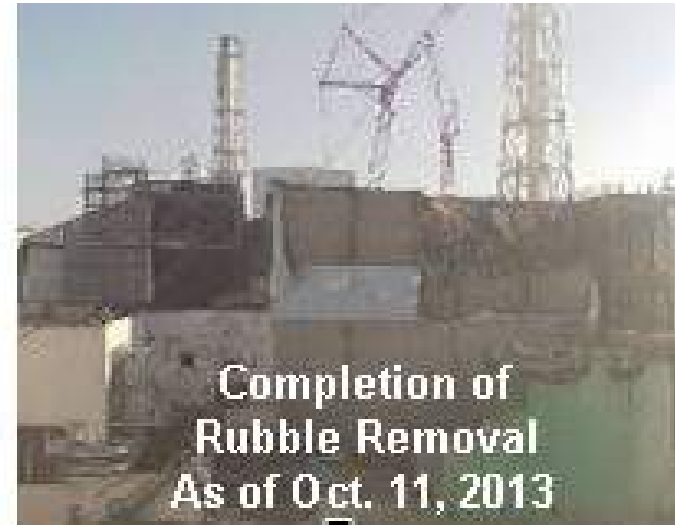
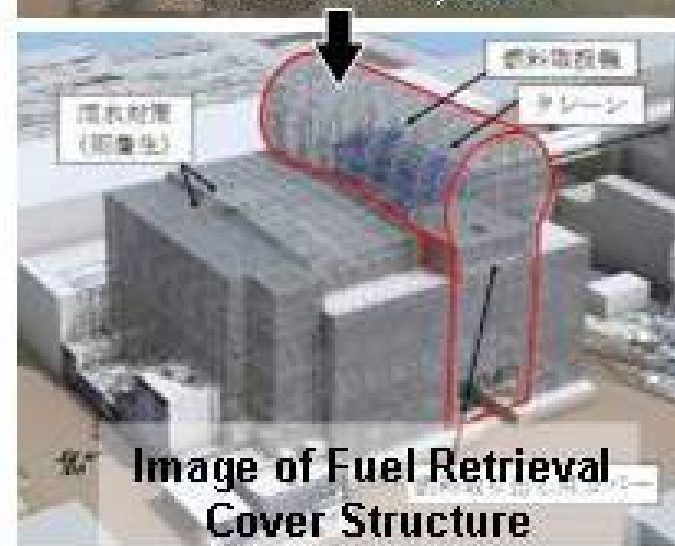
**Rubble removal from the top of the reactor building completed. Installation of fuel removal cover and fuel handling facility planned**

**Damaged by  
Hydrogen Explosion  
As of Feb. 12, 2012**

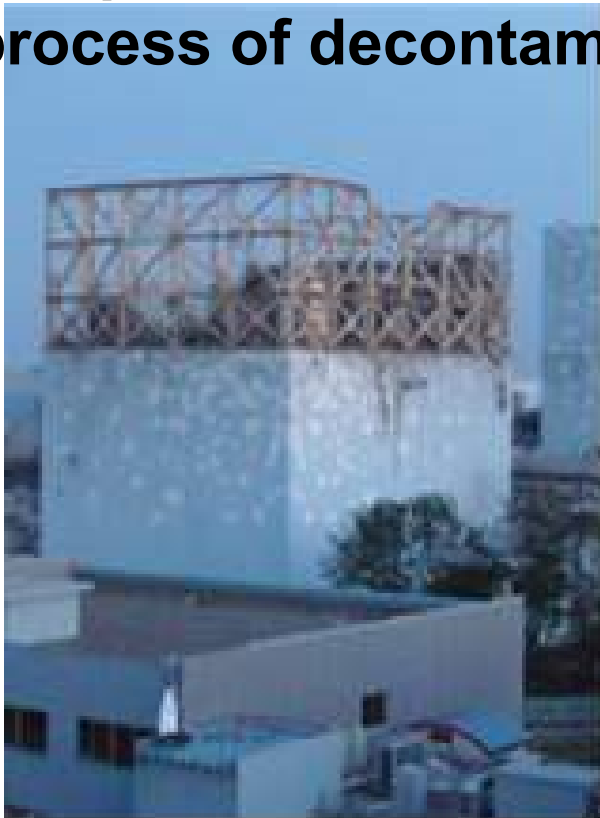
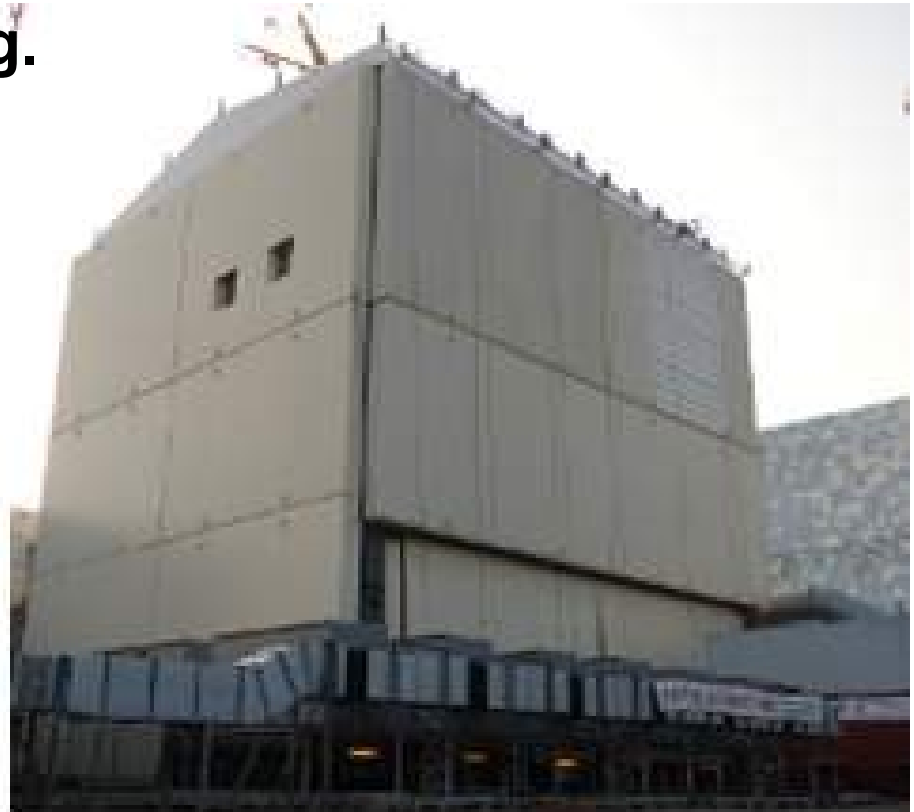
**Sustained stable reactor cooling.**

**The protective cover will soon be removed to continue the process of decontaminating.**

**Damaged by  
Hydrogen Explosion  
As of Mar. 12, 2011**

**Completion of Cover Structure  
As of Oct. 28, 2011**

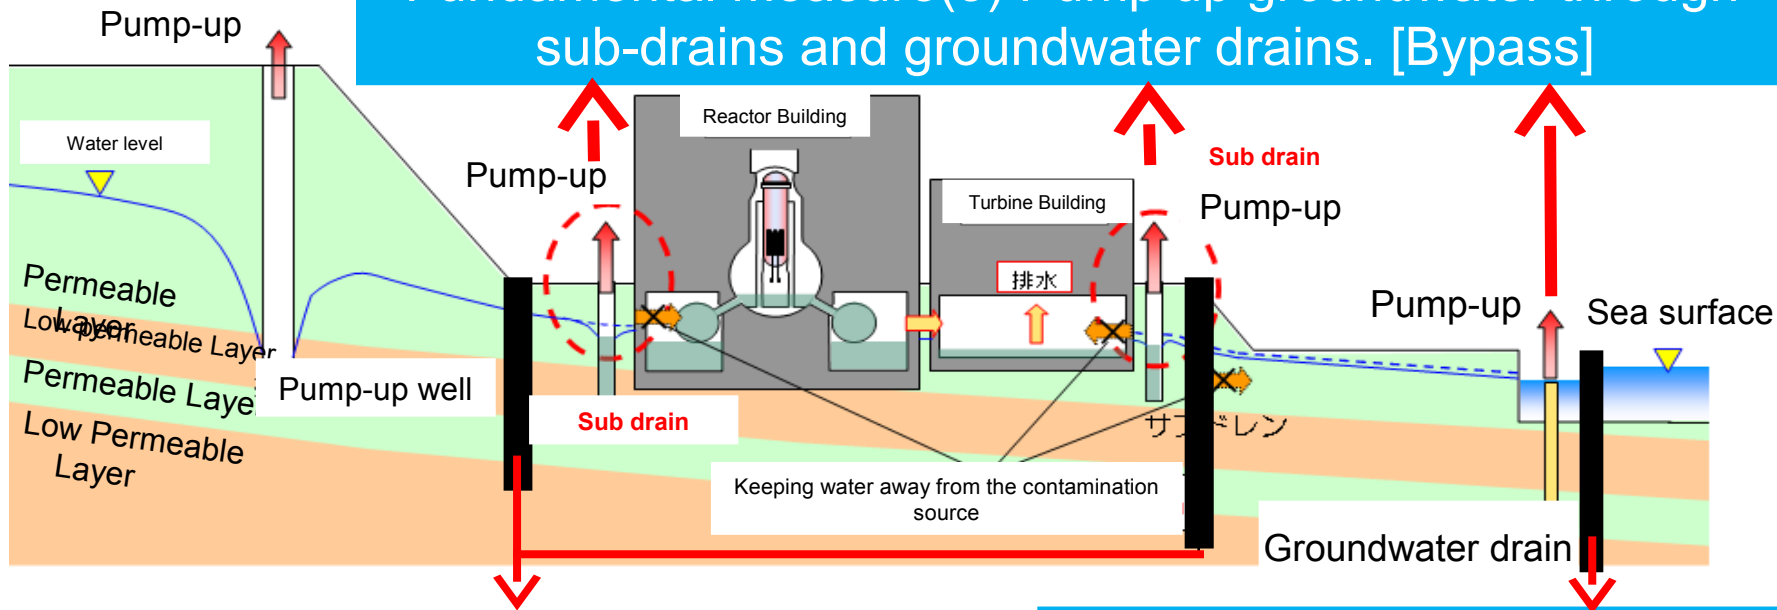
Fundamental Measure(3) Pump up groundwater through sub-drains and groundwater drains. [Bypass]

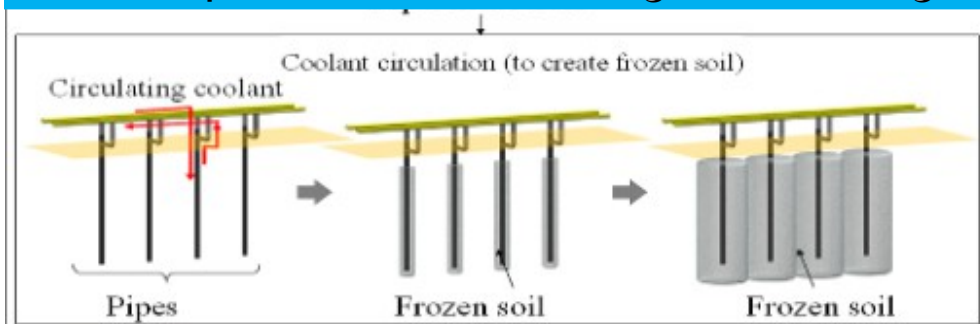
Fundamental Measure (2)  
Install the land-side water-shielding frozen walls to prevent water flowing into buildings

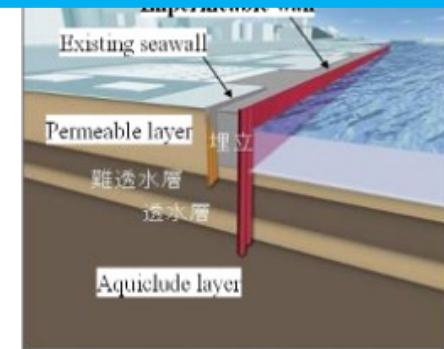
Fundamental Measure (1)  
Install the sea-side water-shield walls to prevent leakage

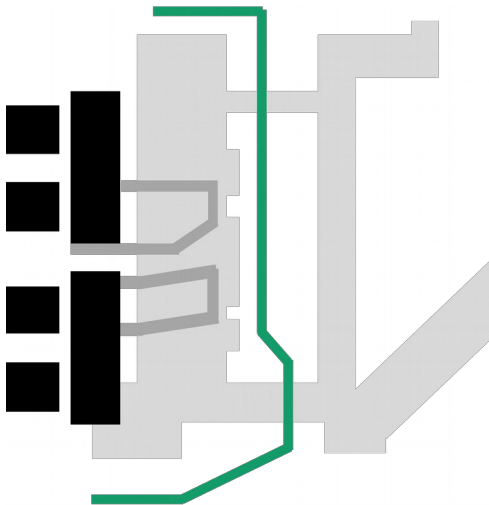
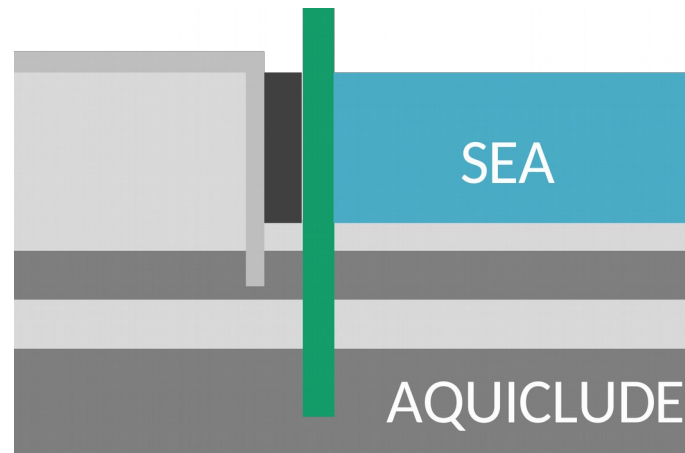
**Block groundwater flowing between the facility and the sea**

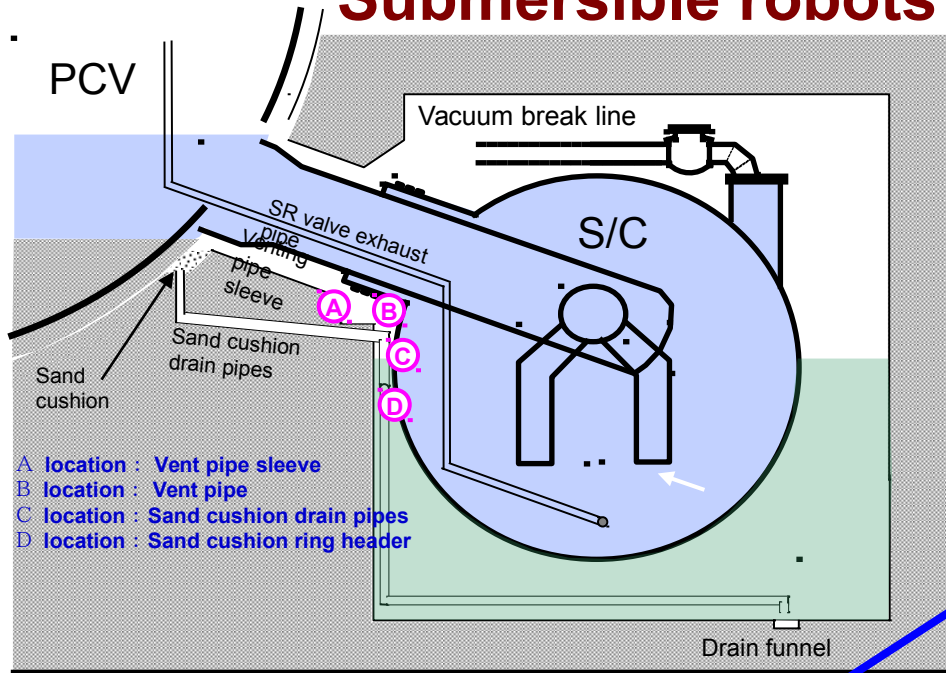
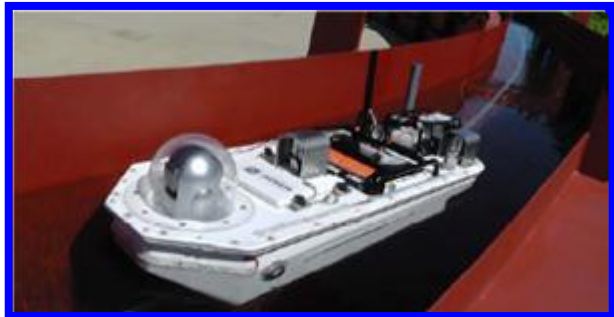
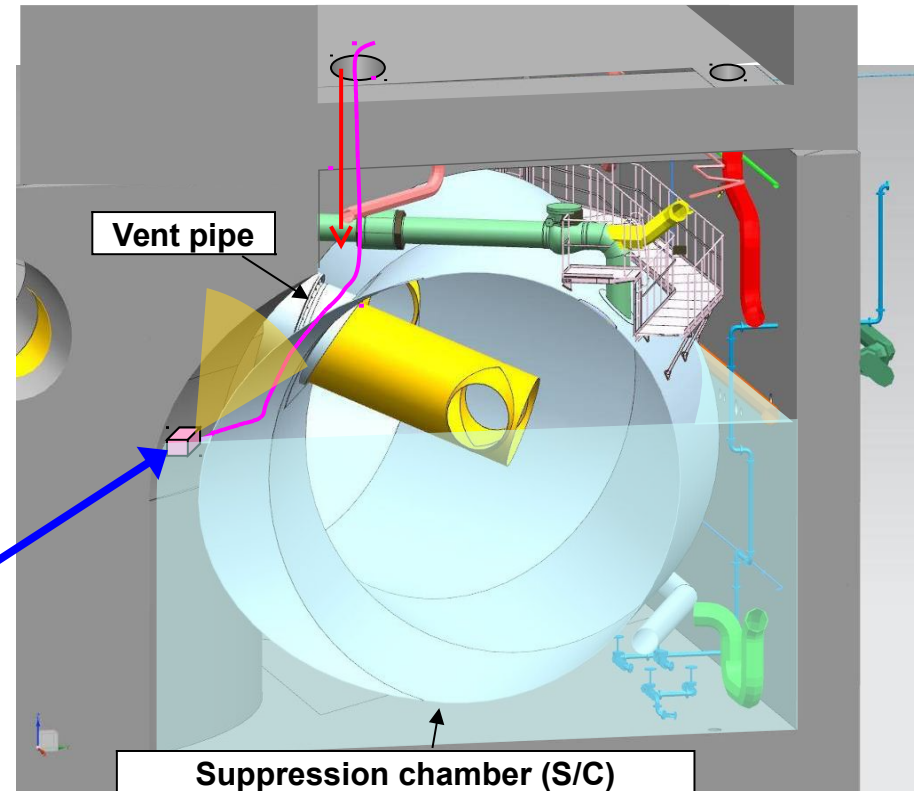
## Survey and repair toward filling PCV with water - Submersible robots

Cross-section of basement  
floor of R/B (torus room)

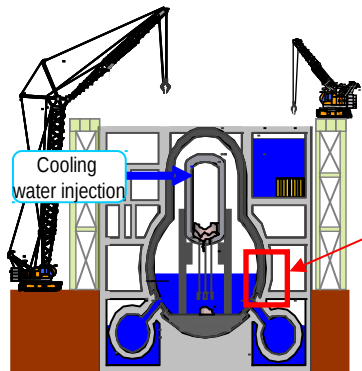
## Finding of water leakage

MSIV room  
Piping penetration part

Main steam isolation valve (MSIV) piping penetration part  
Cross-section schematic diagram

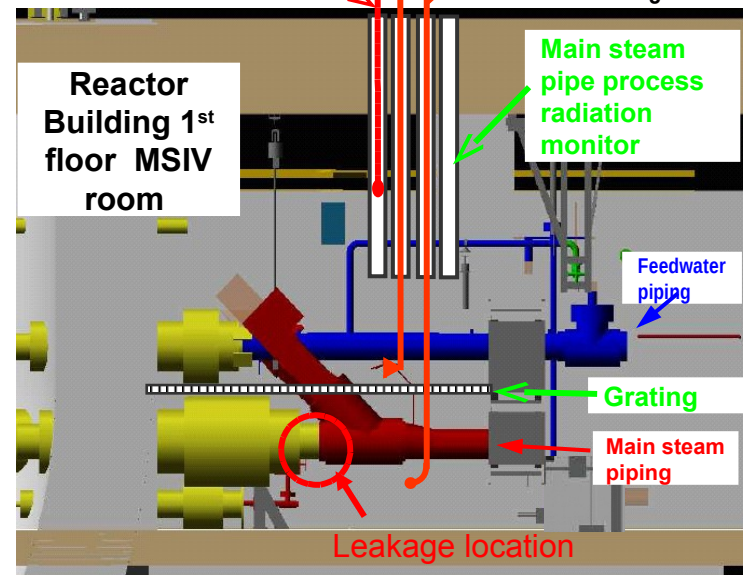
Reactor Building 1st floor MSIV (cross-section)

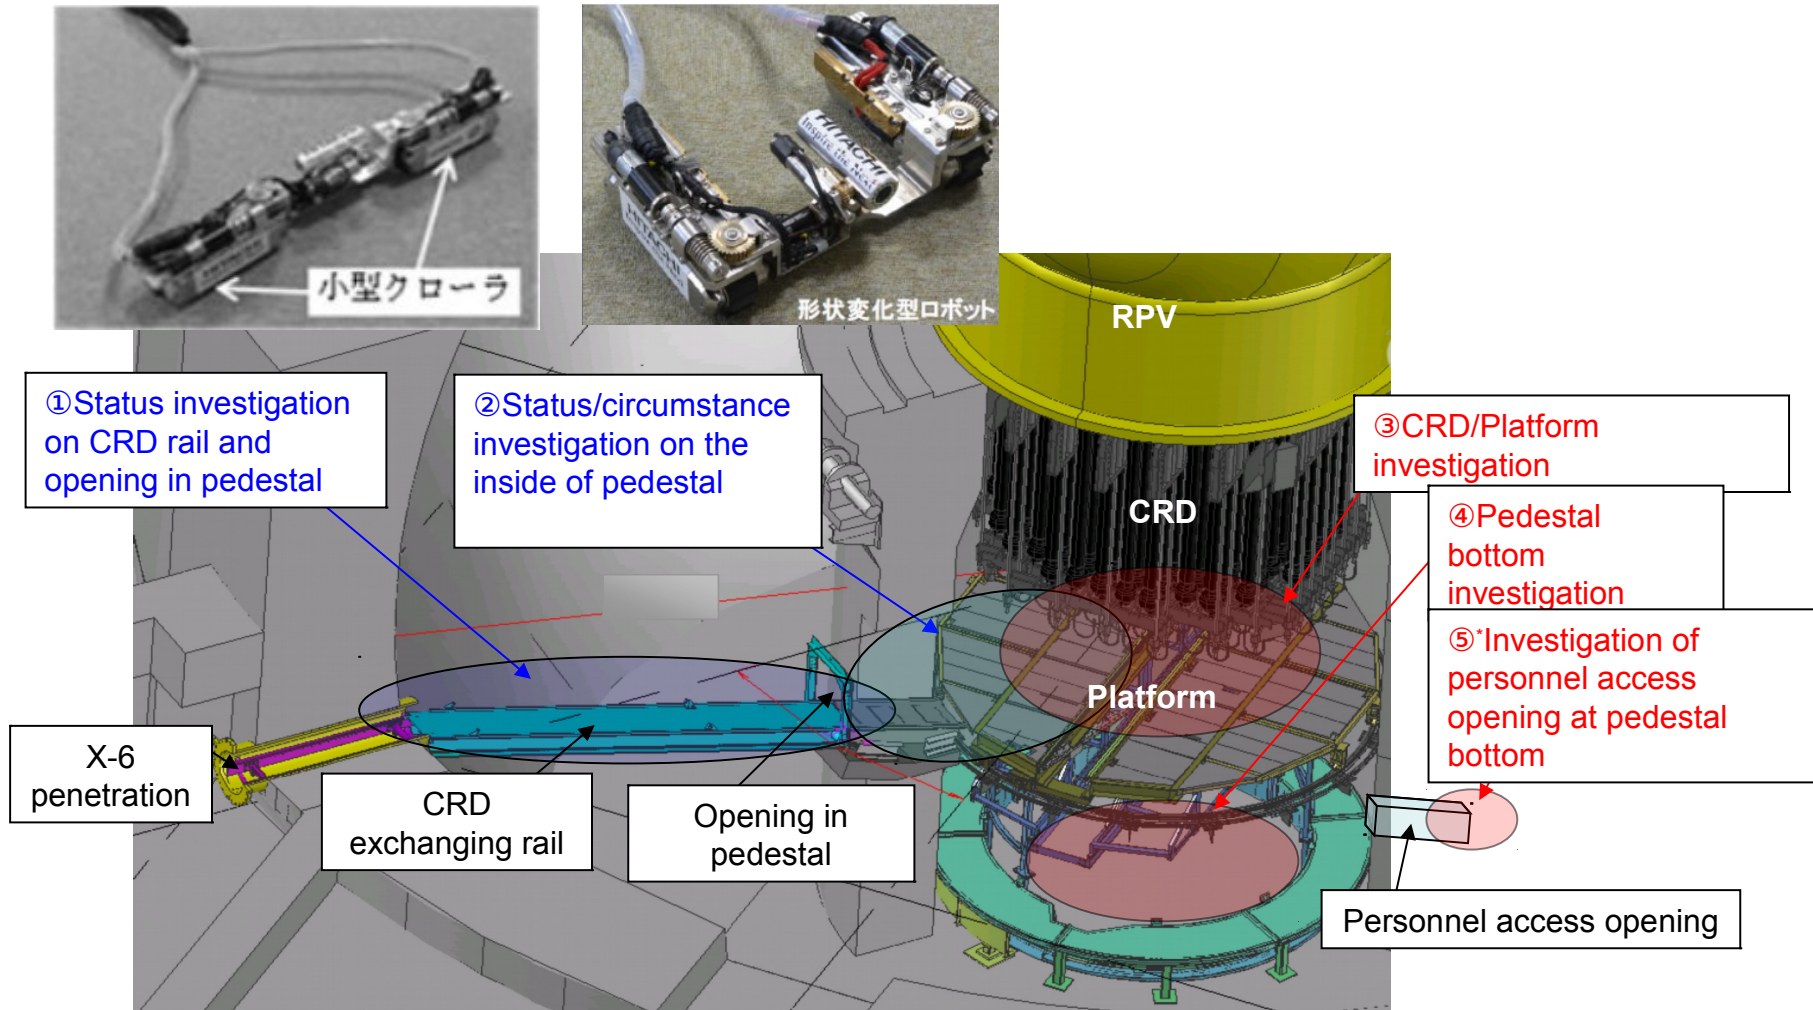
## (1/2) Transformer Type Robot for Investigation debris at pedestal

\* As for ⑤, access from the outside of pedestal is also considered.

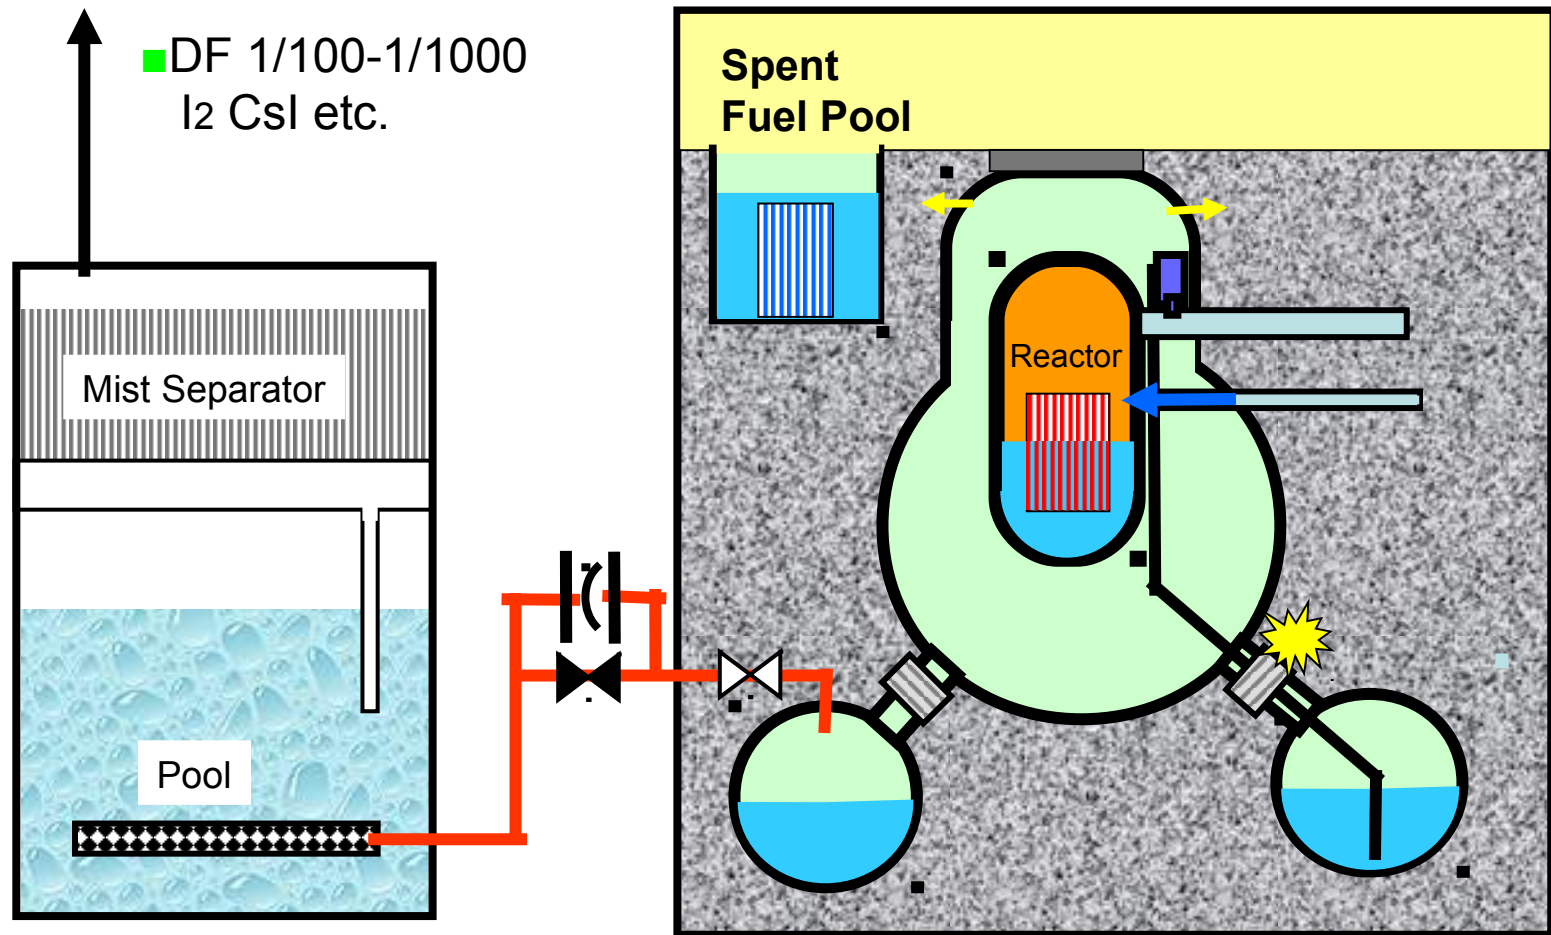
- Lessons of Chernobyl NPP Accidents promoted the installation of Filtered Vent System to protect radioactive materials exhaust.  
( French, German, Switzerland, Finland, Sweden )

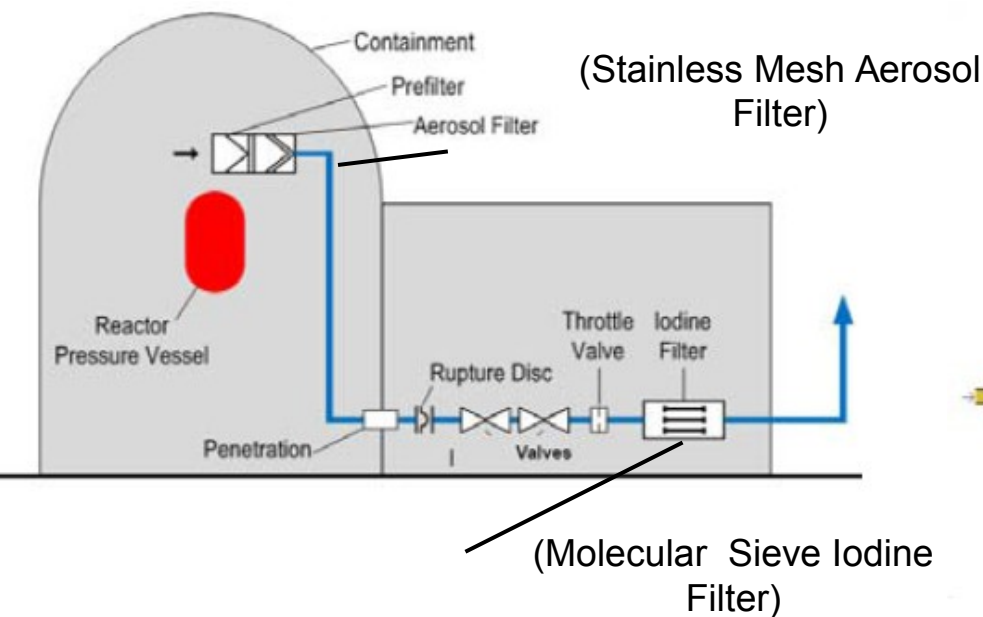
(Dry Type)  
Stainless Mesh Aerosol Filter + Molecular Sieve Iodine Filter

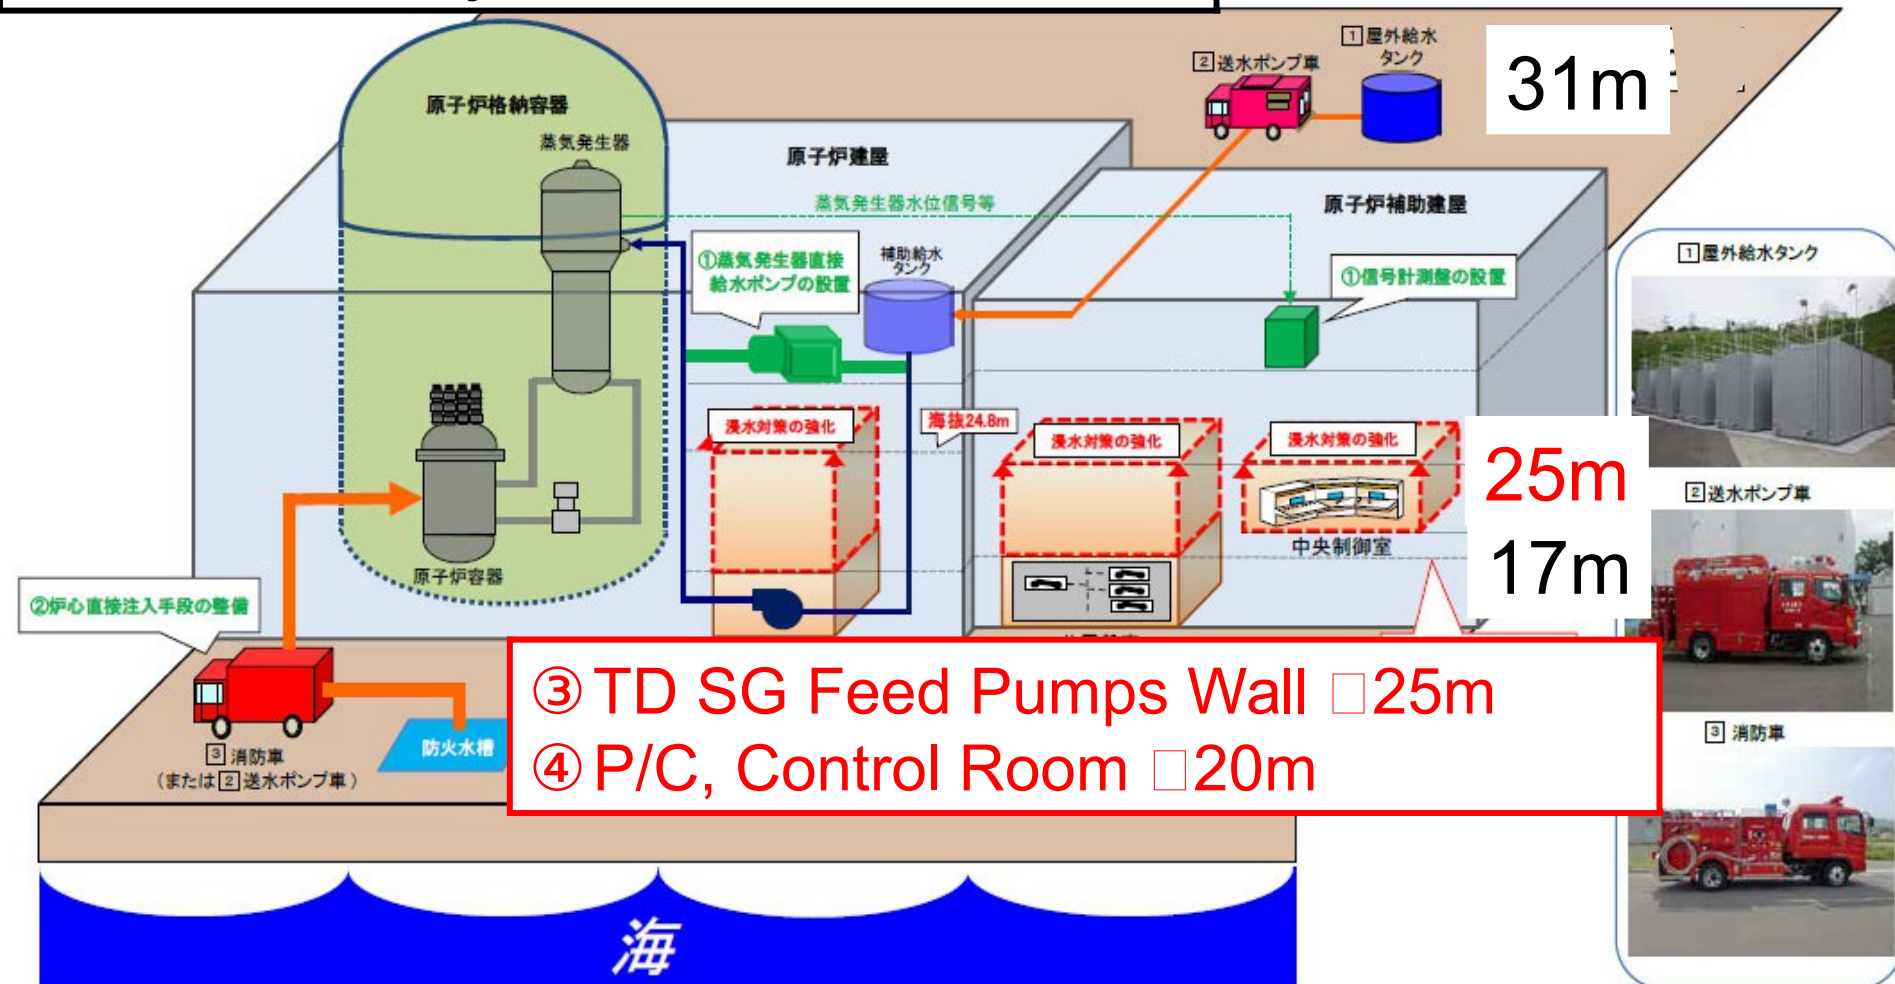
- ① SG Feed Water Pump at 31m
- ② Core Direct Injection Mobile Car at 31m
