# Lessons Learned from the Fukushima Daiichi Accident to Establish Resilience Technology for Nuclear Power Plants Based on the Defense in Depth Philosophy

Jan. 12 , 2015

Dr. Tadashi NARABAYASHI

President of Japan Society of Maintenology

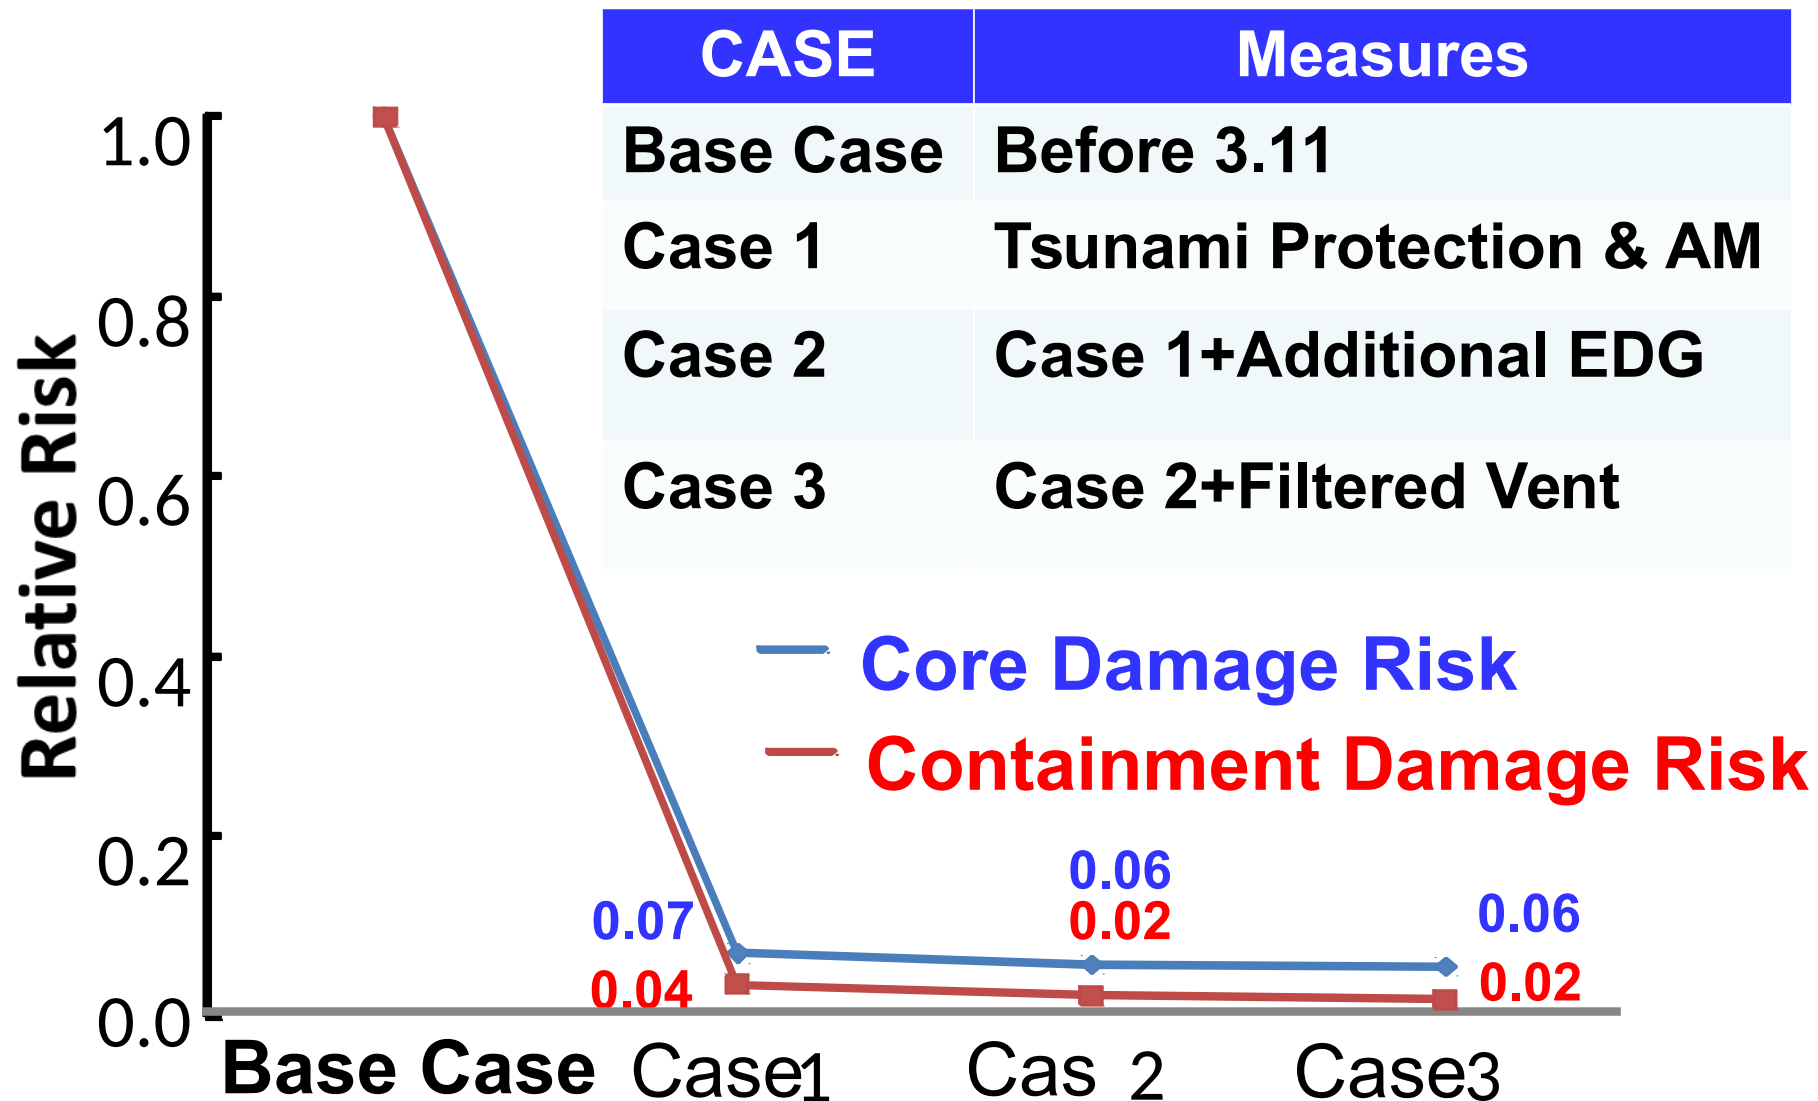
# Risk Reduction by Countermeasures

■ Base Case: Relative Risk=1.0

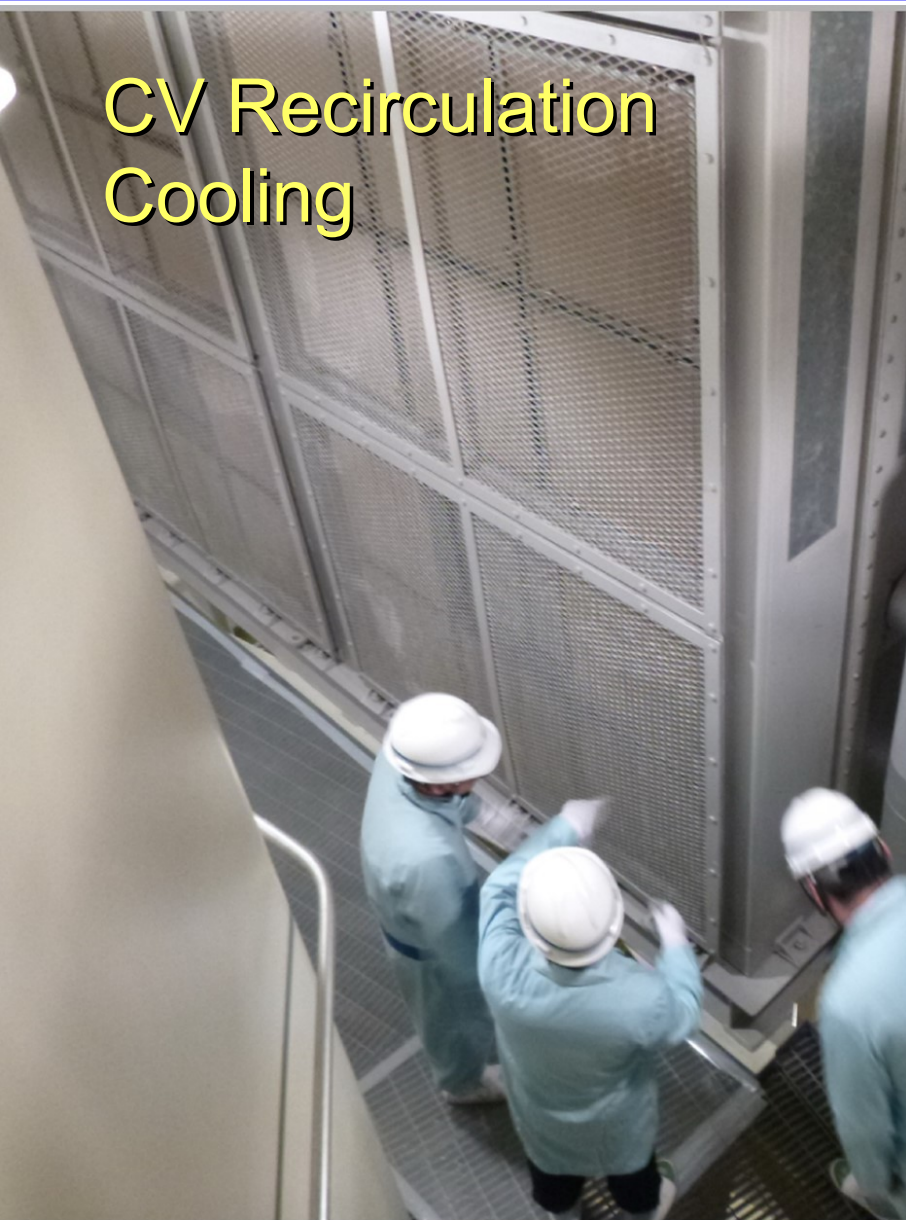
CV Recirculation  
Cooling

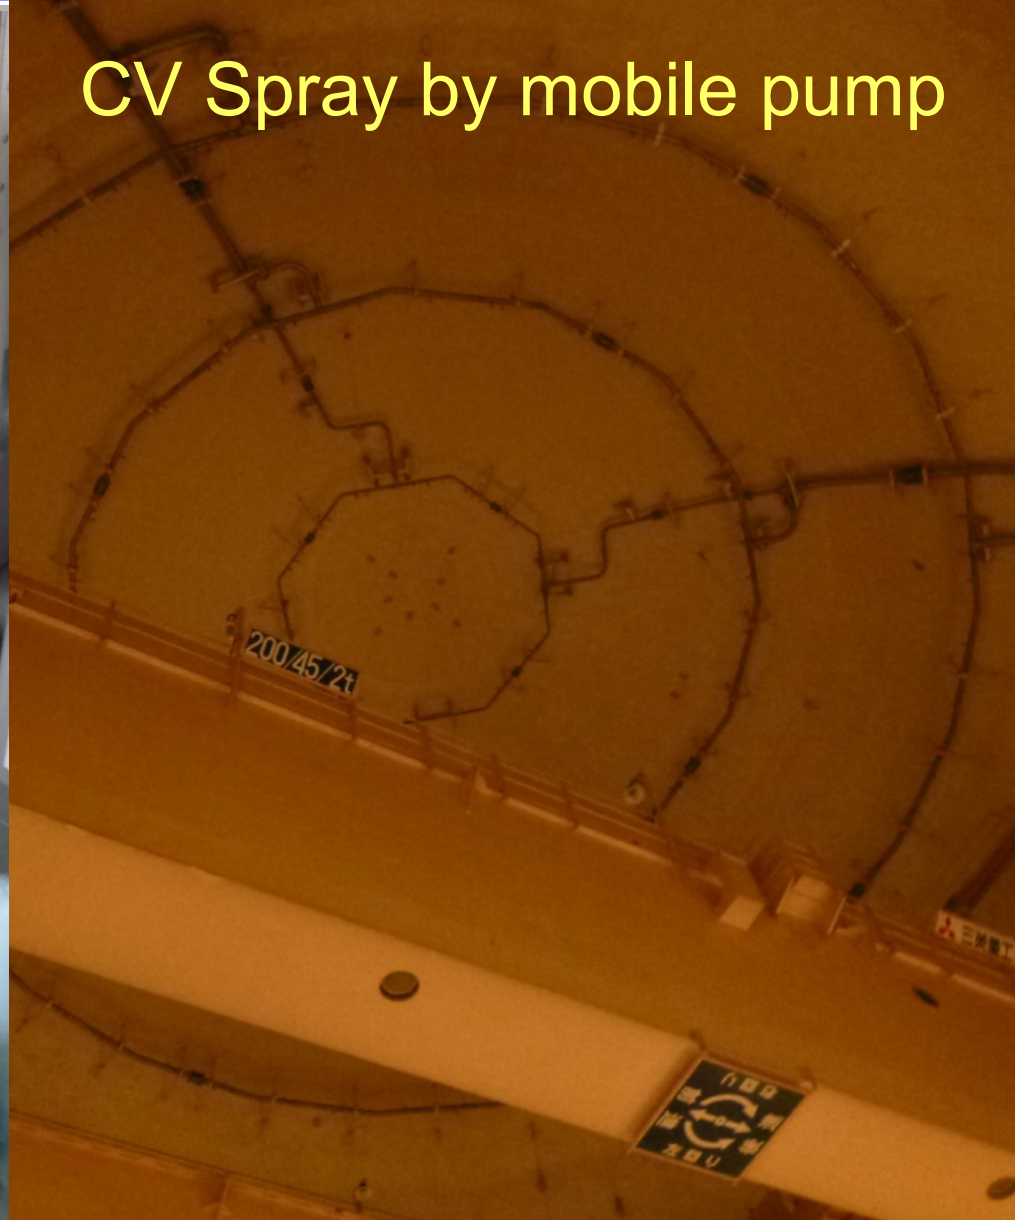
CV Spray by mobile pump

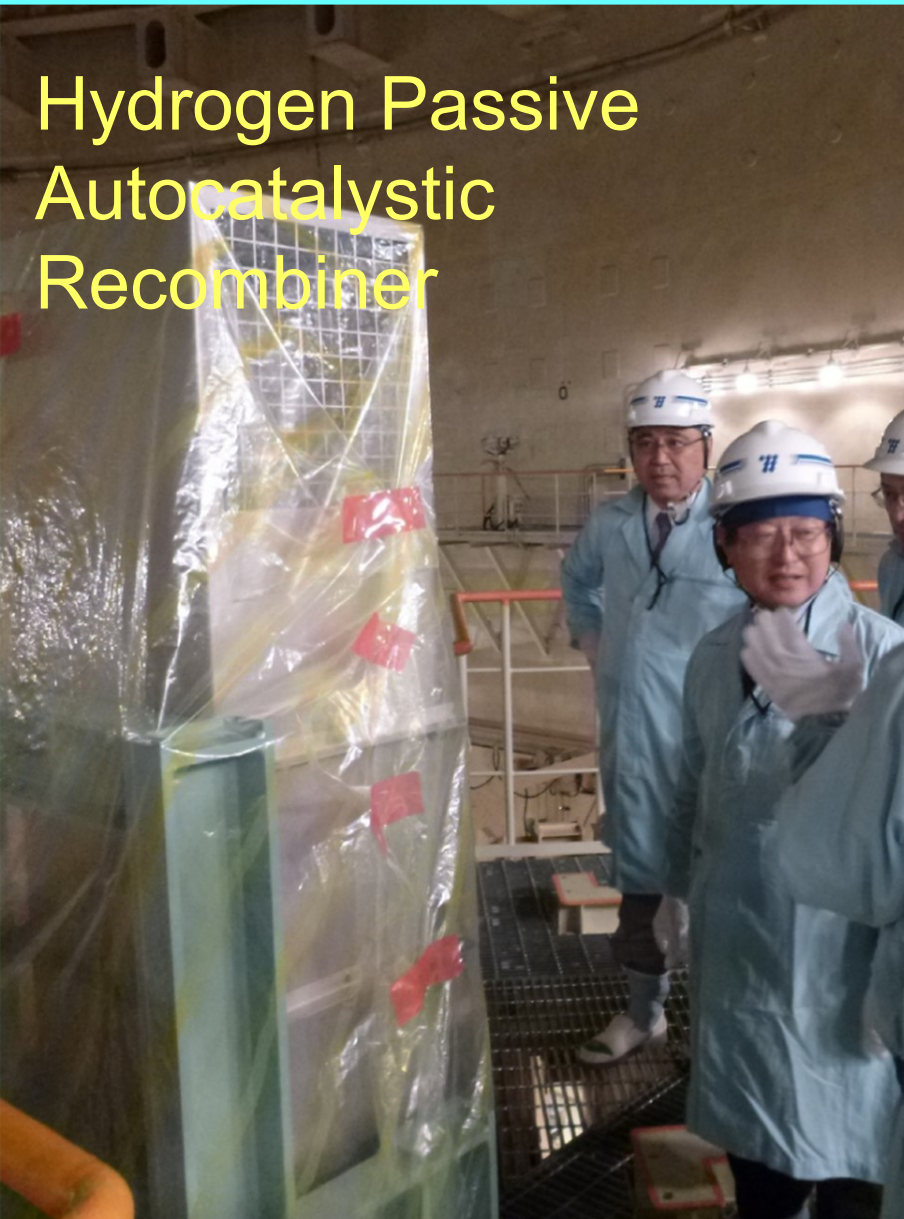
Hydrogen Passive  
Autocatalytic  
Recombiner

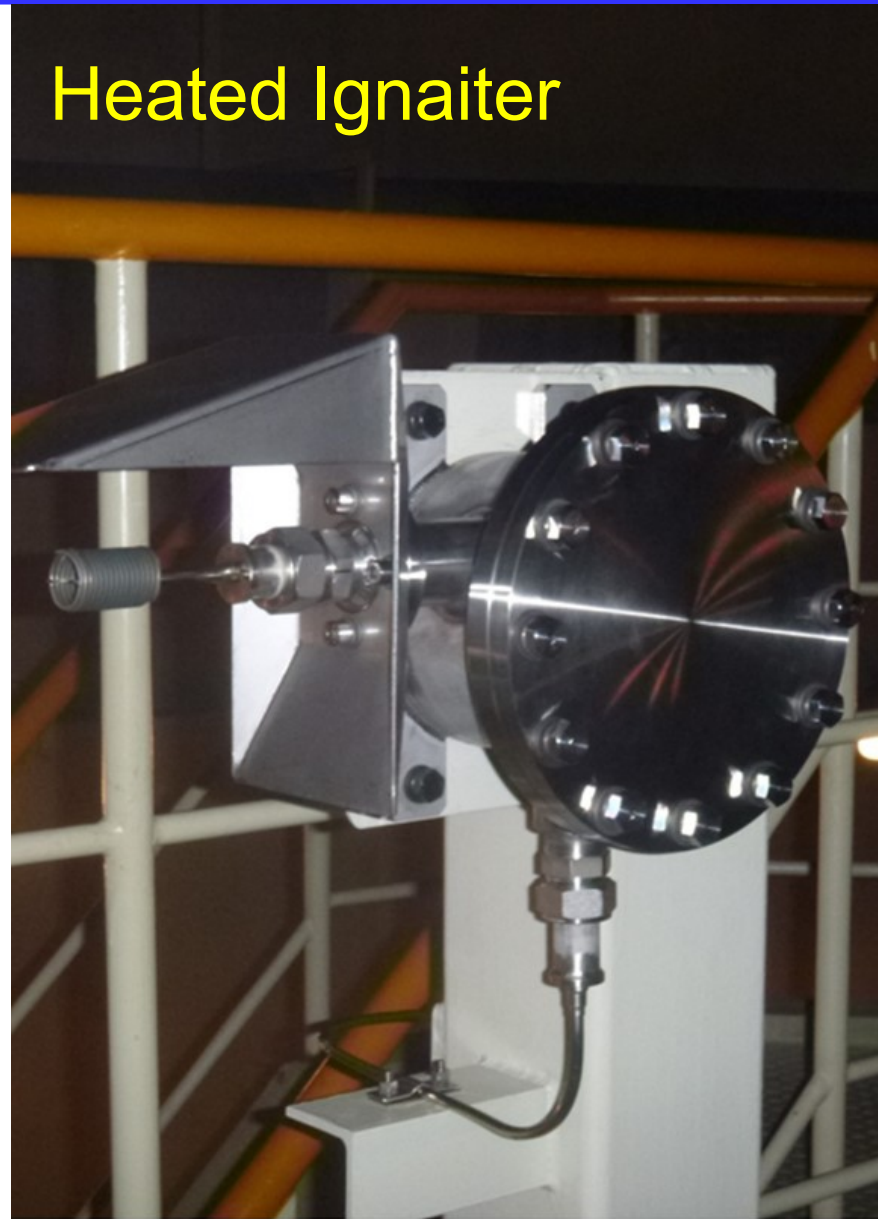
Heated Igniter

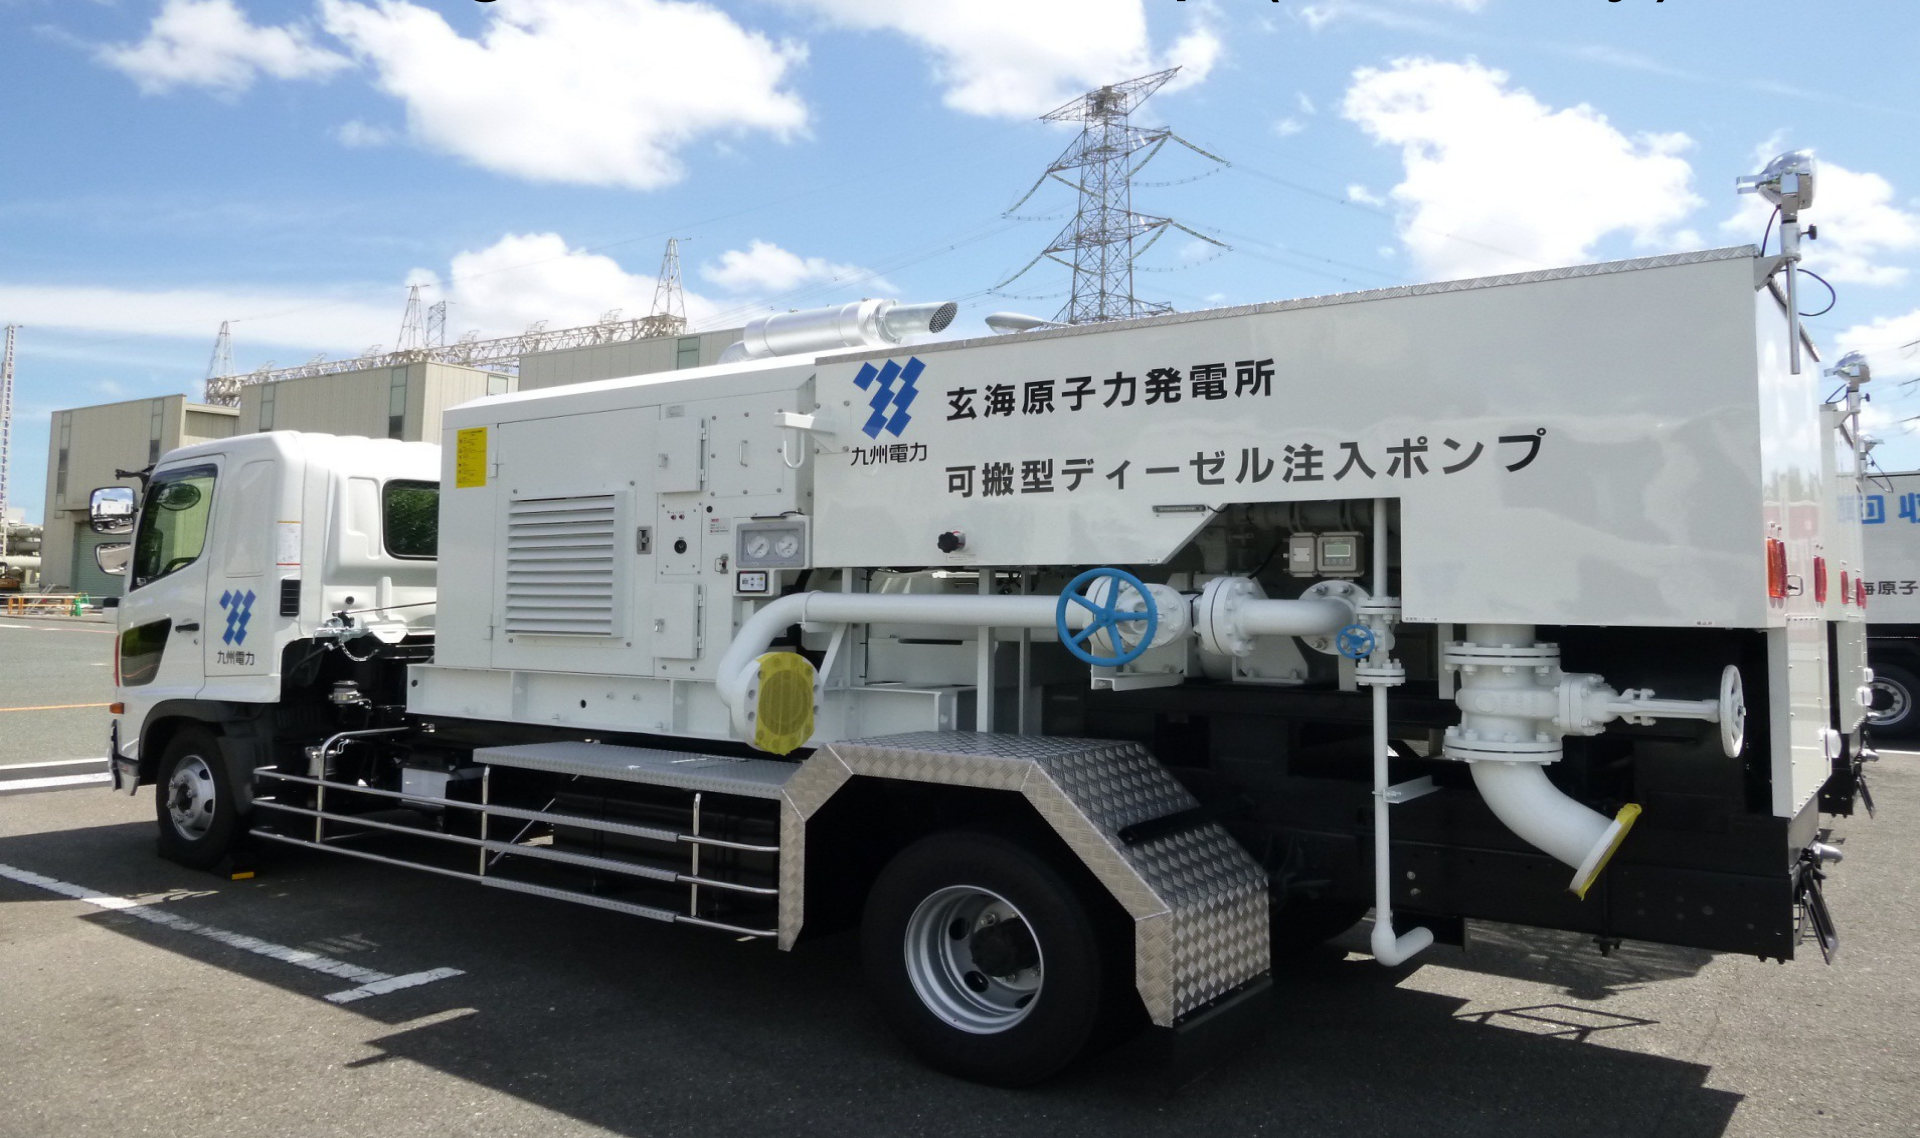
# Resilience for Water Injection: Diesel Engine Driven Pump (Diversity)

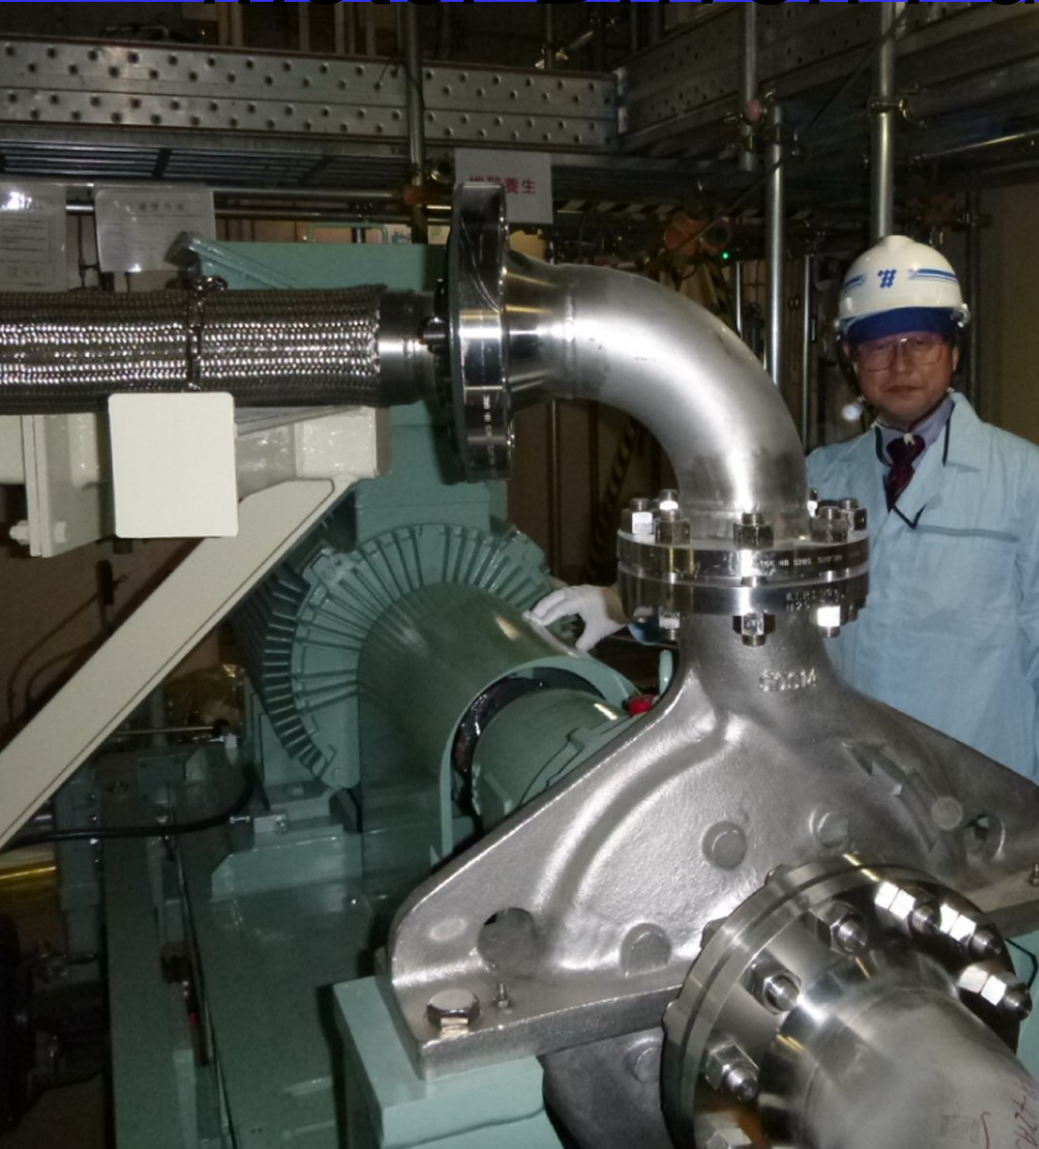
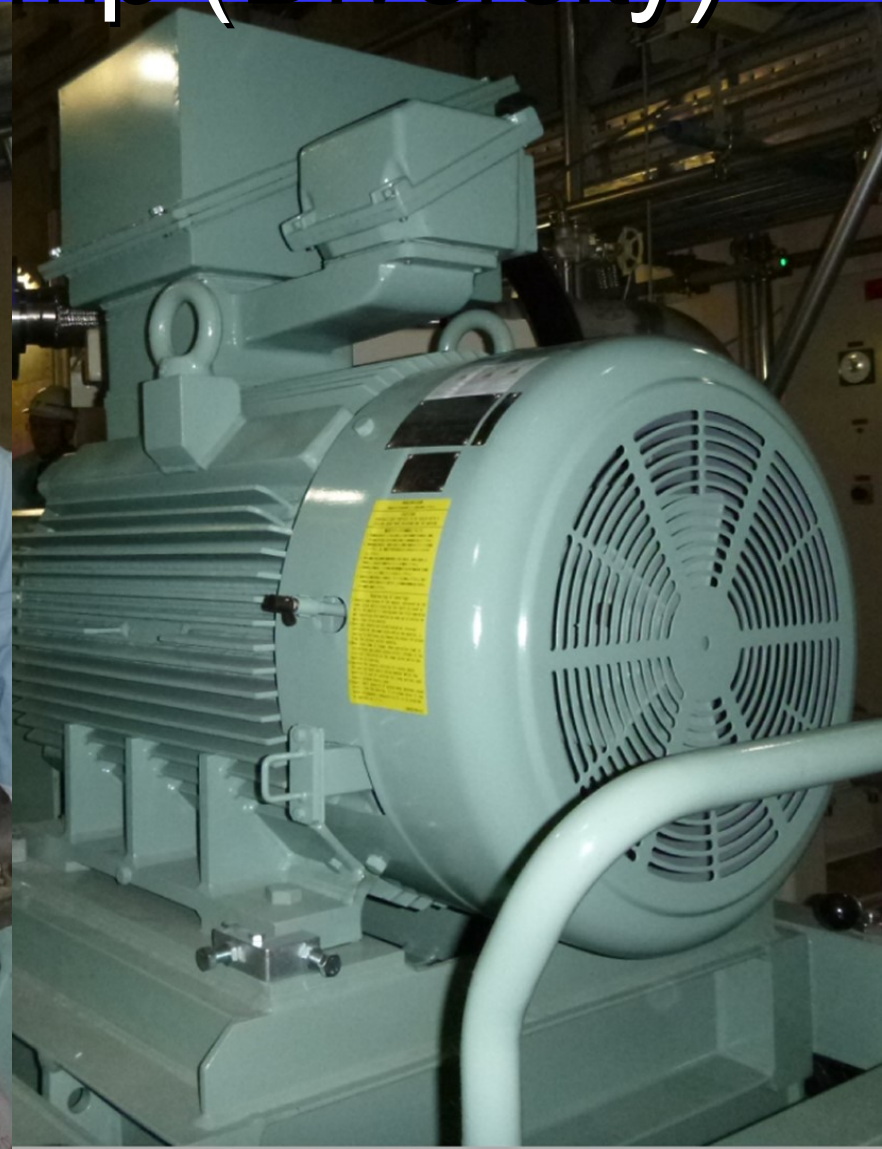
# Resilience for Water Injection: Moter Driven Pump (Diversity)

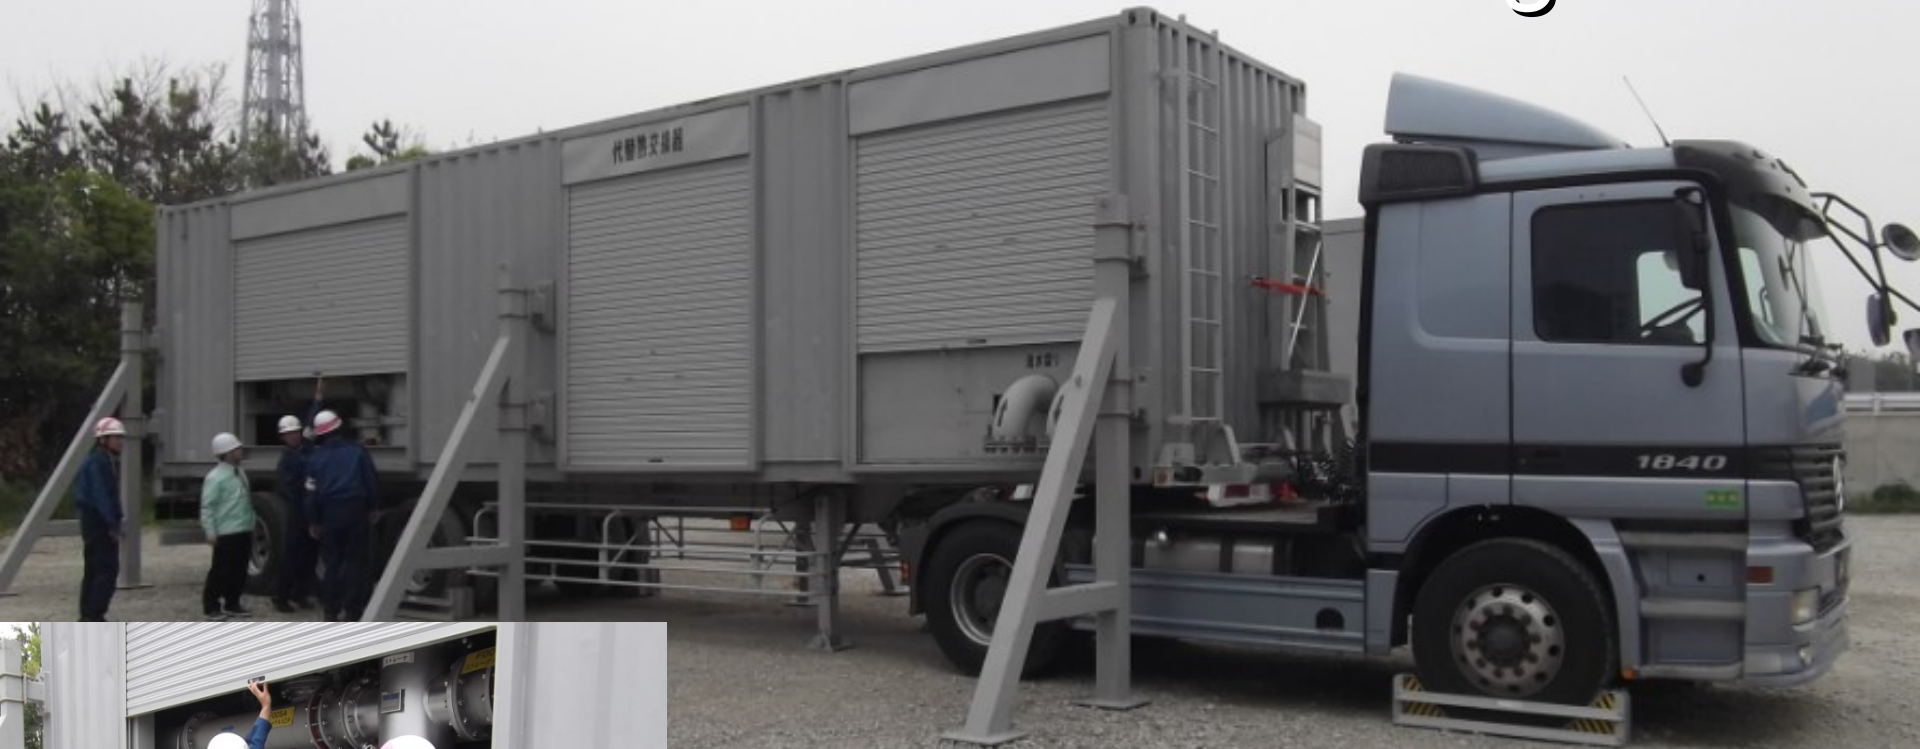
# Resilience for Heat Sink: Mobile heat sink car and fire engines

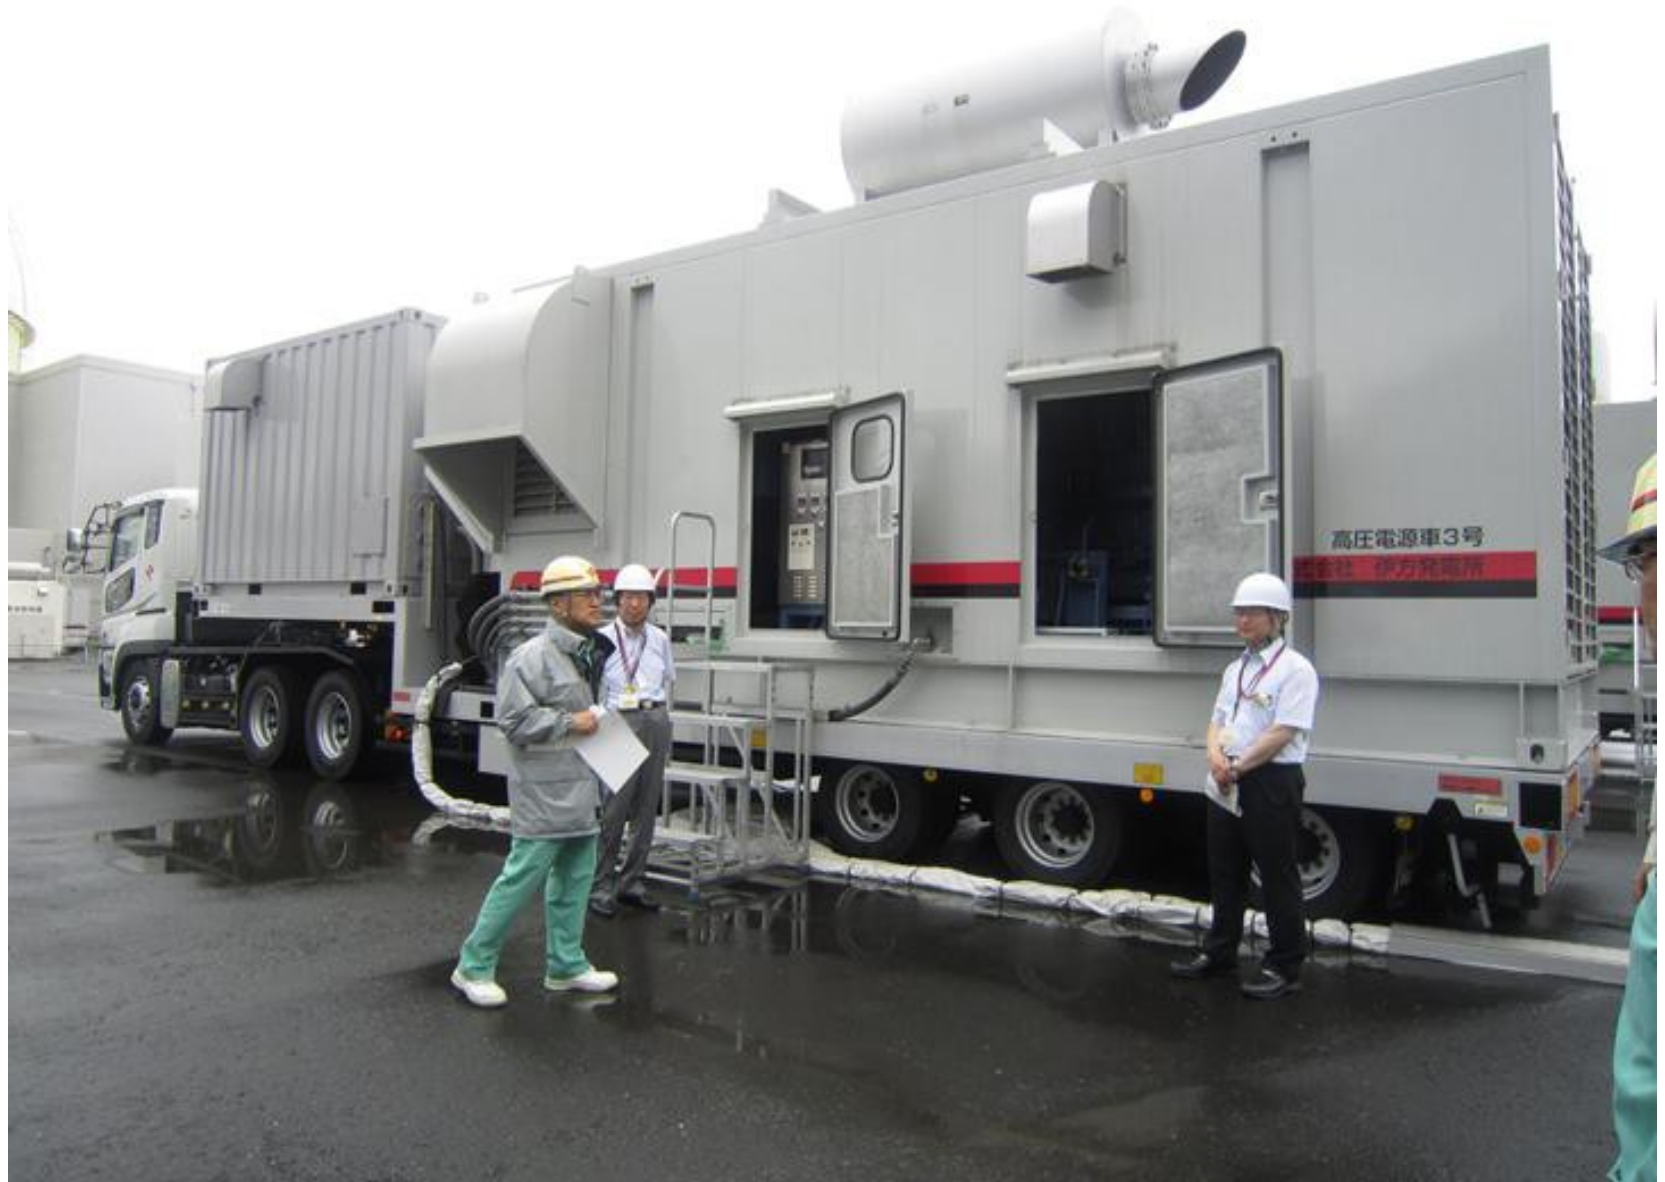
# Electric Power Supply Car at Ikata NPS

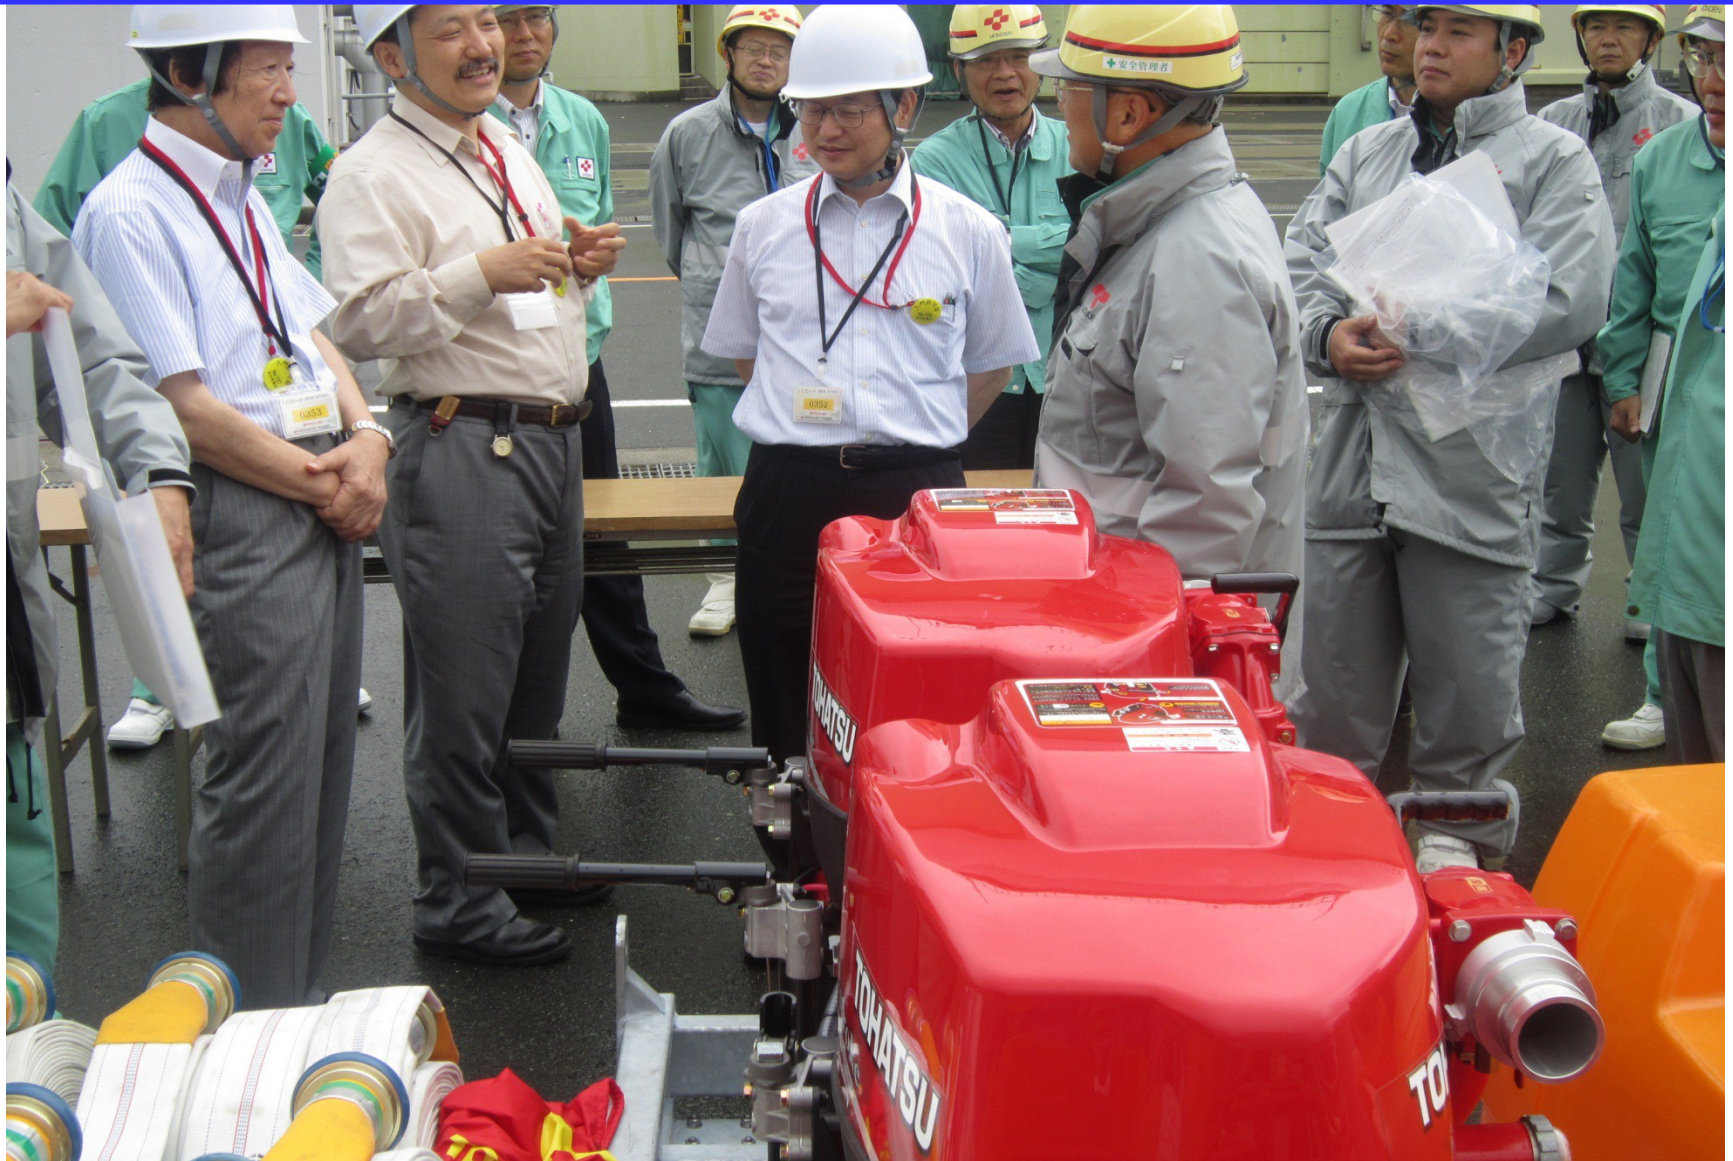
# Portable Water Supply Pumps for Resilience Action at Ikata NPS

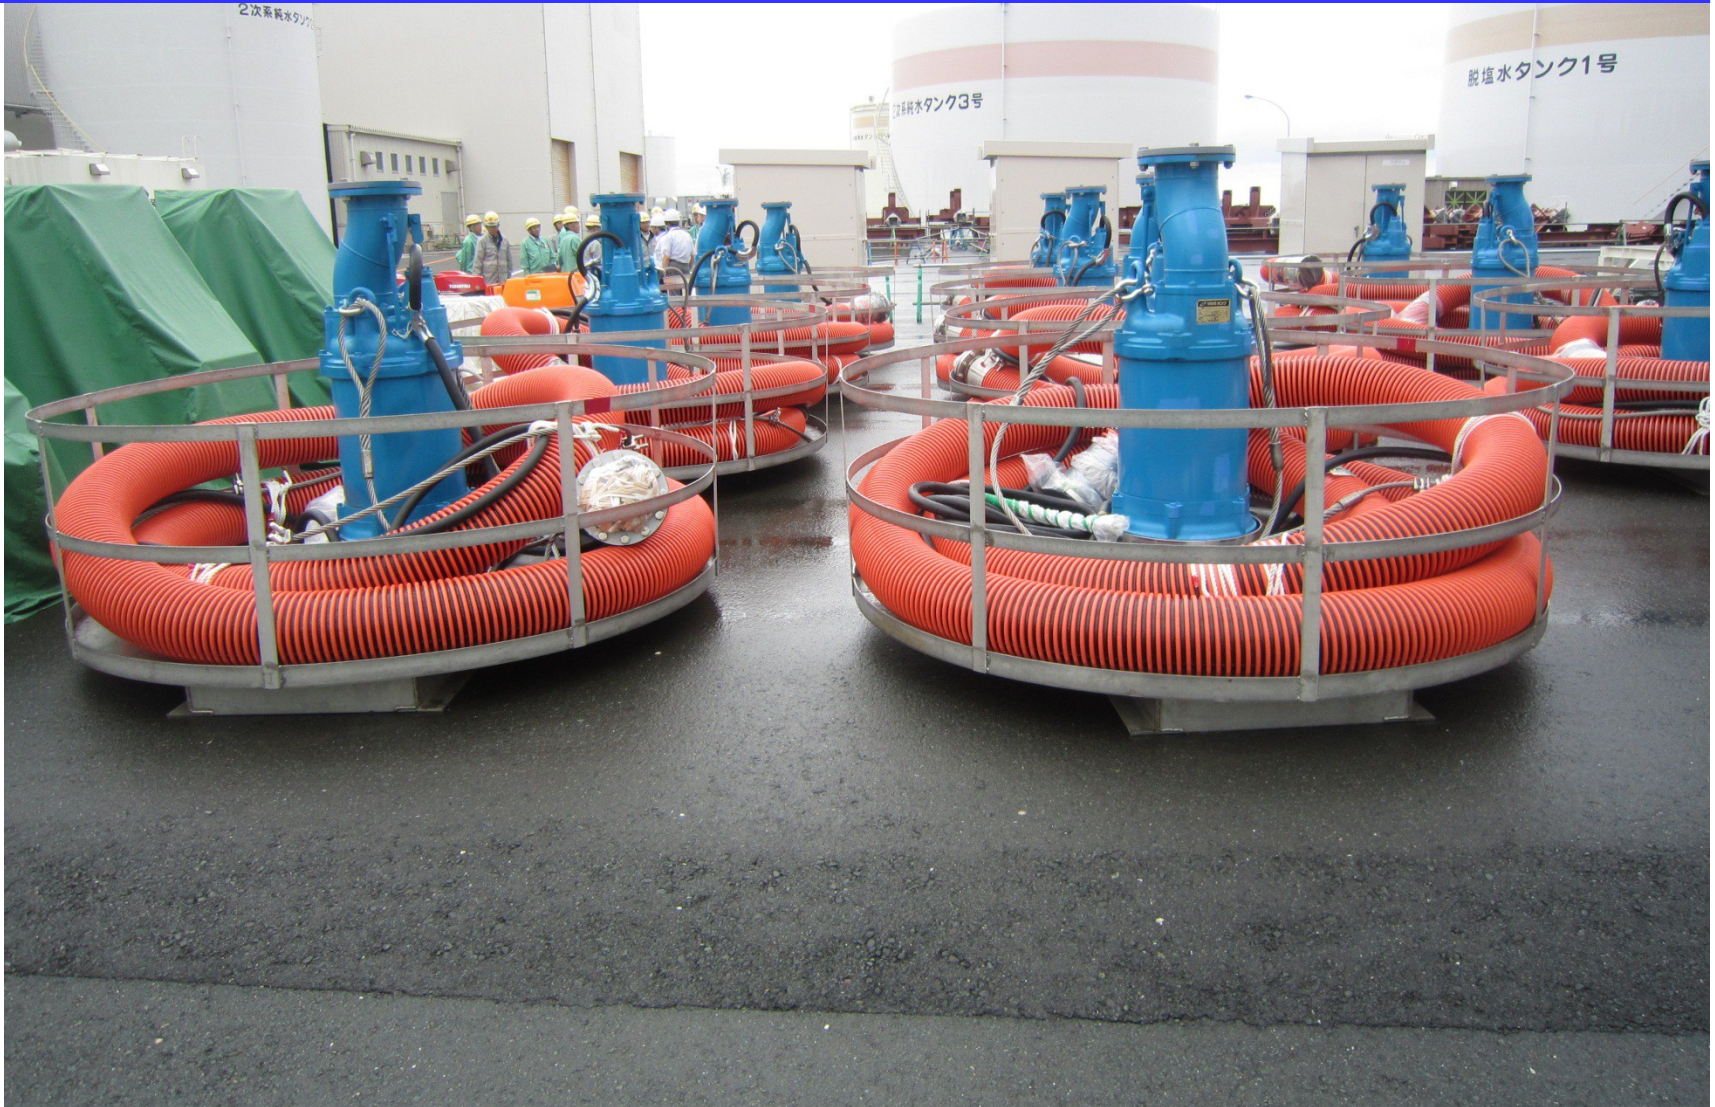
# Under Water Pumps for Resilience Action at Ikata NPS

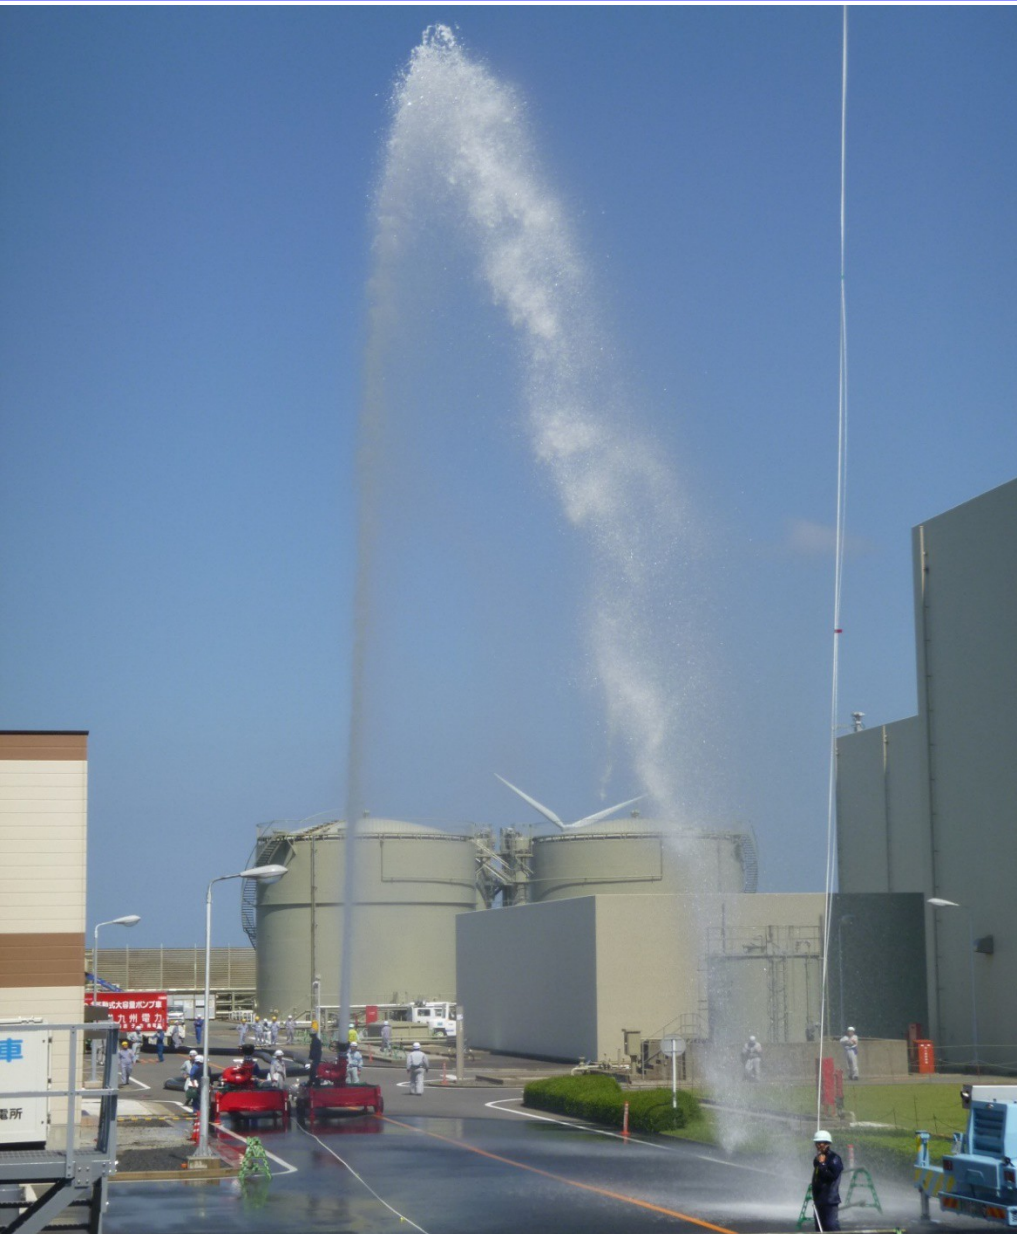
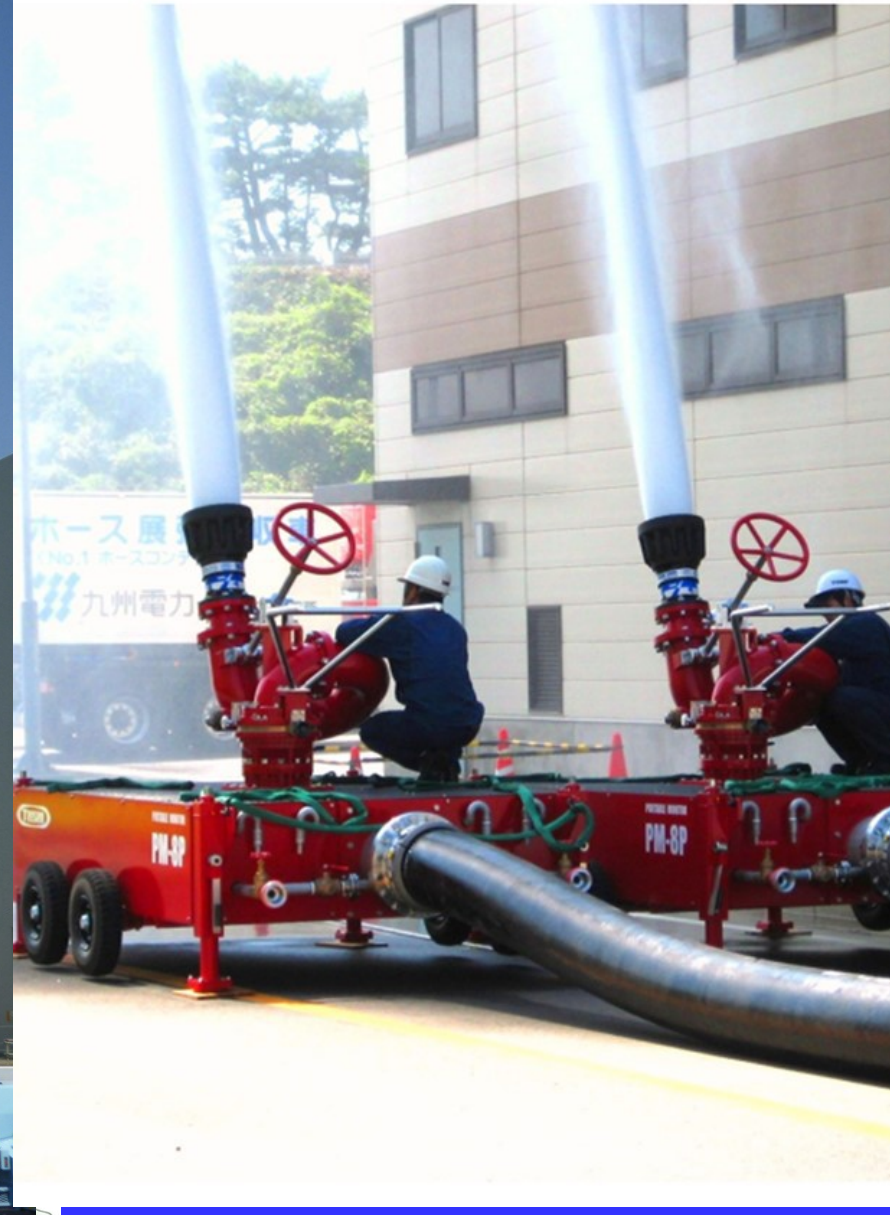
# Resilience for CV damage: Water Cannon
