Spread of contamination through goods taken out from RCA - Lessons learned

ISOE EUROPEAN SYMPOSIUM on
OCCUPATIONAL EXPOSURE MANAGEMENT AT NUCLEAR
FACILITIES

Staffan Hennigor / Johan Uljons
Forsmark NPP
FQR-2010-0224

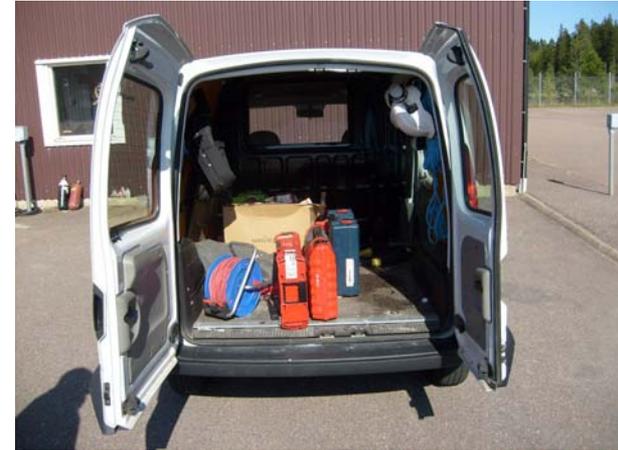
What happened?

- A contaminated car was discovered by the vehicle monitoring system
- The inside of the luggage compartment was found to be contaminated
 - No specific contaminated equipment or goods found
- Suspicion that goods transported from Radiological Controlled Area (RCA) one week earlier was the source of the contamination
 - Suspected goods found in a storage room within the industrial area
 - It was contaminated!
- The goods had been checked for contamination by RP personnel prior to release from RCA
 - The contamination check were done 1 day before the goods were actually taken out from RCA
 - The result of the check were not documented

- Root causes:
 - **The goods were left unattended** 1 day between the RP check for contamination and the release from RCA
 - **No RP personnel present** when goods were taken out from RCA

- The "original" alarm in the vehicle monitoring station not correctly handled (= security item)
- Immediately procedures for taking goods out from the RCA were revised:

- A special locked area inside the exit gate for material which shall be transported out from RCA
- Also well noted:
 - This kind of jobs within RCA shall be better planned and risk assessments shall be performed

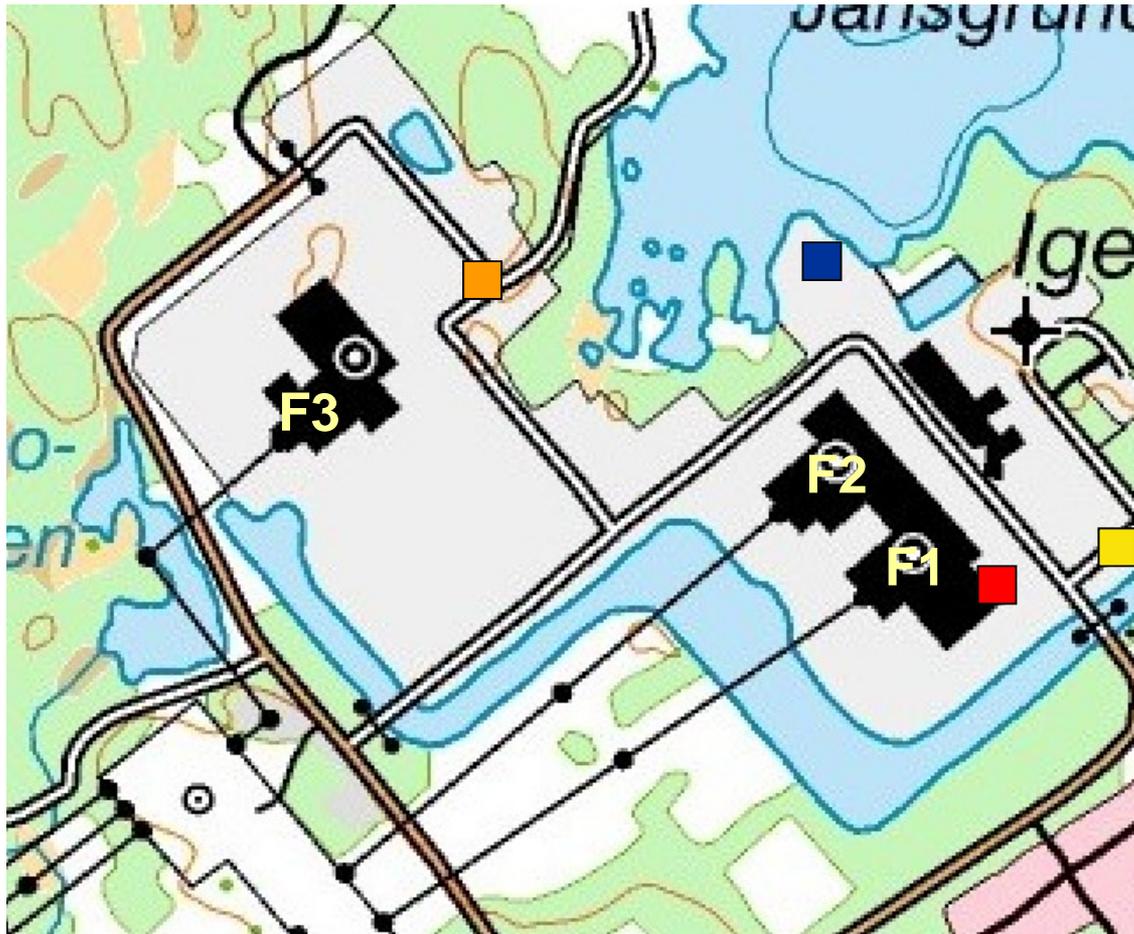
Geographical orientation

- Vehicle monitors
- Goods taken out from RCA - Waste building F1
- Goods found in storage room
- Main gate in to /out from industrial area

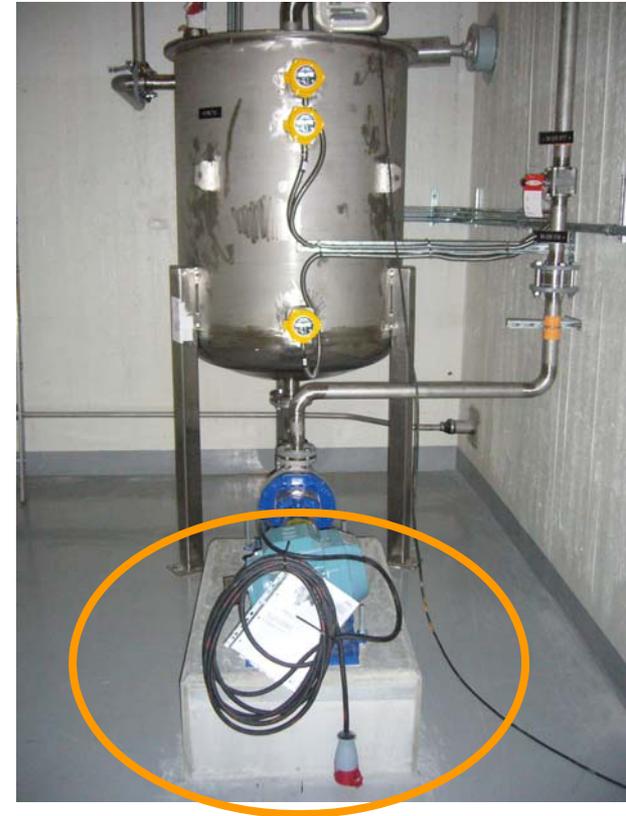
The contaminated goods (1)

- Consisted mainly of
 - some buckets
 - a concrete sack
 - tools for construction work
- Used for construction work within RCA in a room with:
 - equipment connected to the cleaning system for reactor coolant water
 - high probability for surface contamination
- The material used for the job where all taken into RCA prior to work
- After the work had been finished (1 week later):
 - The material checked for contamination & cleared near work place (step-over)
 - The material checked for contamination & cleared at RCA exit point
 - The material were left one day before being taken out from RCA
 - Material taken out without RP personnel being present

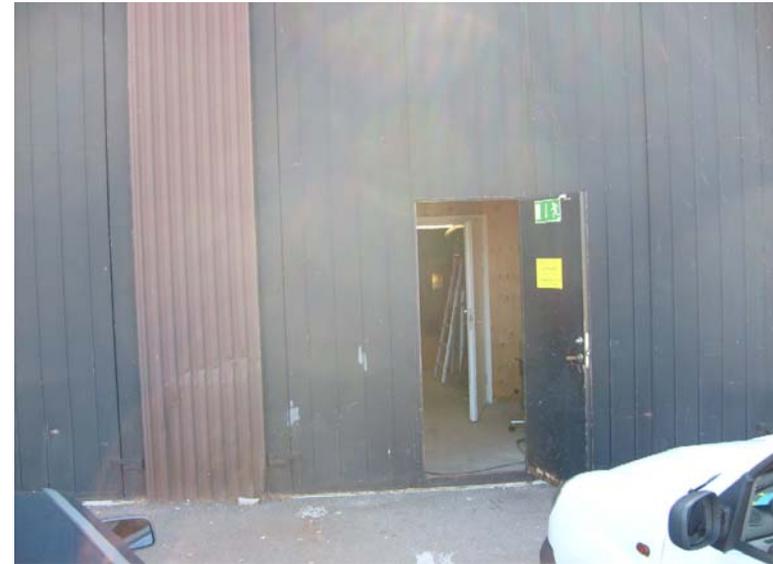
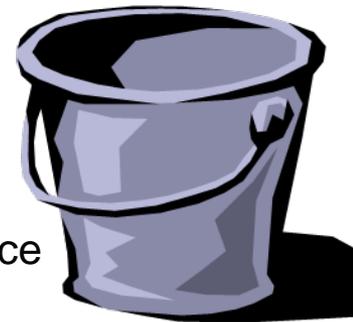
Activity spread & found

- Contamination were found:
 - In the car
 - Outside the gate where the goods were taken out from RCA
 - Inside & outside the storage room at the industrial area
- A bucket used for mixing concrete showed the highest level of contamination
 - Contact dose rate at bottom ~ 11,5 mSv/h
- Total amount of activity spread from RCA ~ 25 000 kBq
 - Activity mix typical for reactor coolant / ion exchange resins
 - Mainly Co-60, Mn-54, Sb-125
 - All measurements pointed towards a common contamination source
