Improving of the working conditions and cleaning of gas discharges during the outage at Bohunice V1 NPP

The presentation will provide the information about the measures and modifications performed in V1 NPP in order to improve radiation conditions of the air in the reactor hall during the outage works.

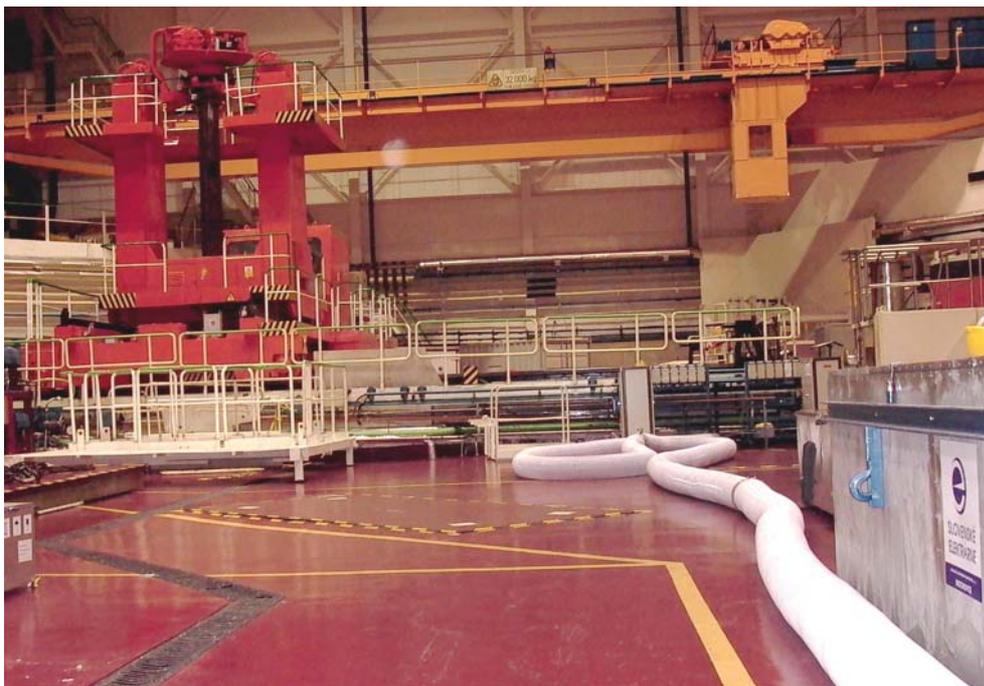
Fig. 2: The example of plastic hose just after its disconnection from the upper part of the control rod drive

An exhausting plastic tube is positioned to the upper part of the reactor control rod drive immediately after the first opening of the reactor. The plastic hose is connected to the ventilation system equipped with the aerosol and iodine filters. The exhausting lasts minimum 8 hours and during that the specific radioactivity of the exhausted air is continuously measured. The example of plastic house just after its disconnection from the upper part of the control rod drive is in the figure 2.

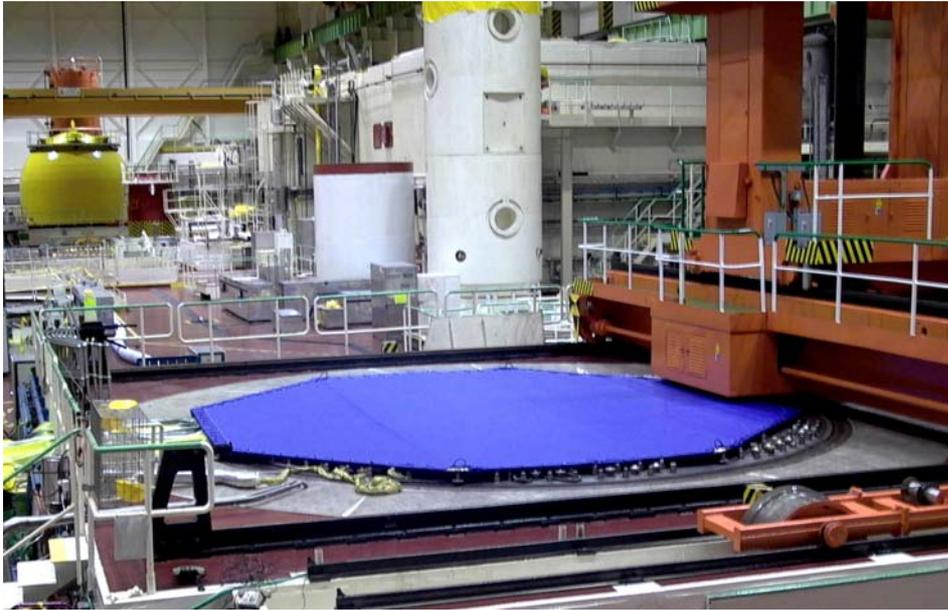
Fig. 3: Blue plastic of the lid, the part of the red refuelling machine and yellow cover of the reactor in the back

The reactor cavity when it is filled with the water is covered with the aluminium plastic lid to improve the efficiency of the exhausting ventilation system. That measure has been used in Bohunice for many years and is also known in other plants. The ventilation system has aerosol and iodine filters. Without the lid the existing ventilation system would not be able to create an effective underpressure above the water level and contamination could spread to the reactor hall. Blue plastic of the lid can be

seen in the figure 3 as well as the part of the red refuelling machine and yellow cover of the reactor in the back

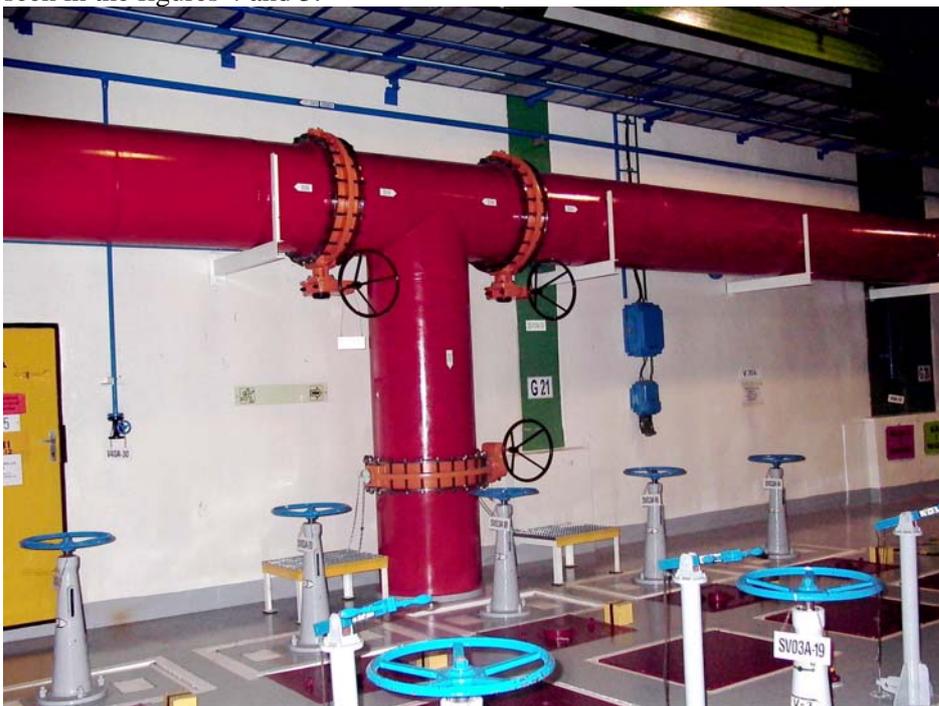
Fig. 4: The modification of air exhaust systems from reactor hall

The modification of air exhaust systems from reactor hall to the ventilation stack had been performed in order to utilise the air purification stations of those systems that had been closed (and no more used) after the reconstruction of V1. The modification was finished in 2004. Modification can be seen in the figures 4 and 5.

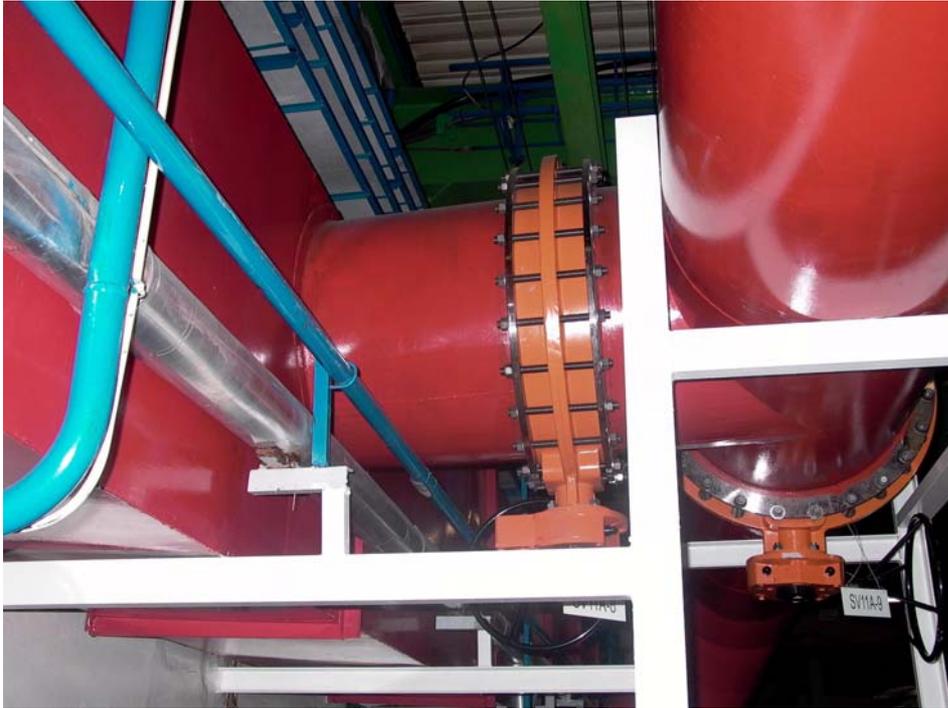
Fig. 7: One part of the modification of air exhaust systems from reactor hall
