2003 International ALARA Symposium

Fuel decontamination at Ringhals 1 with the new decontamination process ICEDEC™

E. Fredriksson, R. Ivars, A. Rosengren
Westinghouse Västerås, Sweden

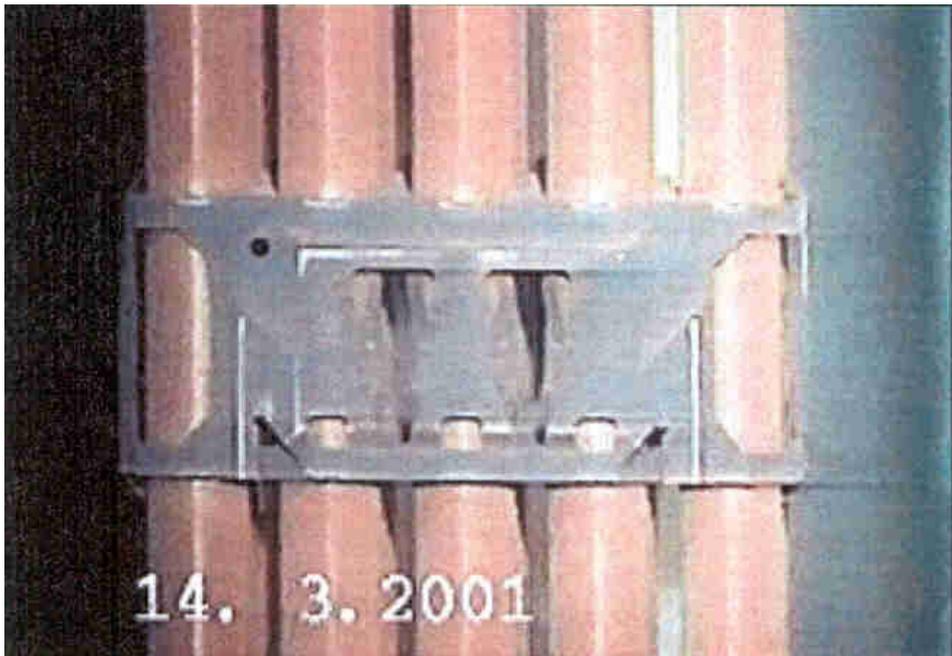
Spacer two before
decontamination

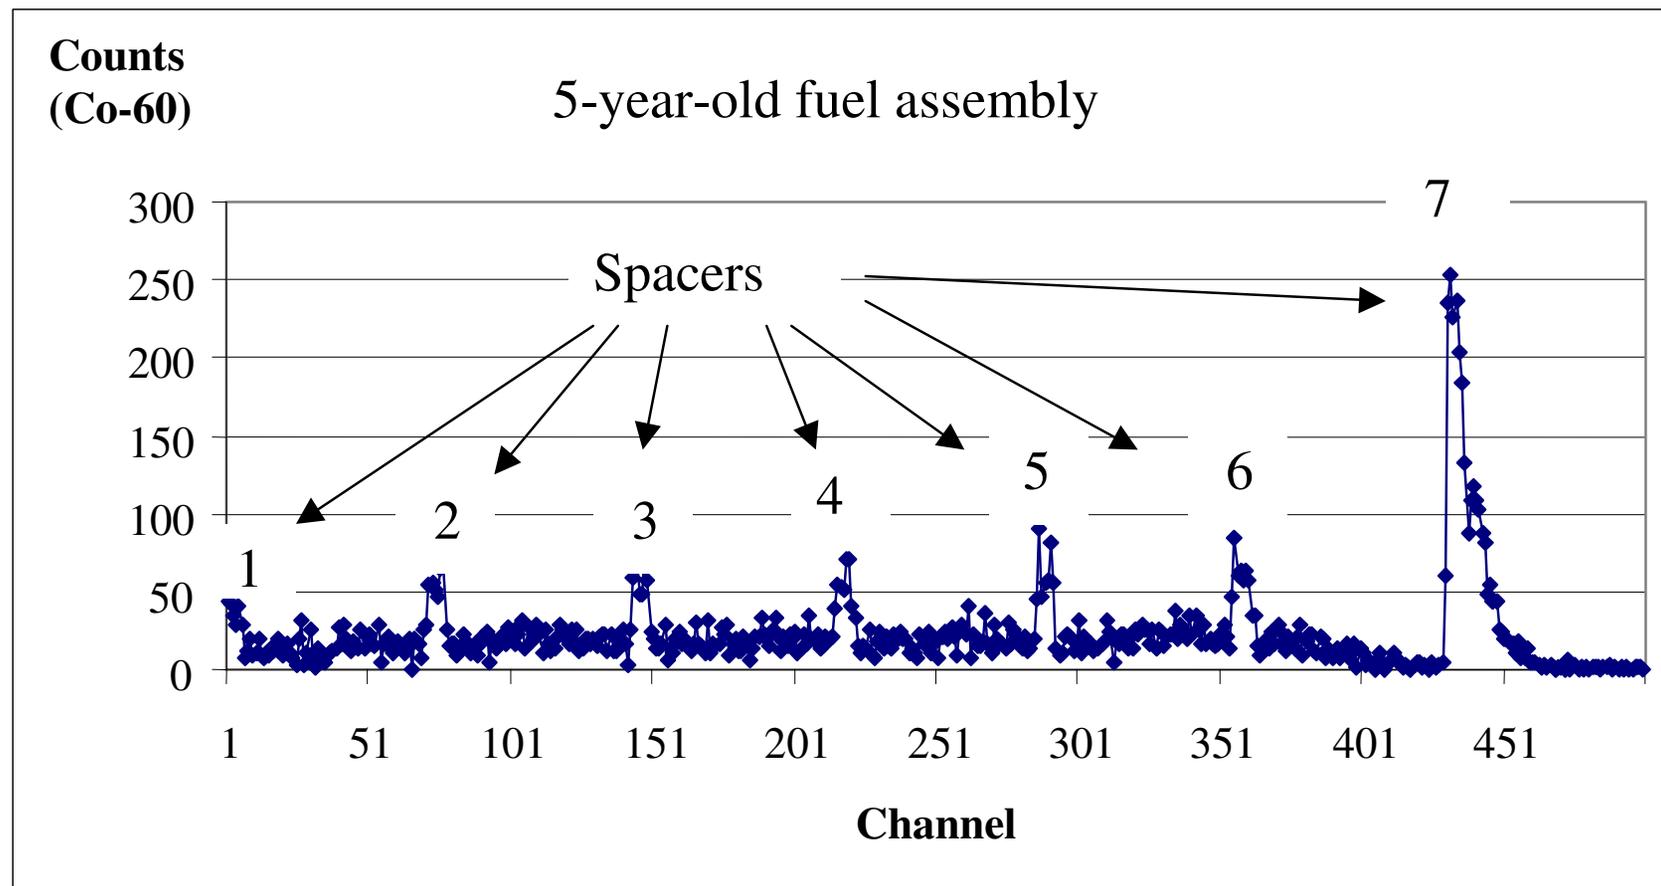
Gamma scanning - spacer displacement

Measurement of Co-60 along the side of the assembly

- Two-year old-fuel: No spacer displacement was shown
- Five-year-old fuel: The lowest spacers had moved upwards to the mechanical stop
 - The first fuel assembly tested before conditions such as flow and pressure had been established
 - Regarded as normal behaviour owing to relaxed spring forces in spent fuel spacers
