CALVERT CLIFFS
NUCLEAR POWER PLANT

2012 Unit 1 PZR Heater Replacement Project

PZR Heater Replacement Project

Replacement of 120 Pressurizer Heaters

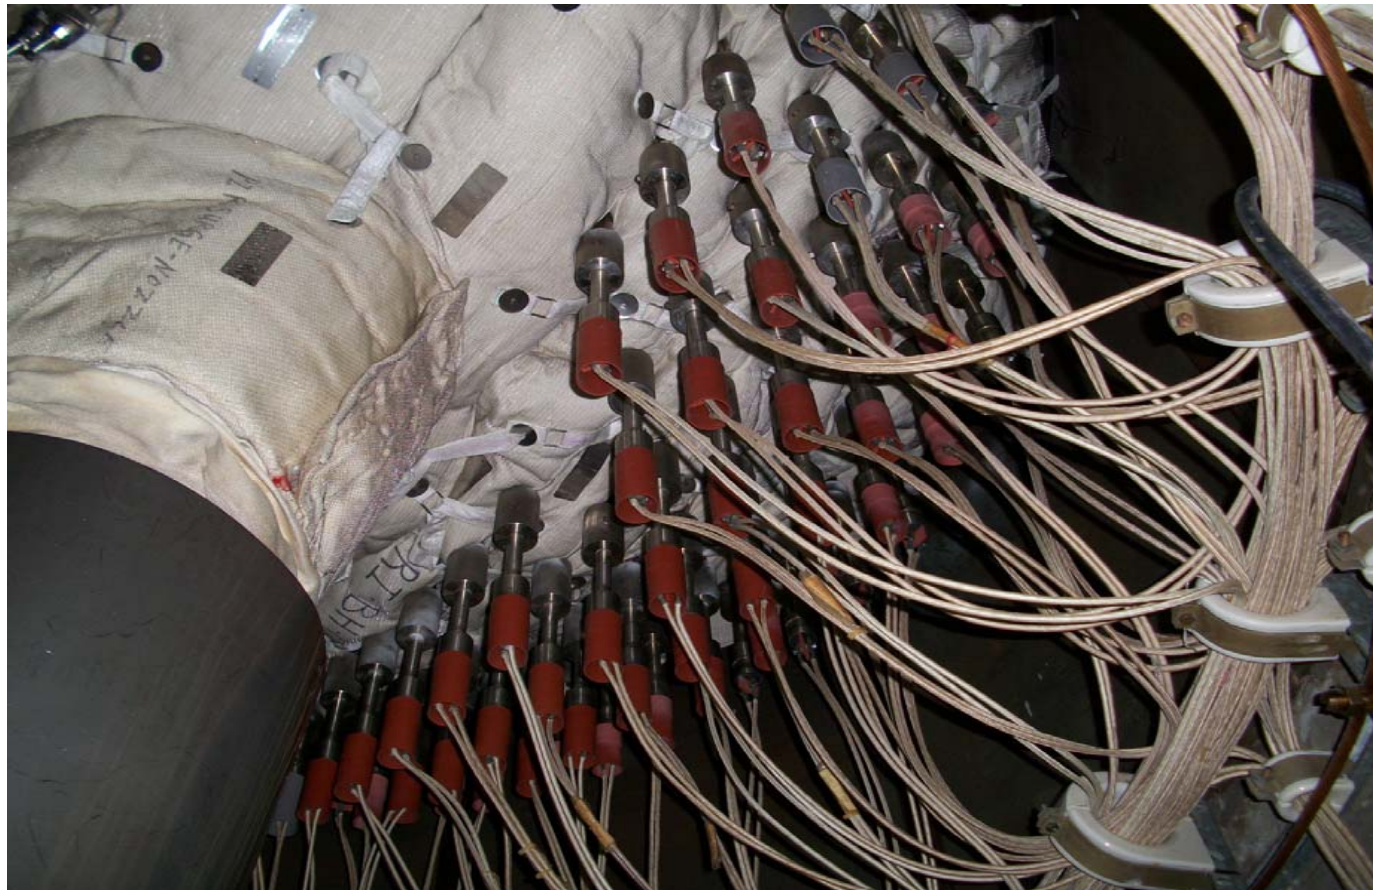
Old PZR Heater Nozzles

Alloy 600 material is susceptible to Cracking in Boric Acid environment

- **Cracks develop leading to failure**
- **Phenomenon: Primary Water Stress Corrosion Cracking (PWSCC)**
- **Choice Material: Alloy 690 and SS**
- **Choice Weld material: SS (Grade 316)**

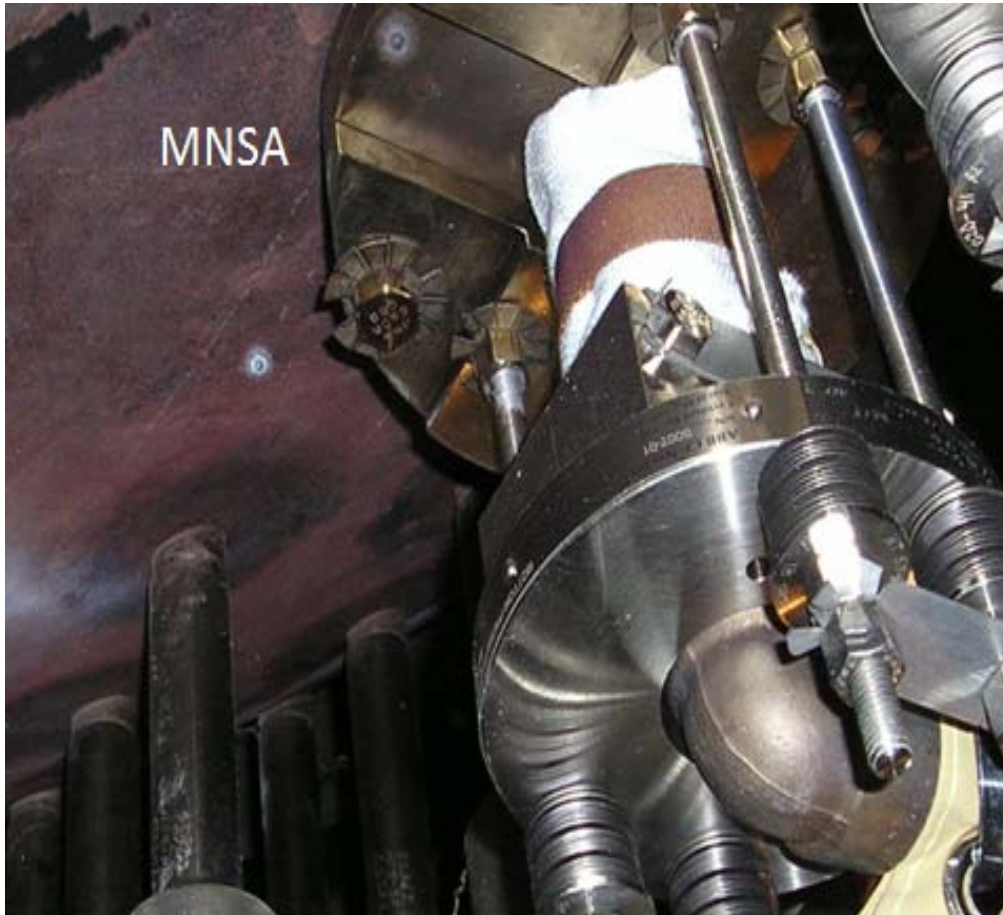
Picture of MNSA Clamp

Mechanical Nozzle Seal
Assembly

Mechanically seals leaking
nozzles to prevent leakage
at potential at susceptible
nozzle sites.

A quick method to correct
small bore system nozzle
leaks.

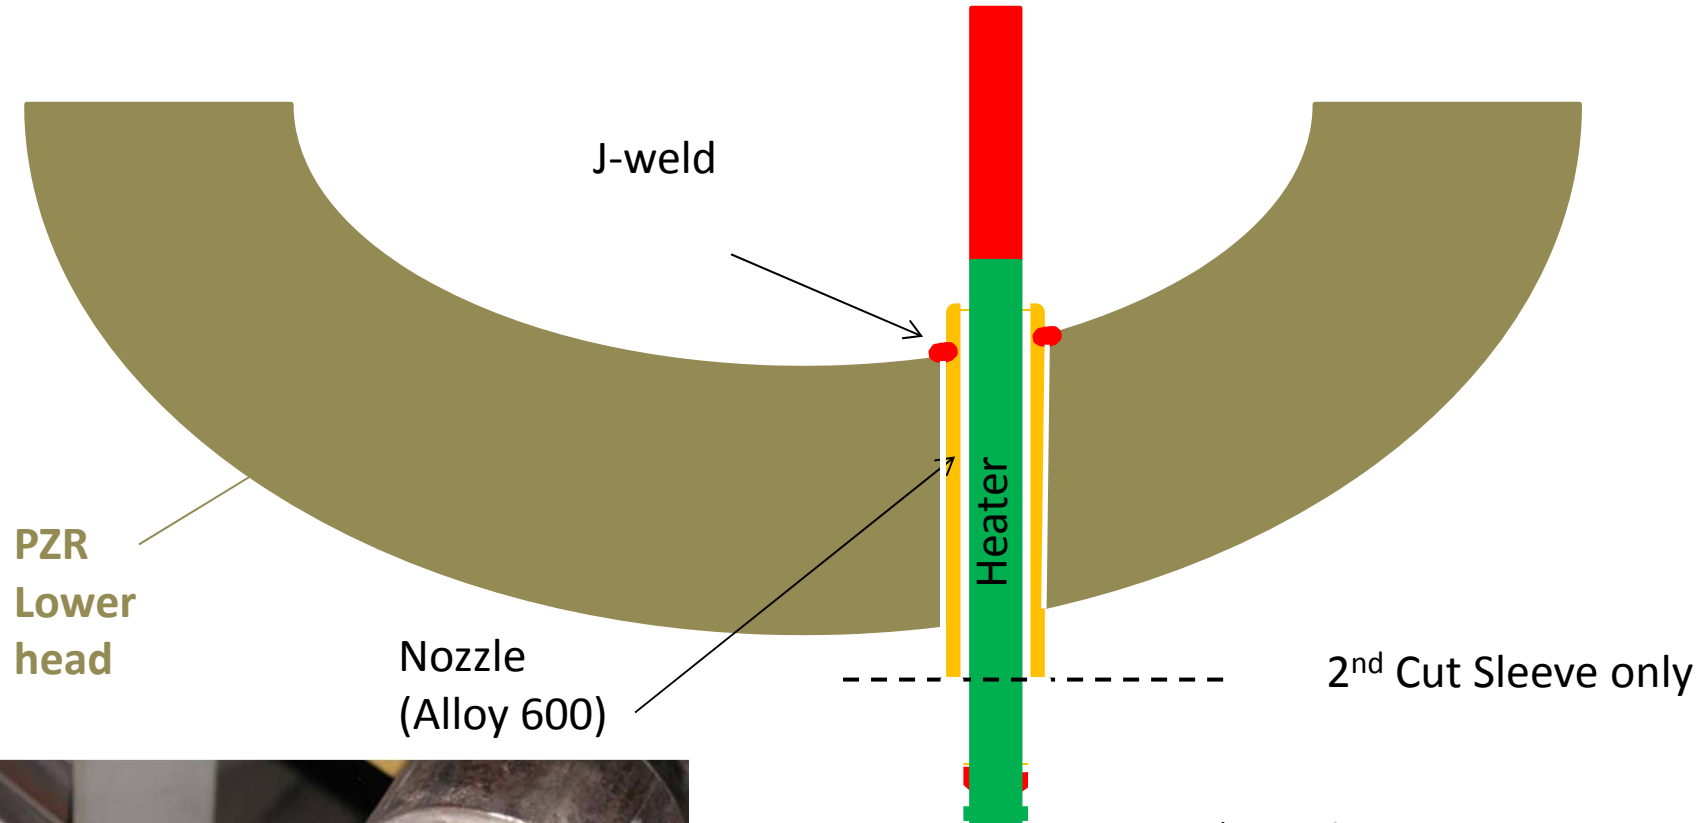
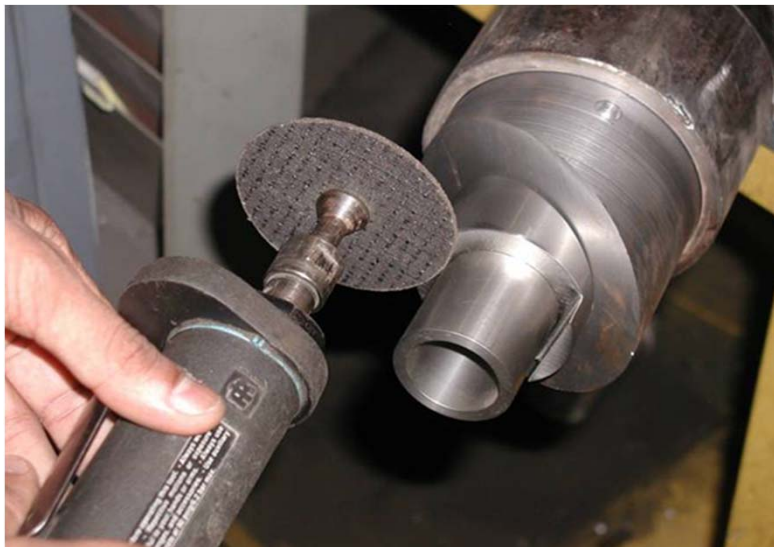
Heater Removal

**Removed 116 Heaters from
the Bottom of PZR Vessel**

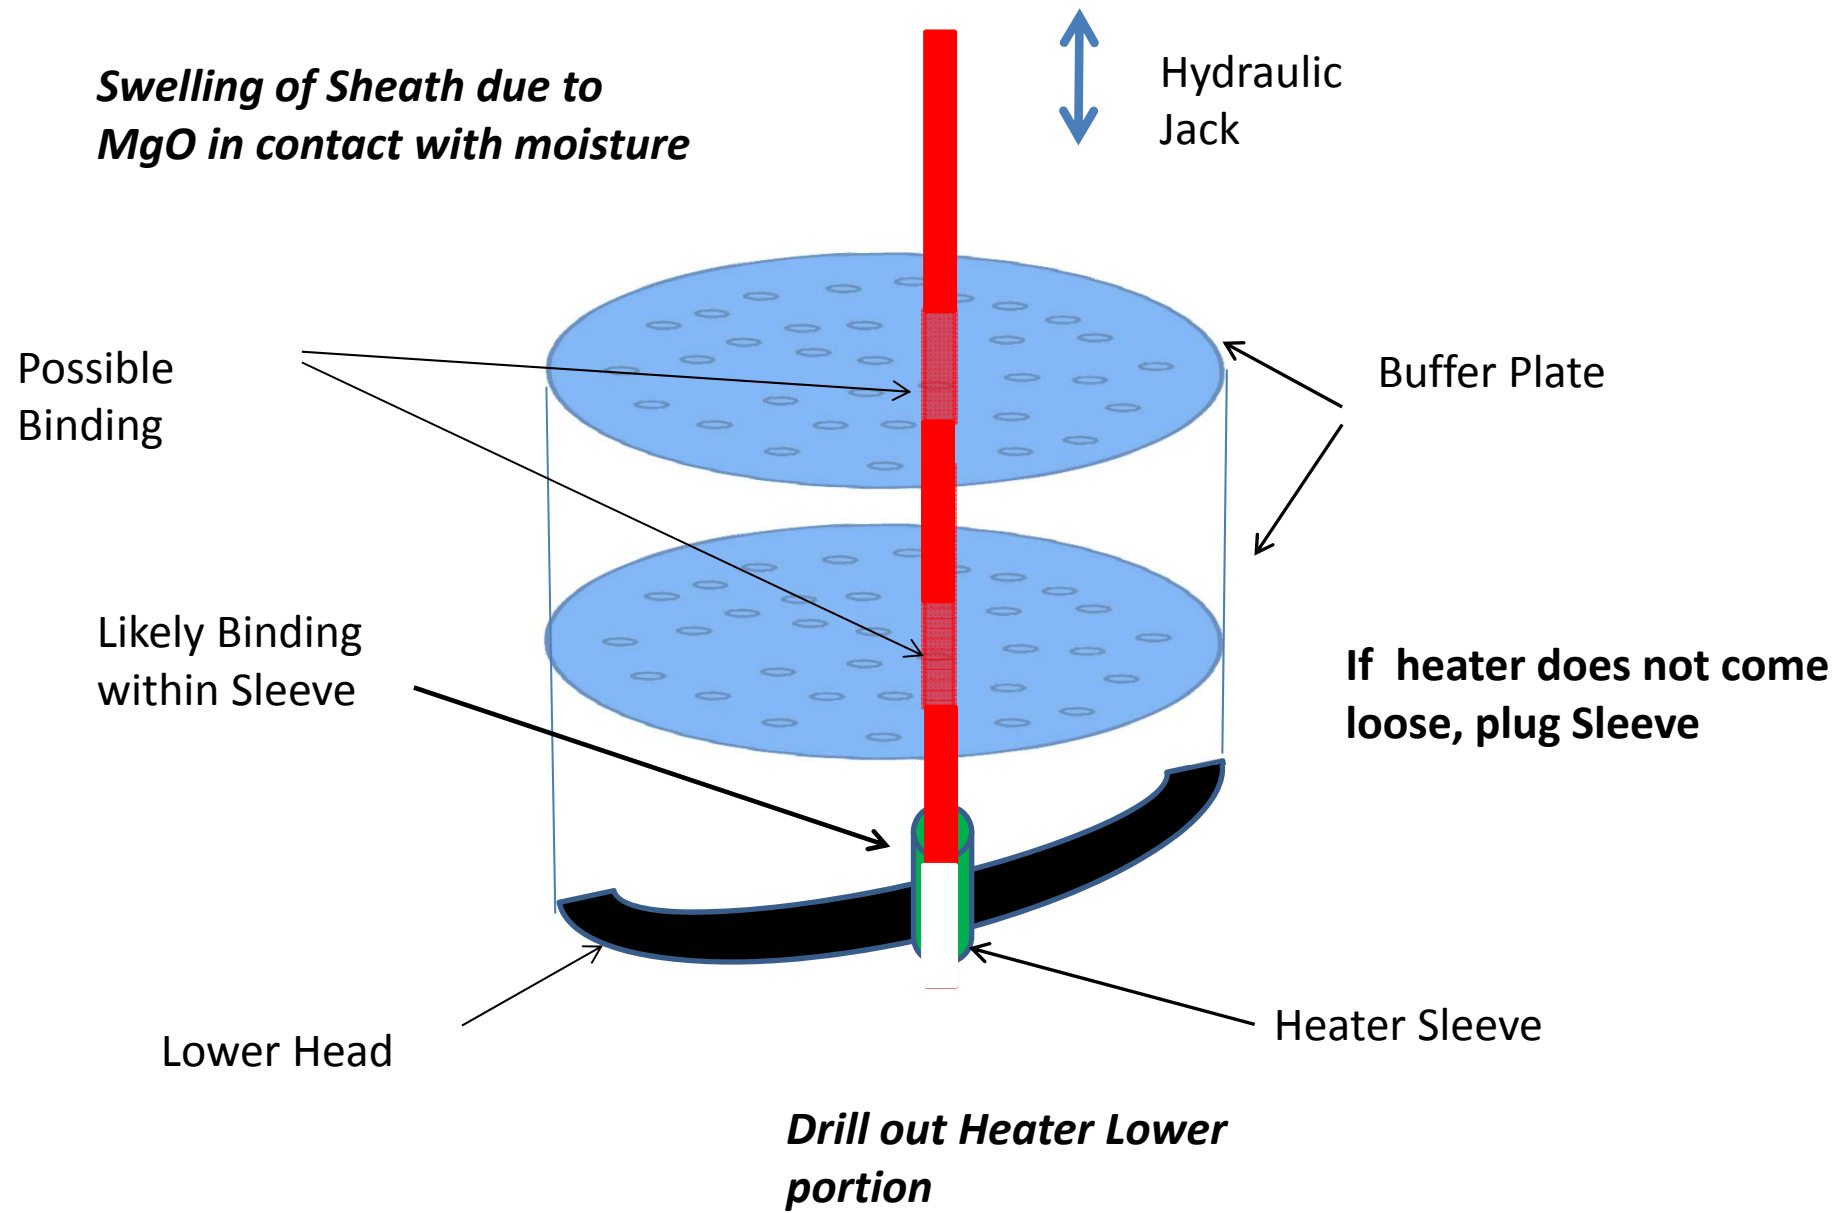
Remove heater by a
hydraulic puller

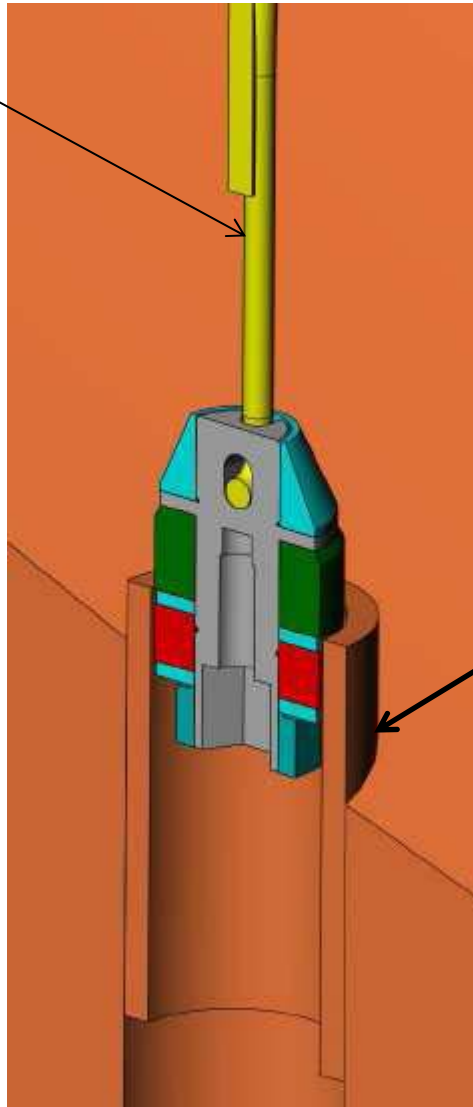
Plug

Tested 50 psig (5 times more than actual pressure).

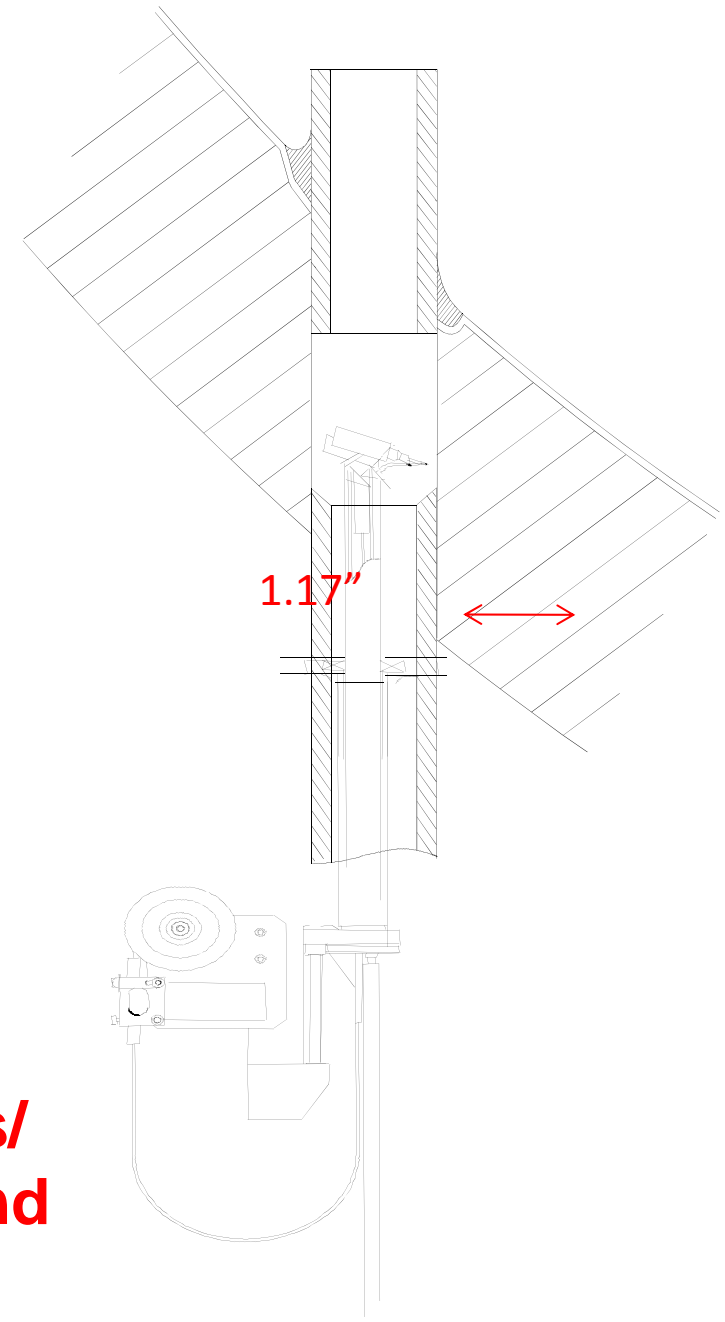
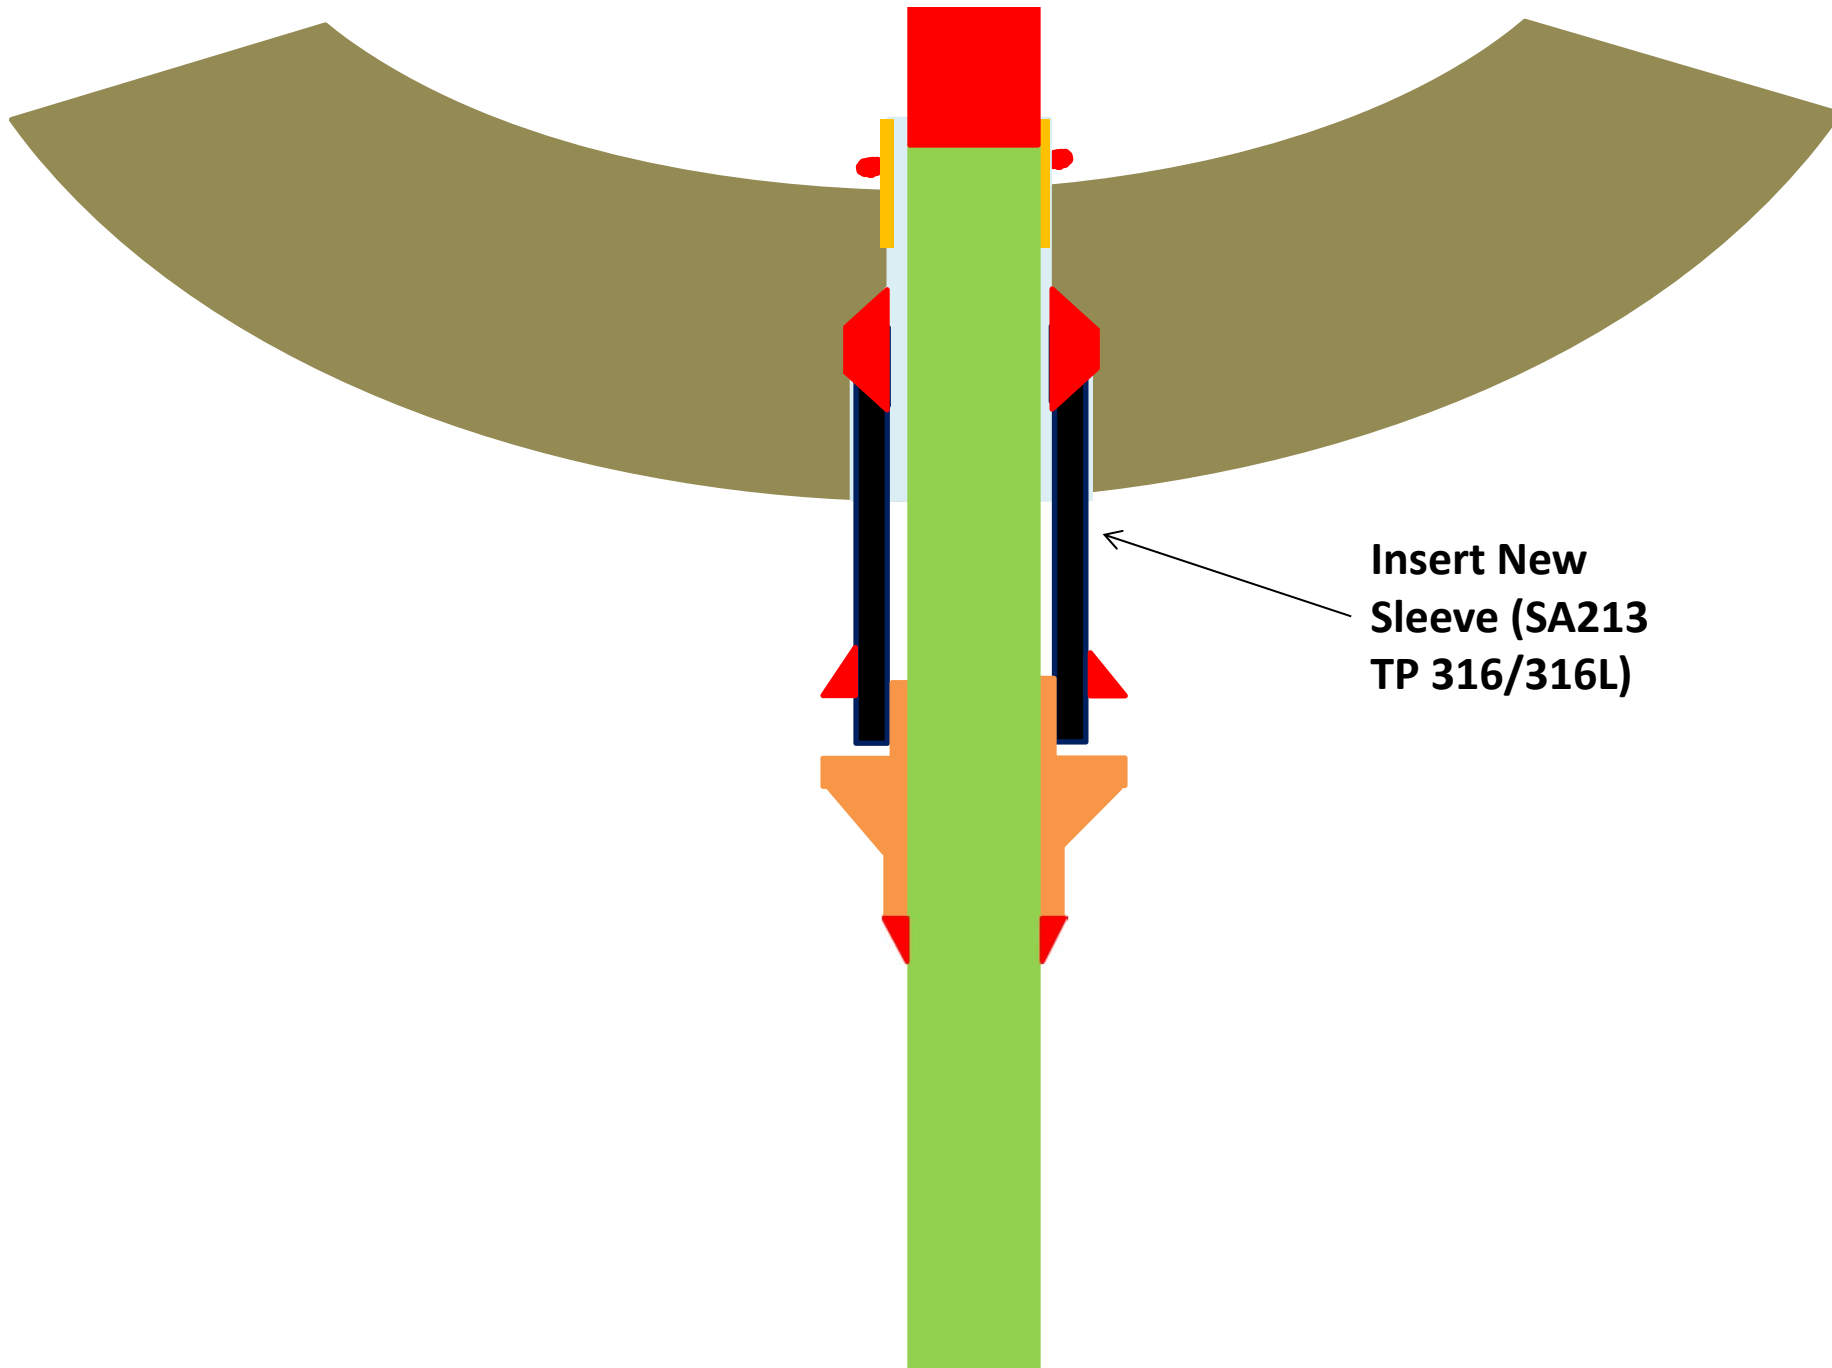
Automated Welding

- **Narrow Sleeve opening (ID: 1.17"):**
custom made welding machine
- 6 hours per weld
- 48 hours hold
- **Weld Flaws: If UT & PT for defects/
flaws, if found need to excavate and
start all over**

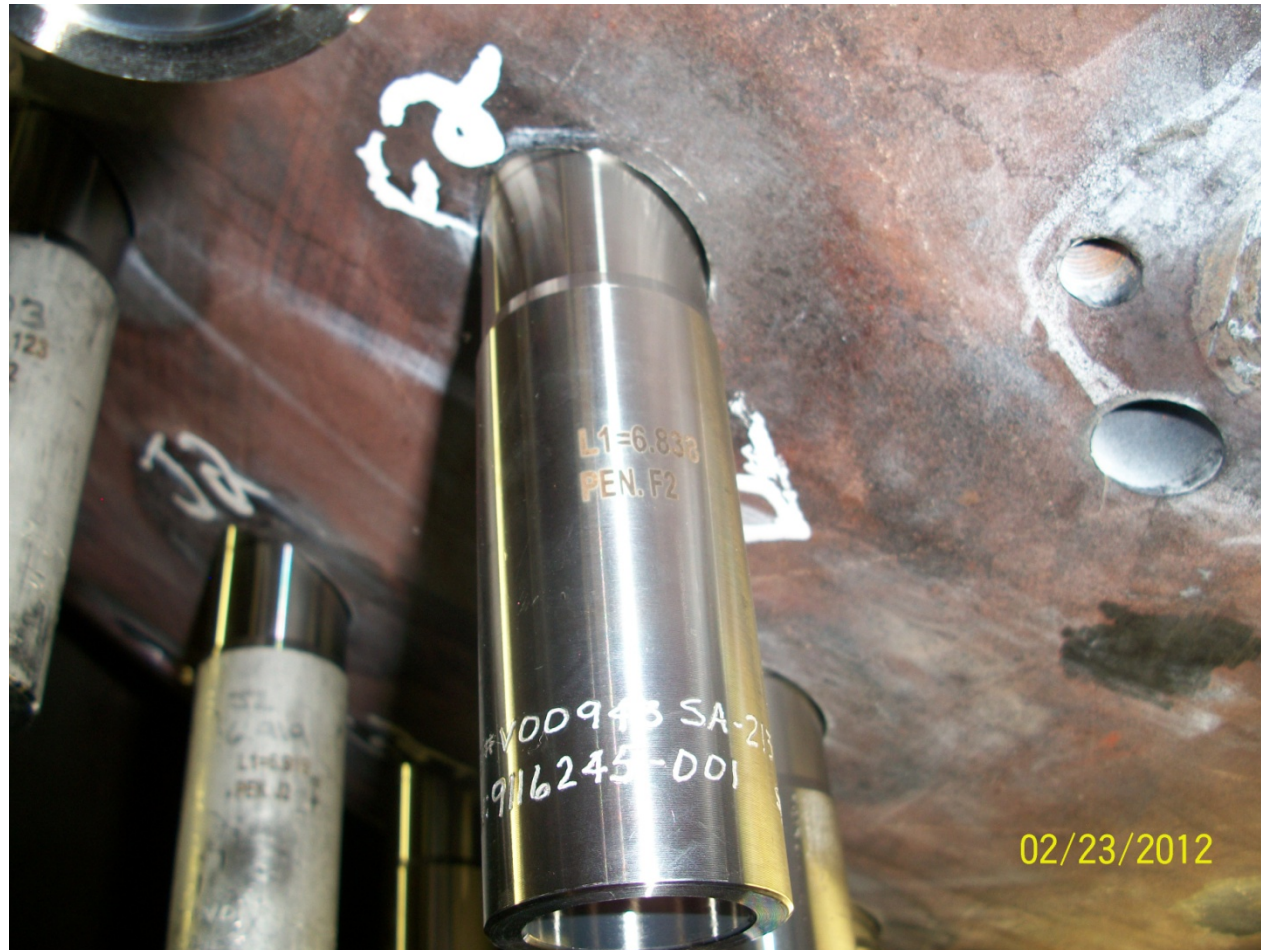
**Insert New
Sleeve (SA213
TP 316/316L)**

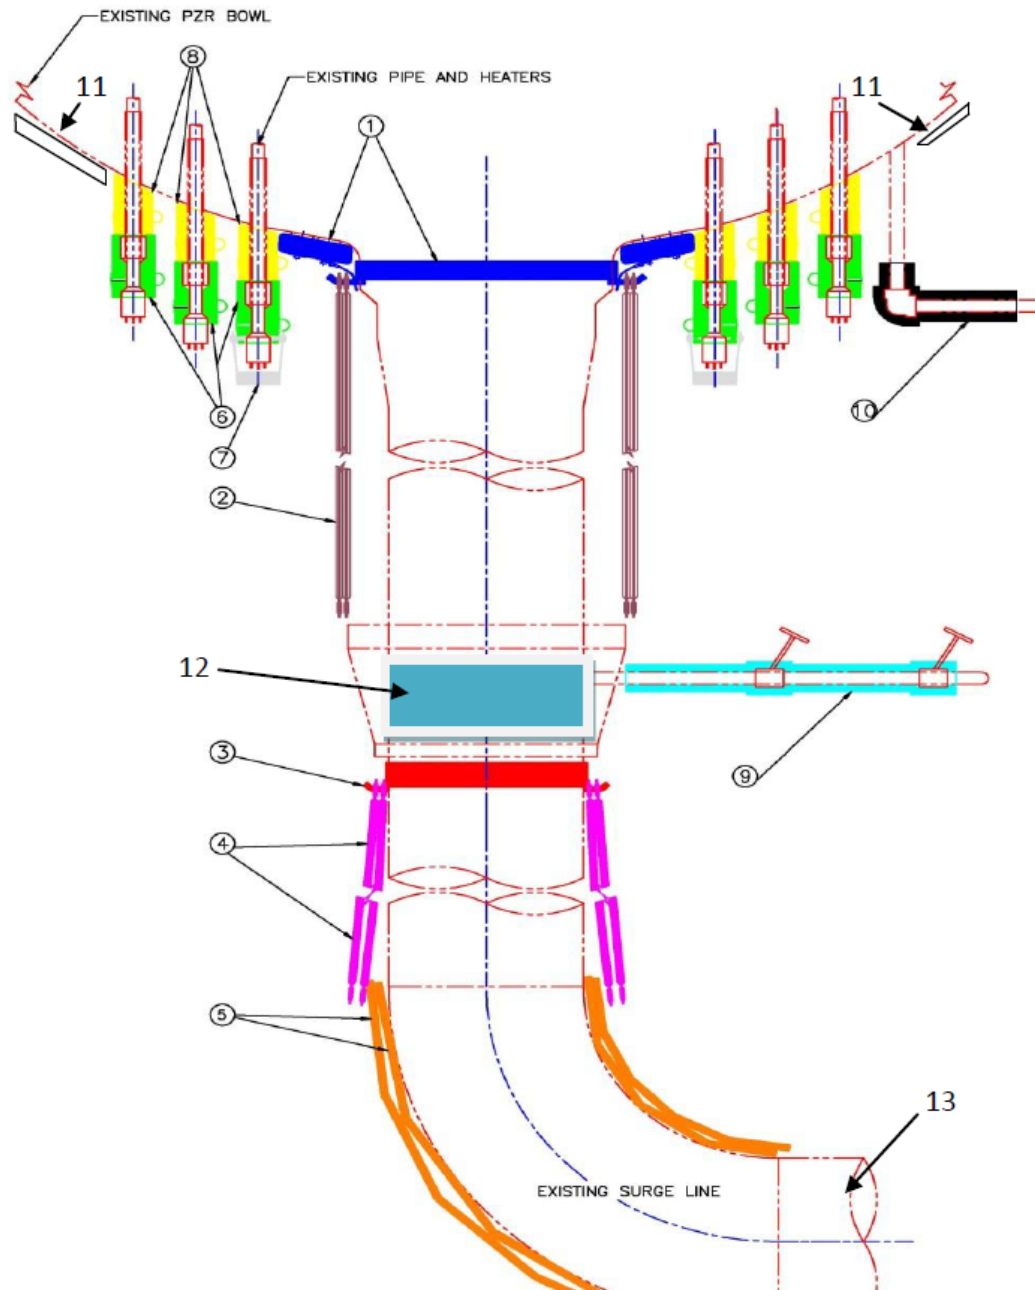
Shielding Locations

1. Shielding support ring and segmented nozzle shield

2. Upper surge line (LWB)

3. Shielding support ring

4. Surge line below tool

5. Surge line elbow (LWB)

6. Heaters (Molded Tungsten)

8. Heater sleeves (Tungsten)

9. 3/4" sample line and valves

10. Two 1" level lines

11. Magnetic tungsten applied

12. Tungsten wrap

13. Surge line horizontal

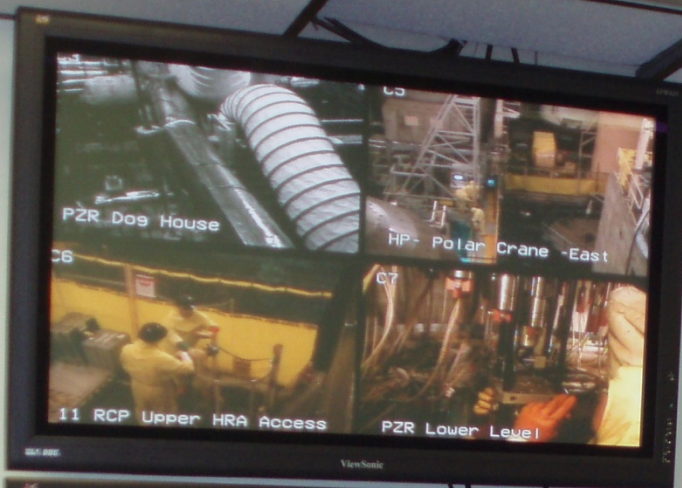
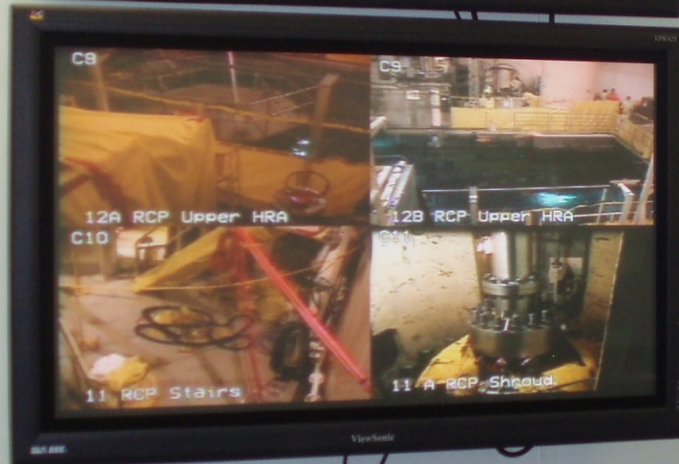
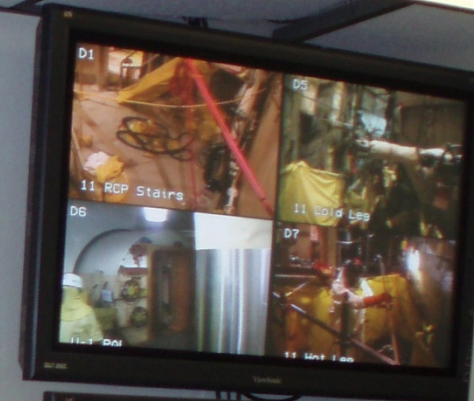
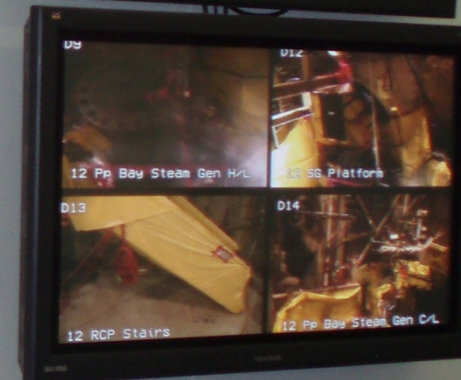
Tungsten Shielding on old PZR heater sleeves, sample lines, & level indication sensing lines.	Use of EDEX – Effective Dose Equivalent – 4900 hours of work in EDEX.
Lead Blanket Shielding on Surge Line & Spray Lines.	Shielded drums for old sensing lines and sample lines.
PZR flush via initiating PZR backup heaters before planned RFO.	Three HEPAs – (1) 1600 cfm, & (1) 1000 cfm under PZR, (1) 700 cfm on PZR manway.
Remote continuous RP Coverage & Mock-up Training.	Shielded boxes for old heaters.

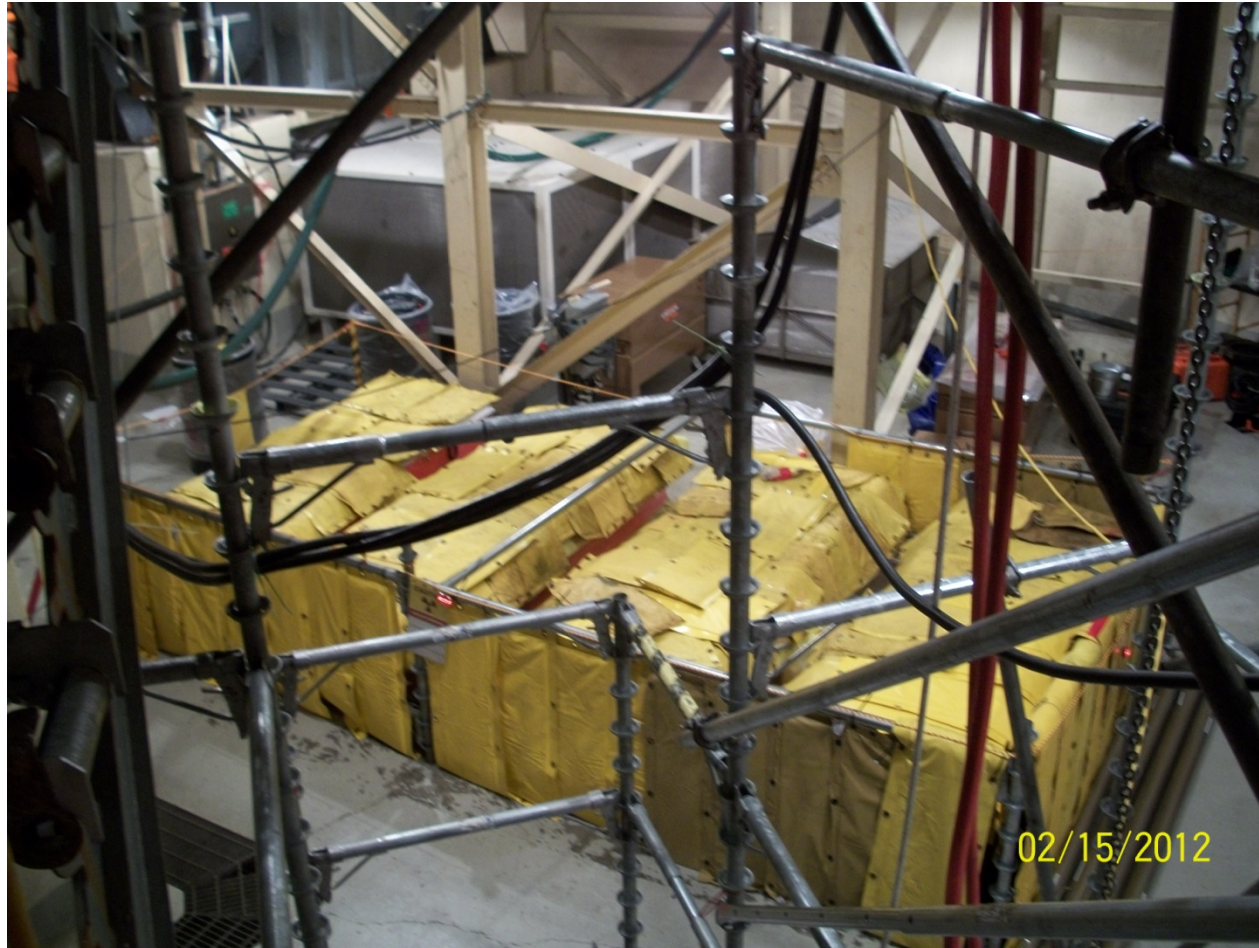
PZR Heaters Dose Rates (3) Times Higher than Expected

- Initial dose rates on old PZR Heaters were higher than anticipated.
- Reliability issues with automated welding equipment.
- Mid-way through the project water was removed from the surge line to support other work not related to the PZR. This increased G/A dose rates for one week.
