DAEC Torus Recoat Project-2012

Presented by: Robert L. Porter,
Radiation Protection Manager

- Historical Information
- Project Overview
- Pre-outage set up
- Grit Blasting/recovery
- Lessons learned
- Corrective Actions
- Project Review

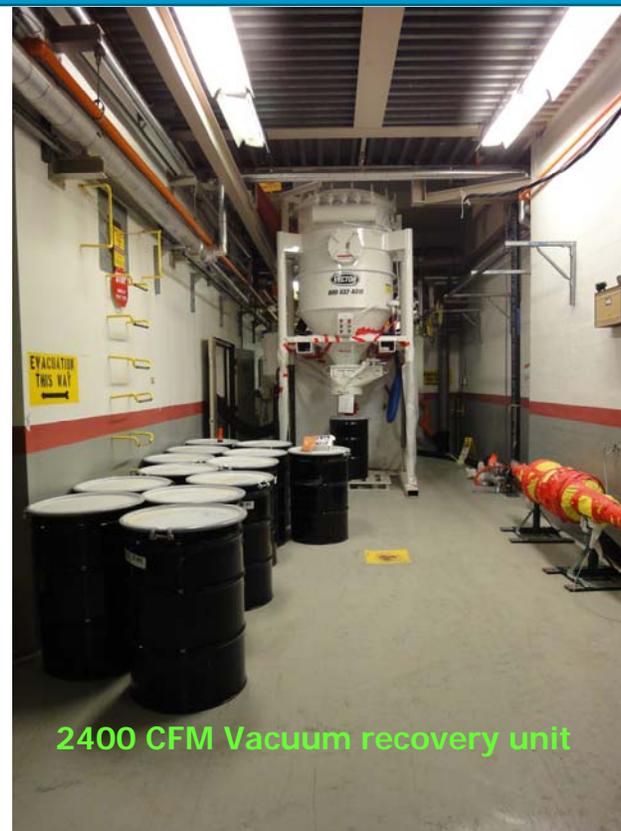
2400 CFM Vacuum recovery unit

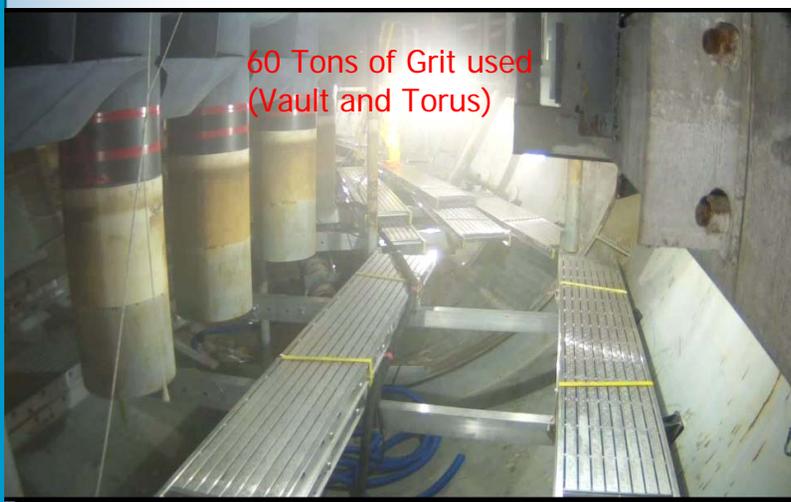
60 Tons of Grit used
(Vault and Torus)

~700 gallon water intrusion
through T-Quenchers
(unidentified source)
