**The situation of individual dose management of the workers
who engaged in emergency work in
Fukushima-daiichi nuclear power station accident**

Tokyo Electric Power Company, Inc.
September ,2012

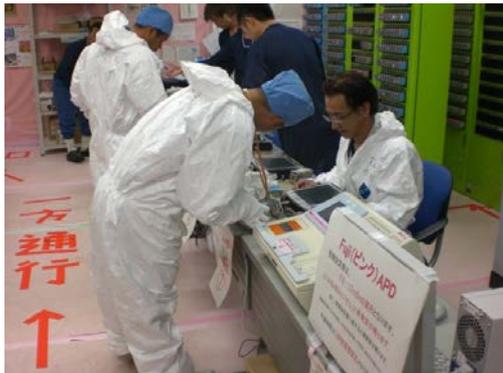
- Unable to use about 5,000 APDs and their chargers for the tsunami.
- Gathered 320 available APDs.
 - All workers couldn't have APD.
 - A representative of the work carried a APD. (necessary condition: same work, same work place .etc)
- Newly purchase of 100 APDs 1 April, 2011 and brought 640 APDs from Kashiwazaki Kariwa Nuclear Power Station (1,060 APDs in total)
 - It went back up for the use that all workers could have APD (Now about 6,300 APDs in total).
- Started operating the individual discrimination system (bar codes) at 1F 1 April, 2011 and J-Village 8 June, 2011.
 - Sure of radiation management
- Started to notify individual dose by receipts 6 August, 2011.

APD lending place
at anti-earthquake building

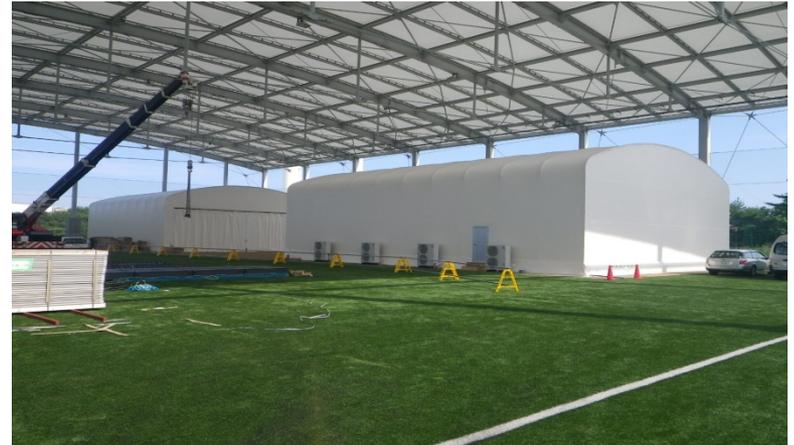
■ The inside of WBC center

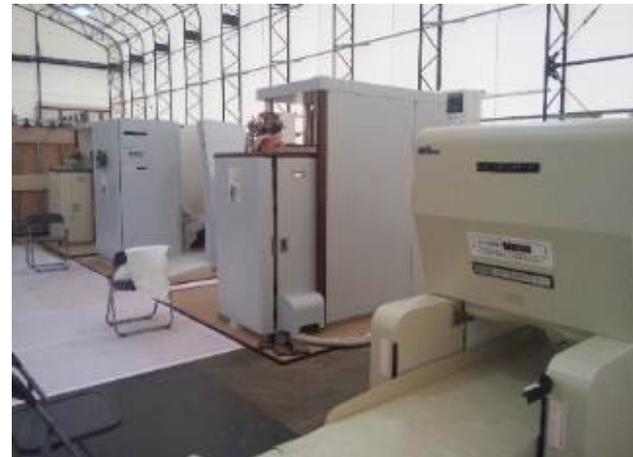
■ WBC of installation type

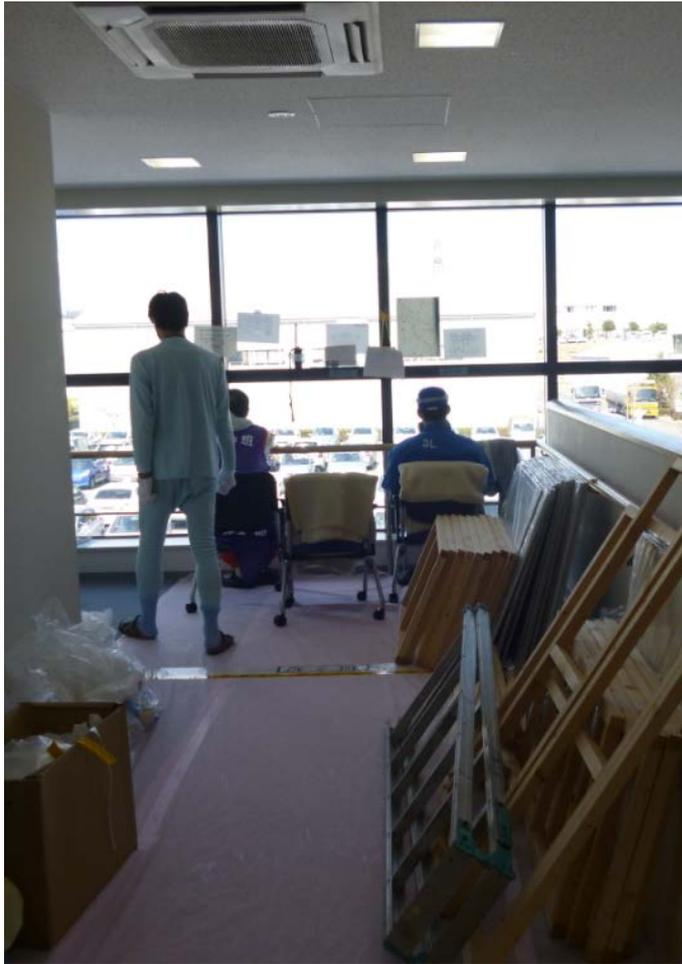
Before construction

*The dose exposure reduction measures of seismic isolated building
(Setting of the lead board to the window)*

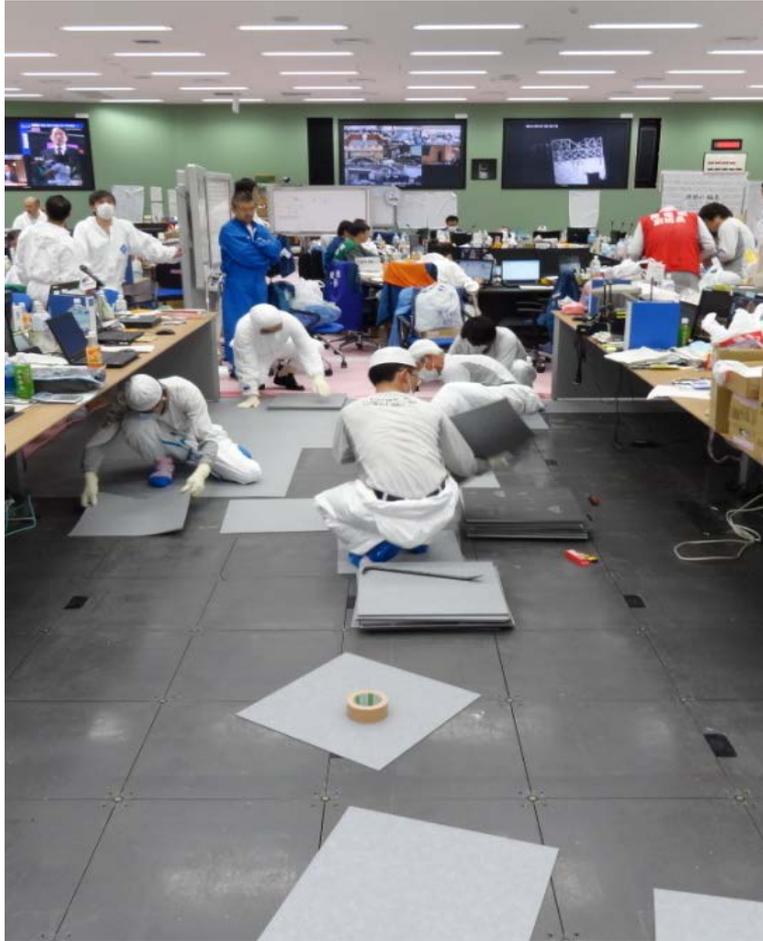
Under construction

***The dose exposure reduction measures of seismic isolated building
(Setting P-tile on the floor)***

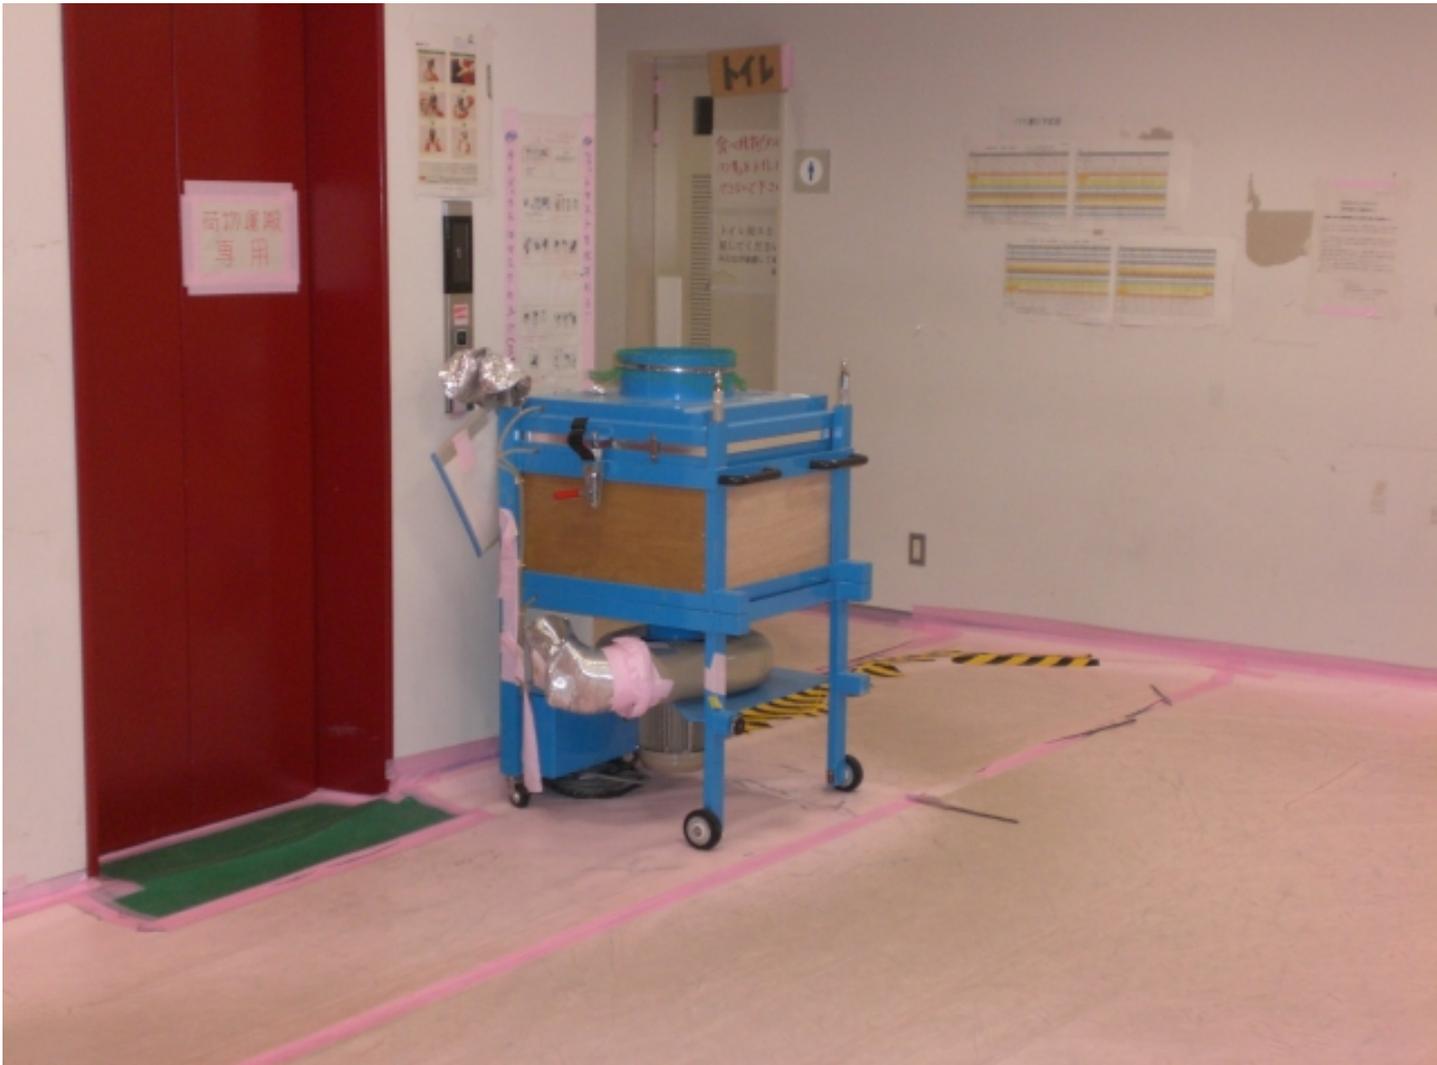
Setting of the local exhauster

- Use not to let female workers work at 1F since 23 March ,2011.
- Change to the tile which is hard to attach and deployment of the local exhauster.
→Reduction of radioactive matter concentration in air in the anti-earthquake building.

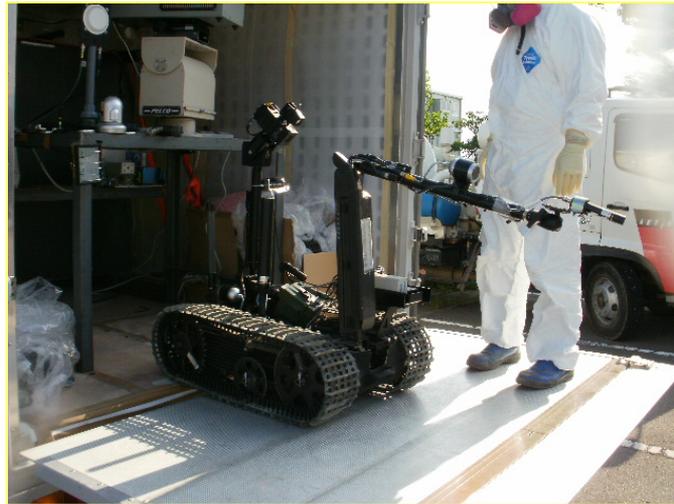
Robot for measurement of dose rate(Taron)

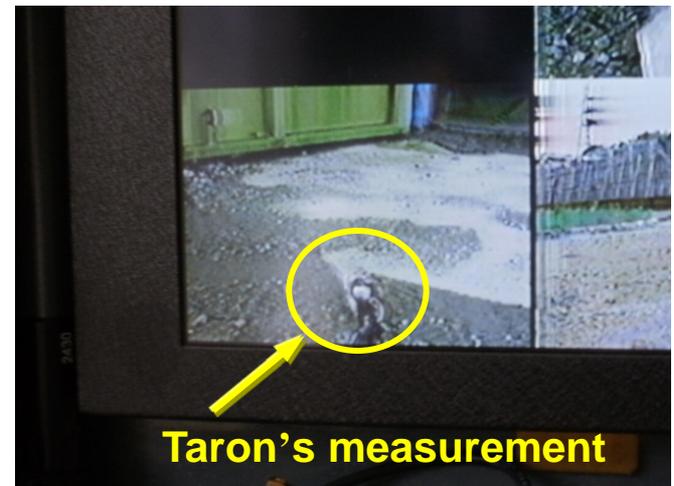
Make sure of picture and measurement result by parked operation vehicle in low dose area.

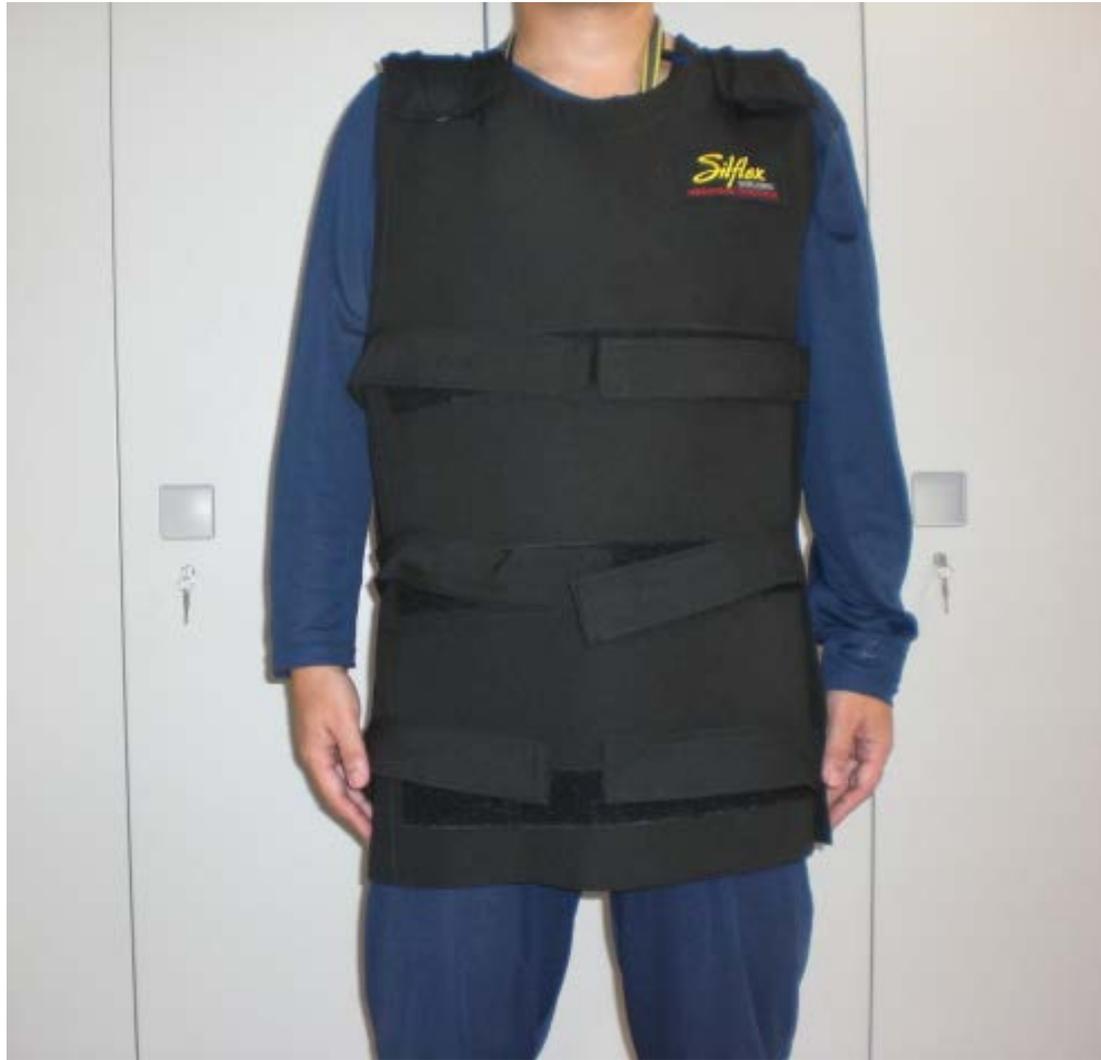
The tungsten best

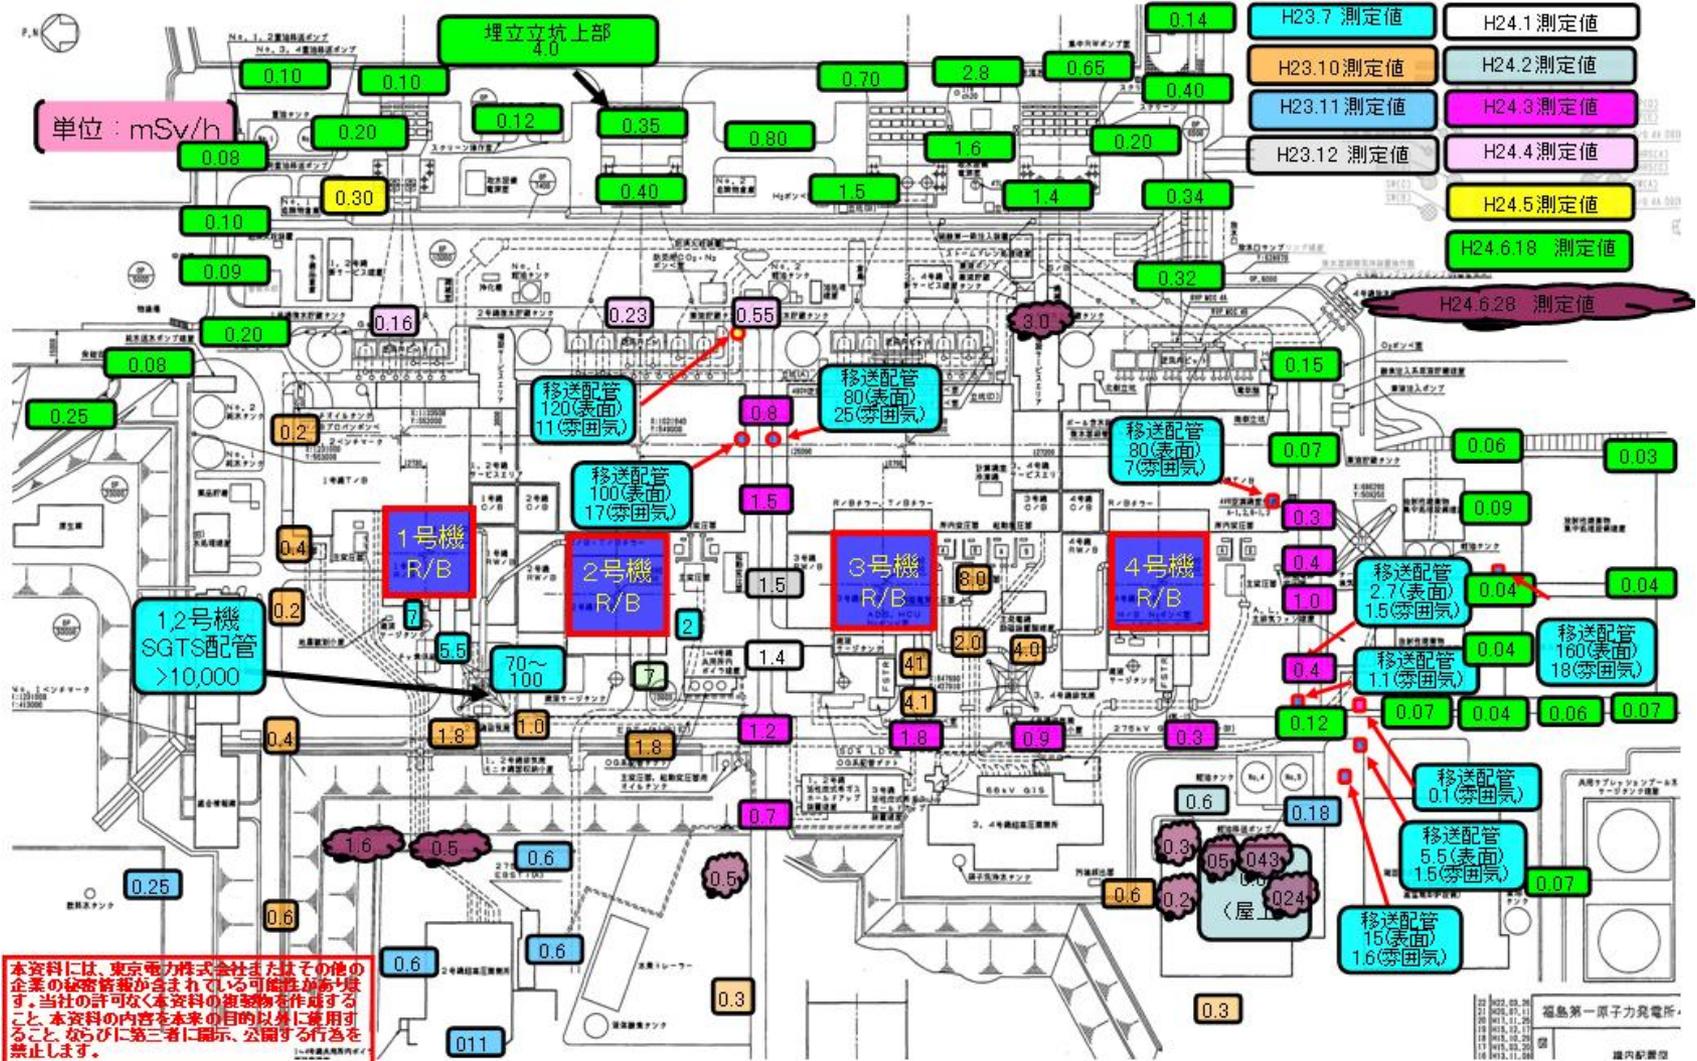
福島第一サーベイマップ (平成24年 6月28日 17:00現在)
