2016 ISOE ALARA
Symposium
Ft. Lauderdale, FL
January 10-13, 2016

Dry Cask Storage • Cook Nuclear Plant

DC Cook NPP

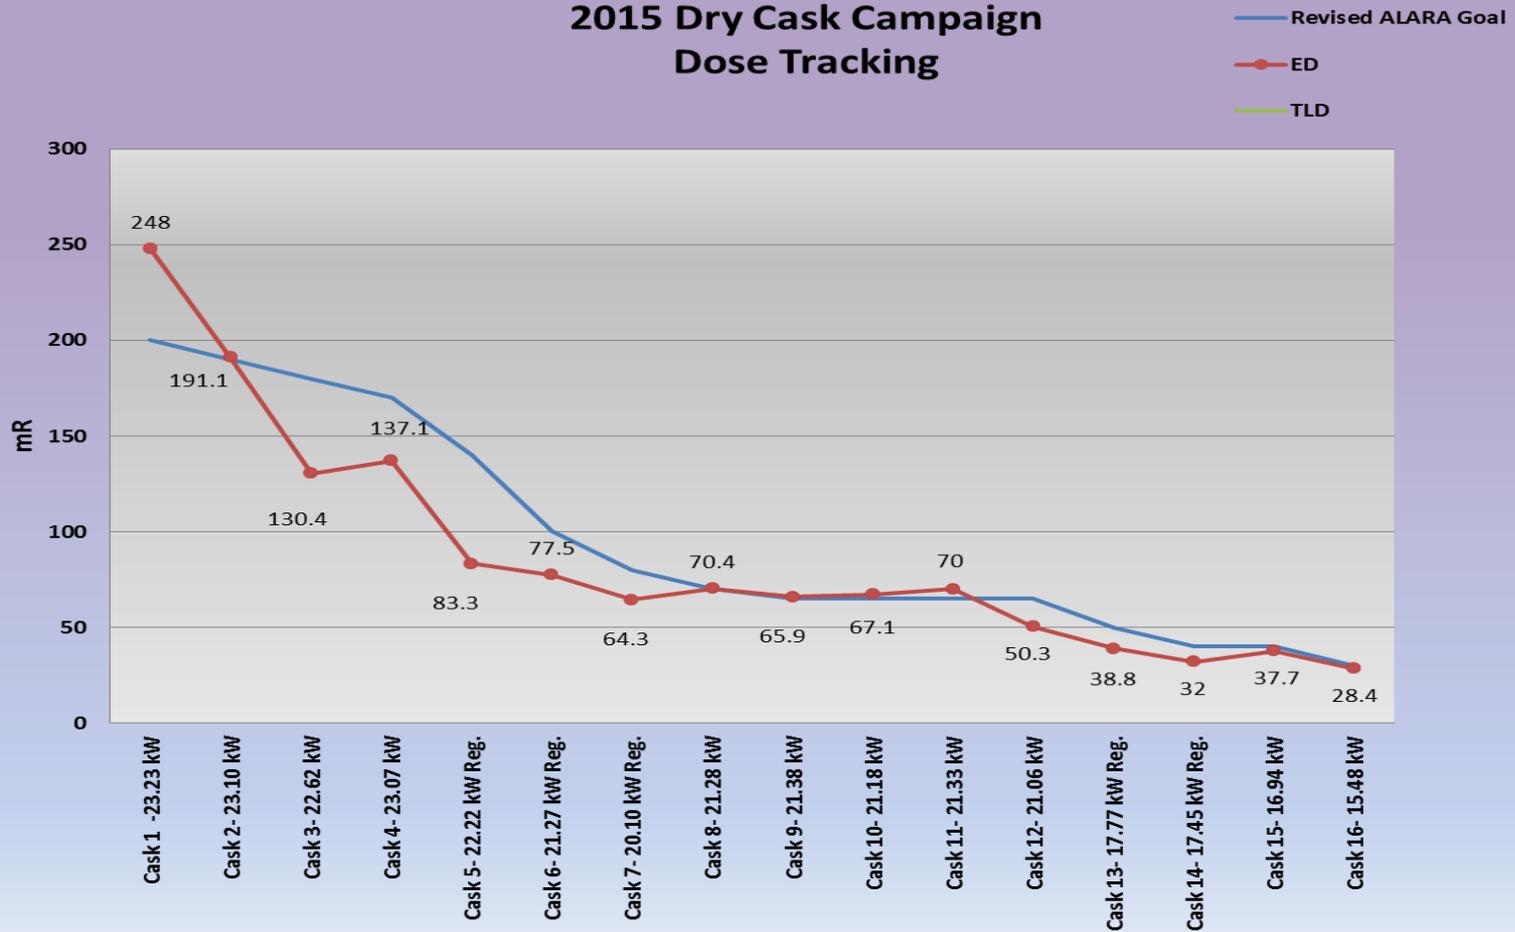
2015 Dry Cask Campaign Dose Tracking

- 16 Casks Loaded in 18 Work Weeks
 - 0 Injuries
 - 0 Personnel Contaminations
 - 0 Dose/Unanticipated Dose Rate Alarms
 - 1392 mR Total (ED), 21,429 RWP Hours
 - Highest Dose Cask: (1st Cask) 248 mR
 - Lowest Dose Cask: (16th Cask) 28.4 mR
 - 0 FME Events
 - 0 Dropped Objects
 - 0 NRC Violations/Findings/Open Items
 - 36,355,800 lbs. Lifted/Set Safely
