# System decontamination of two BWR units performed during 2011 and 2012

ISOE 2012

# Forsmark Kraftgrupp AB

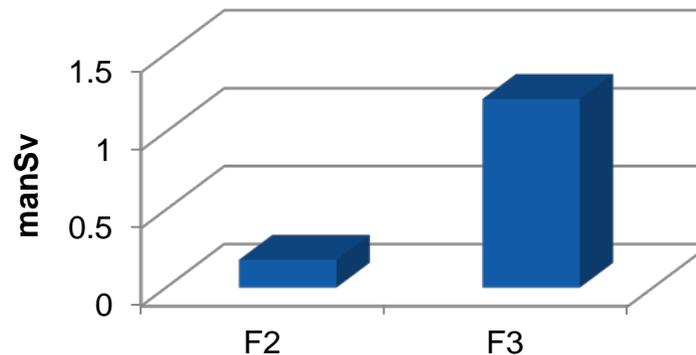
**Collective dose savings**

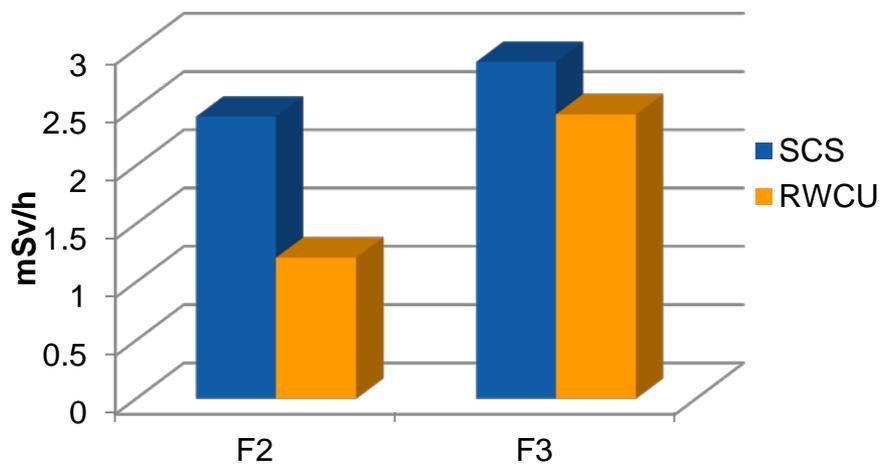
Higher initial dose rates at F3  
but lower after  
decontamination

Average dose rate before  
decontamination

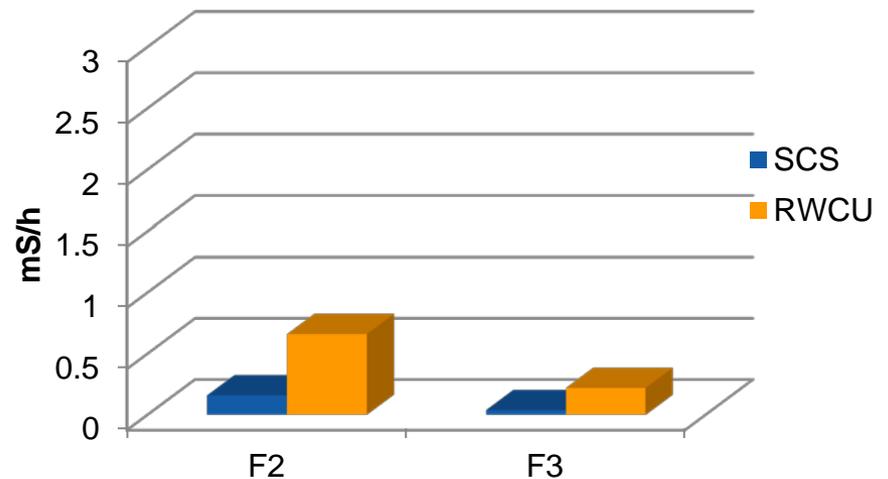
Average activity after  
decontamination

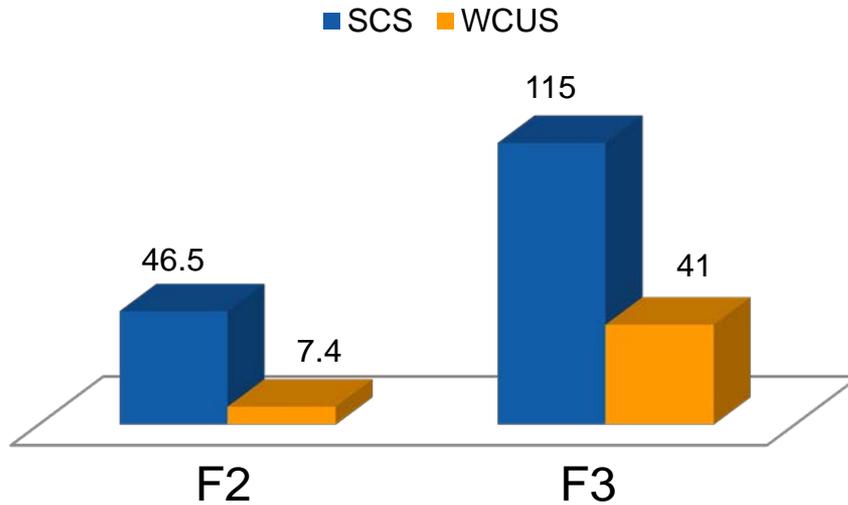
## Decontamination factors for F2 and F3

Decontamination factor higher at F3 for almost all comparable locations

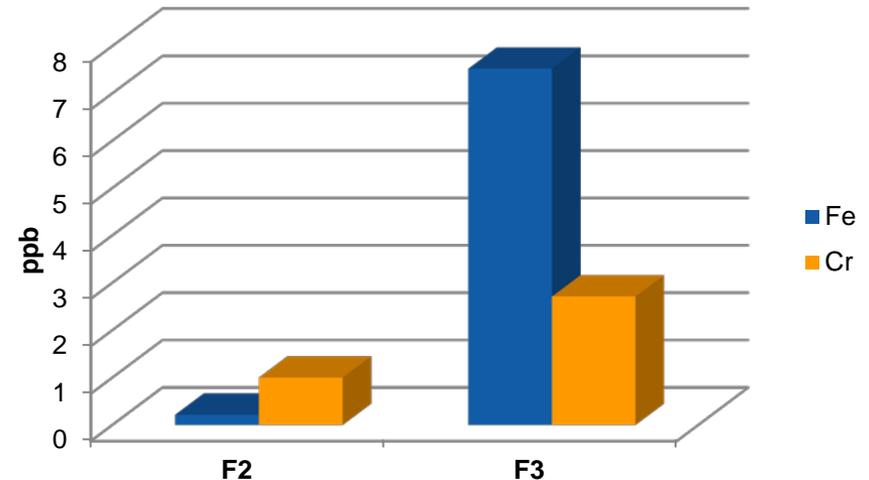
- Different design
  - F2 5 year older than F3.
  - Piping thickness, flow velocity, material selection
- History
  - F3 decontaminated 2001. F2 never been decontaminated. Older oxide.
- Differences in water chemistry
  - Higher Fe and Cr content in F3 system water.
  - Due to bypass of condensate cleaning system.
  - Results in a thicker, more readily dissolved oxide?
- Differences in dose rate measurements
  - Effect only on low dose rate areas

Fe and Cr in reactor water
