Operational Experience during the replacement of Pressuriser Heaters in Forced & Planned Outages

Sizewell B Power Station

Forced Outage 43

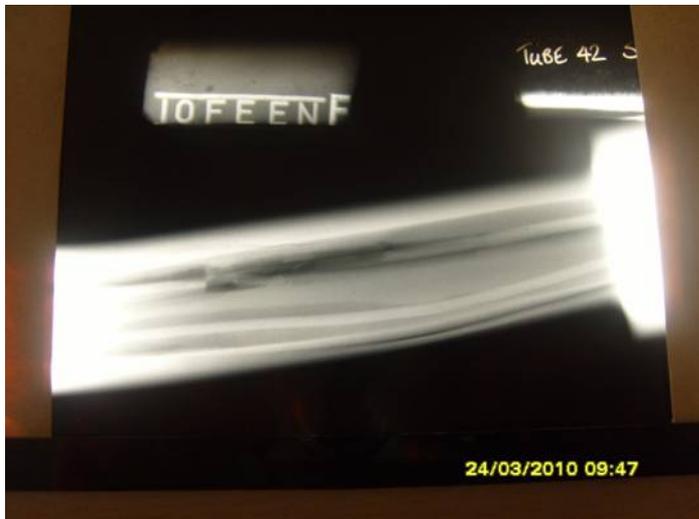
Heater 42 Radiograph showing disruption to the heater and the HWI

- Radiography confirmed that heater well insert (HWI) 42 had failed because of the expansion of the heater.
- All the other HWIs were radiographed and HWI 70 was also found to be expanded - both were electrically failed heaters.

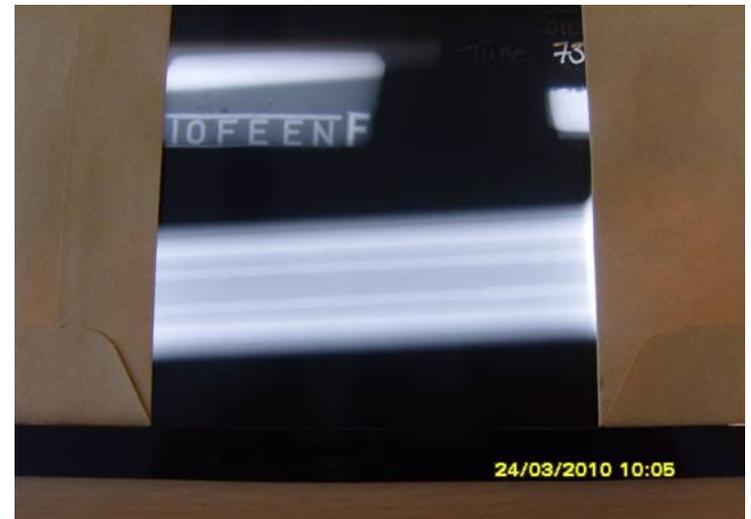
Heater 72 Radiograph showing a normal heater and HWI

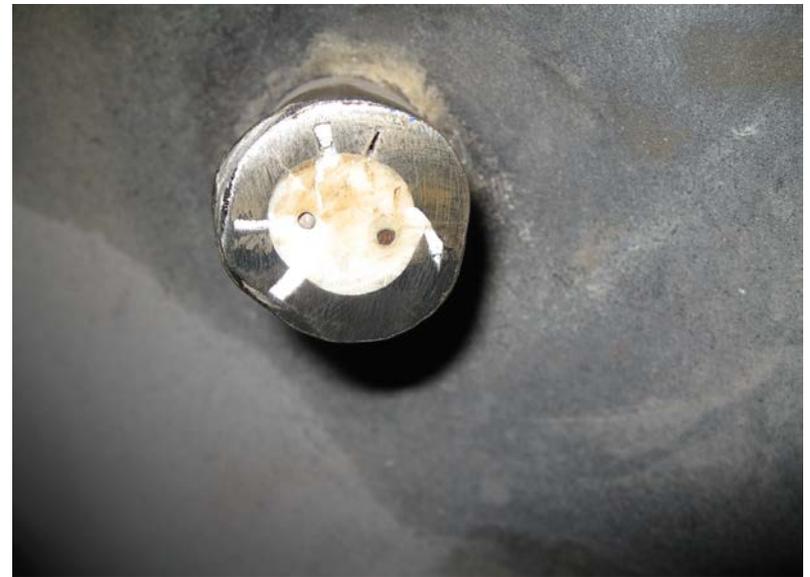
HWI 70 after cutting

- HWIs 42 & 70 were cut which showed the heater sheaths were cracked and fully expanded into the wells.

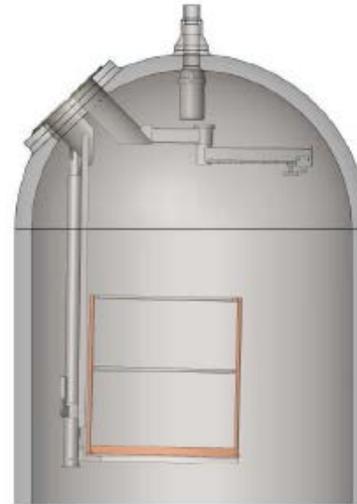
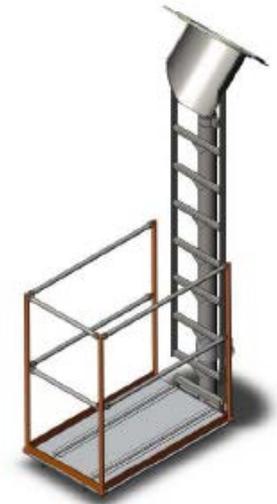
Removal of mechanically damaged heaters

- Removal of damaged heaters using Electrical Discharge Machine tool
 - Manually deployed from internal platform.
- EDM tool used to cut through support plates & “canned” heater then removed.
- Full size mock-up built to practice techniques & man-entry arrangements.

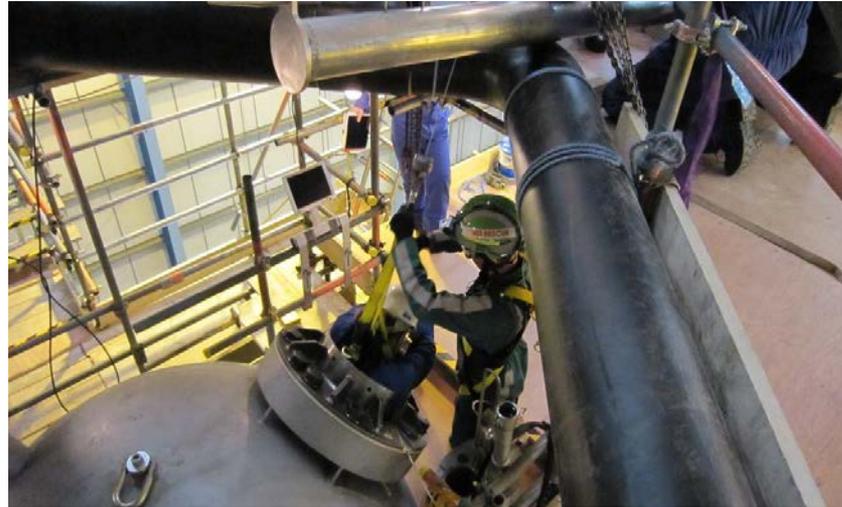
Practising man-entry

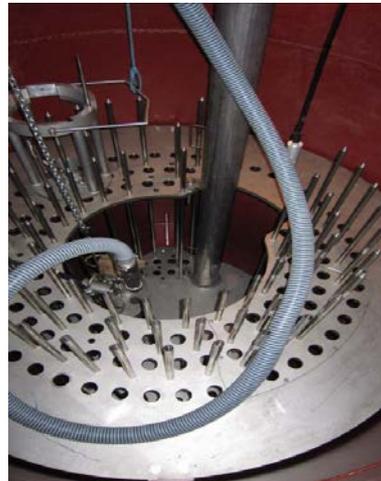
Mock-up of upper support plate with heaters

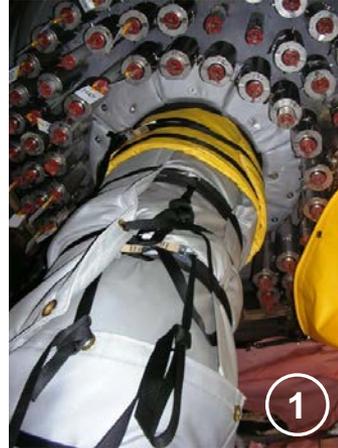
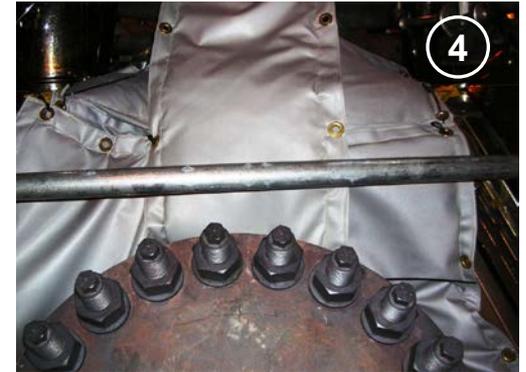
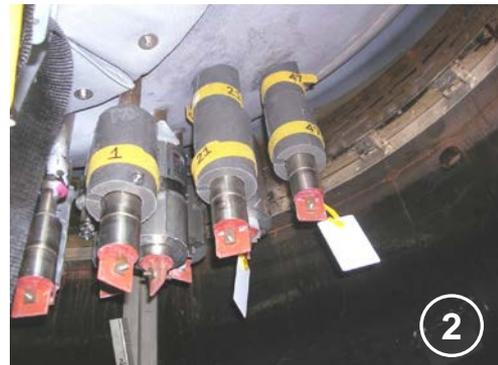
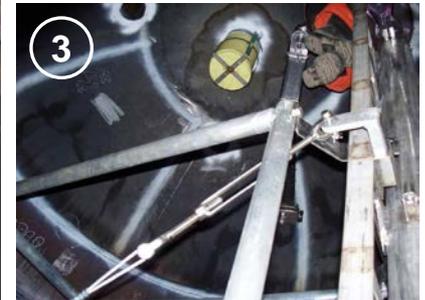
Shielding

- “Clam shell” style heater shielding packages loaned by Seabrook NPP, USA (1).
- Tungsten heater well shields, magnetic bowl shielding & surge pipework shielding purchased from NPO (2).
- Radishield spray nozzle shield from Mazel (3).
- Standard blanket shielding on Pressuriser spray pipework (4).

Shown on mock-up

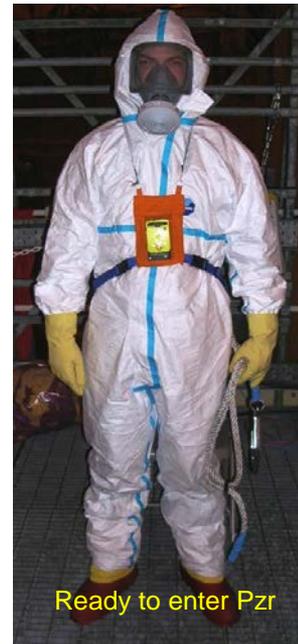
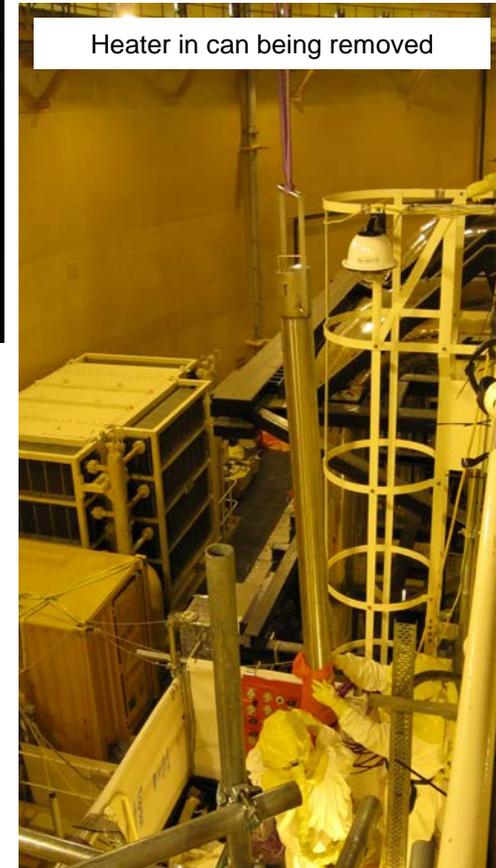
Pzr Heater Removals

- All electrically-failed heaters removed
 - 14 heaters removed from bottom of Pzr via Heater Well Inserts, then plugged.
 - 3 heaters removed from manway after cutting by EDM tool, then plugged.
- Modified Tri-Nuke vacuum used to collect EDM cutting material
 - ~ 6 filters used.
- 120 man-entries inside Pzr
 - ~66 hours inside Pzr.

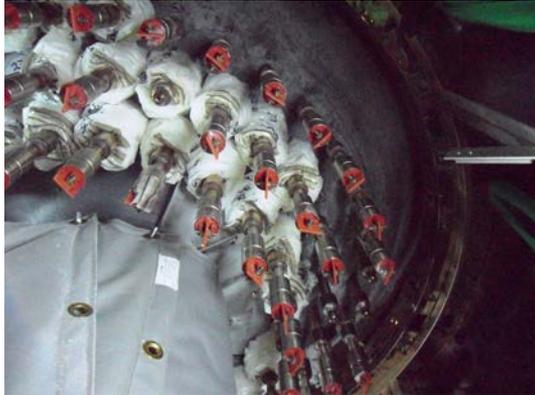
Heater wells with sleeving ready to cut

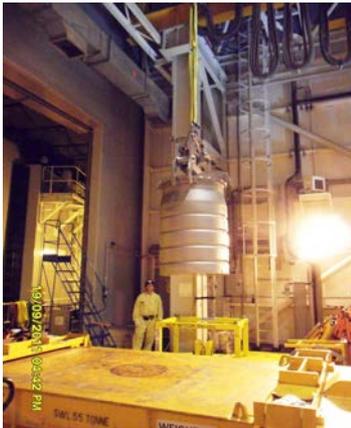
Demobilising a shielded drum of heaters

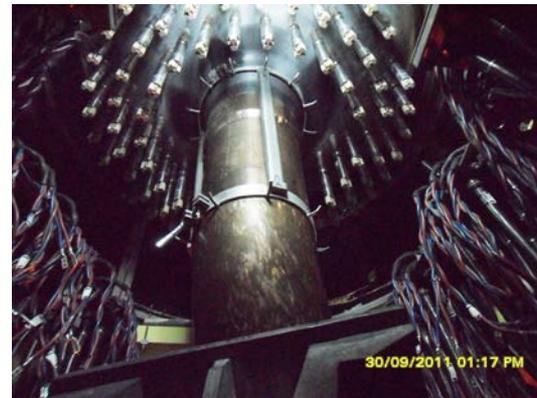
Pressuriser with new heaters installed
