## Hot Spot Experience at KKL

Andreas Ritter, KKL

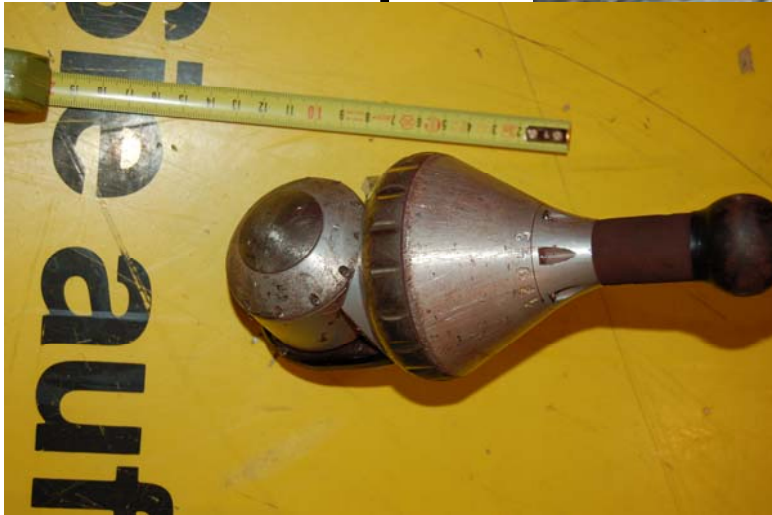
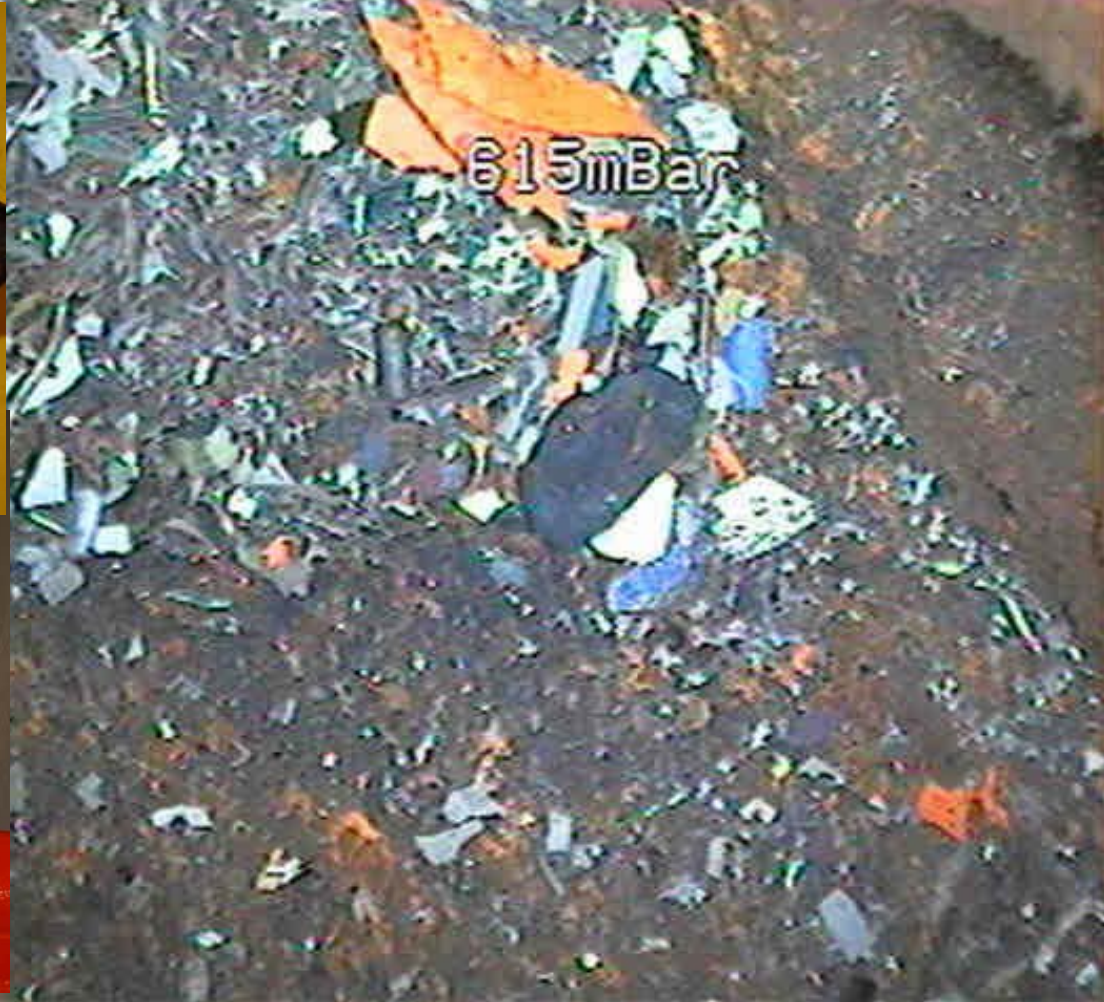
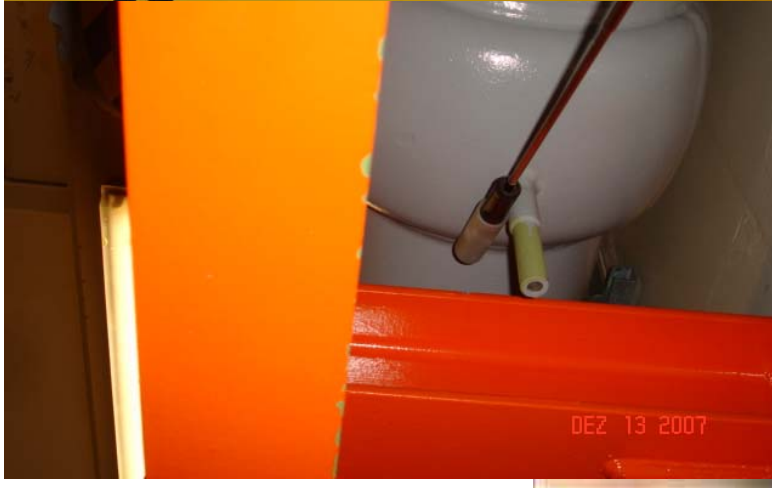
# TG10S001 valve lower housing picture taken by endoscope

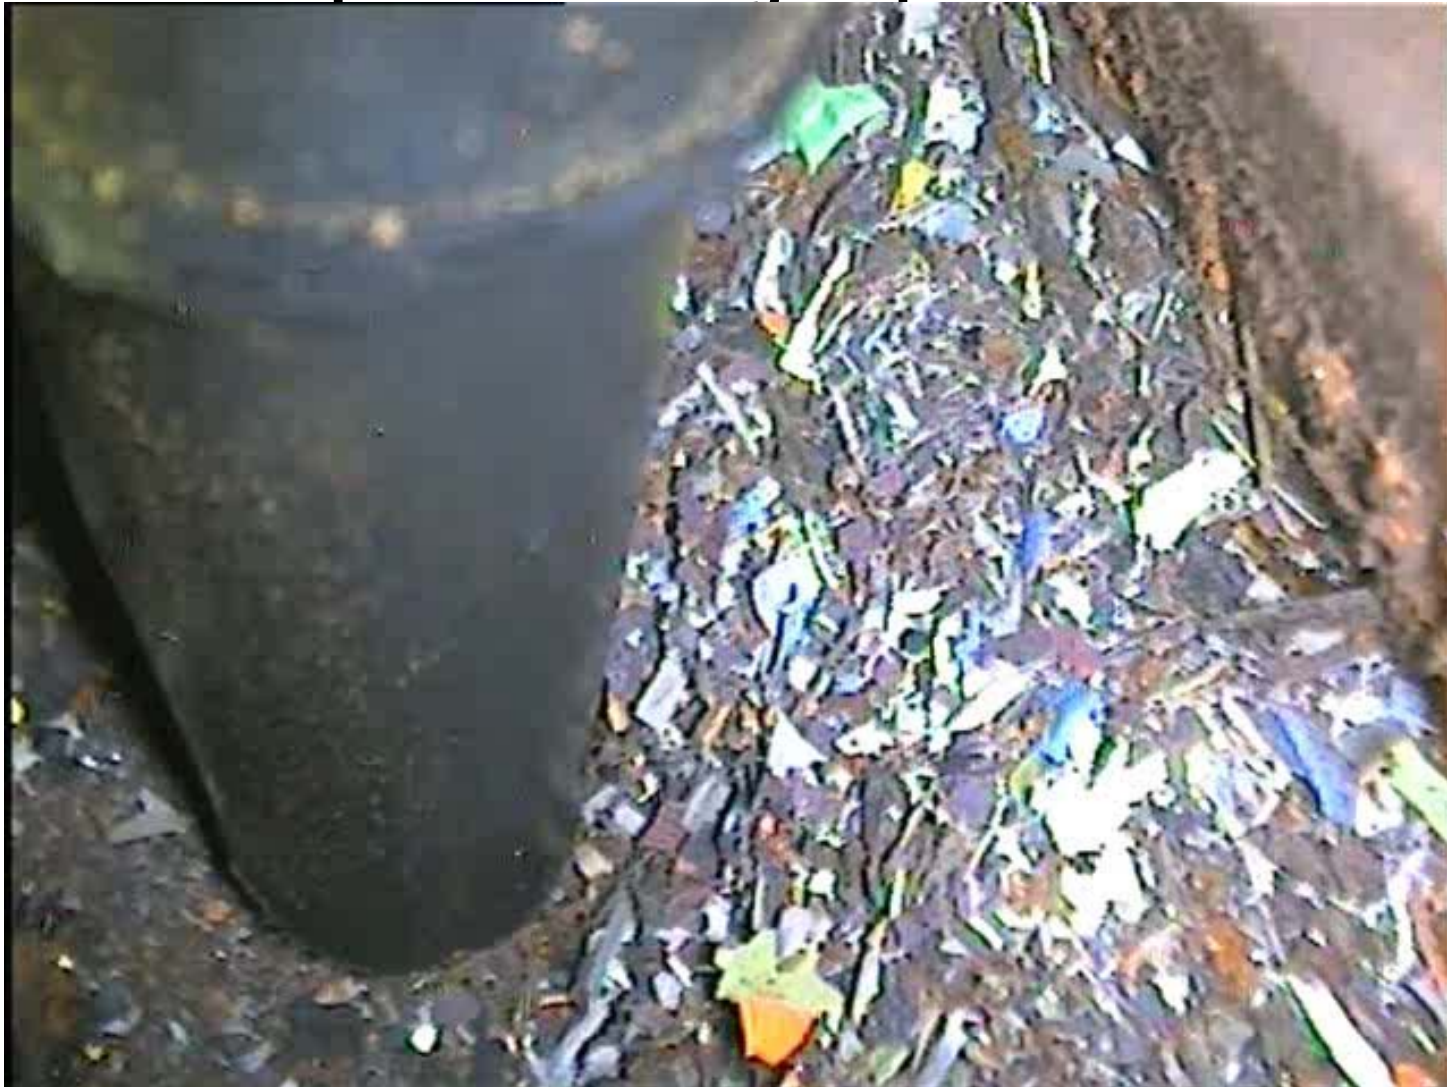
## Video: Hot-Spot vacuuming sequence TG10S001

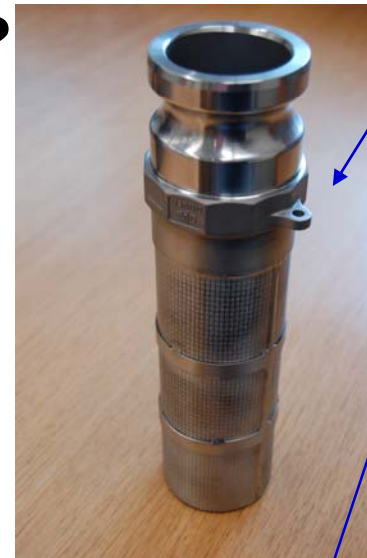
# Where did the Hot Spot go?

Commercial filter cartridge: clogging

Customized „star-filter“:  
wider mesh, 800 mSv/h,  
disposal during Control  
Rod disposal campaign  
2010

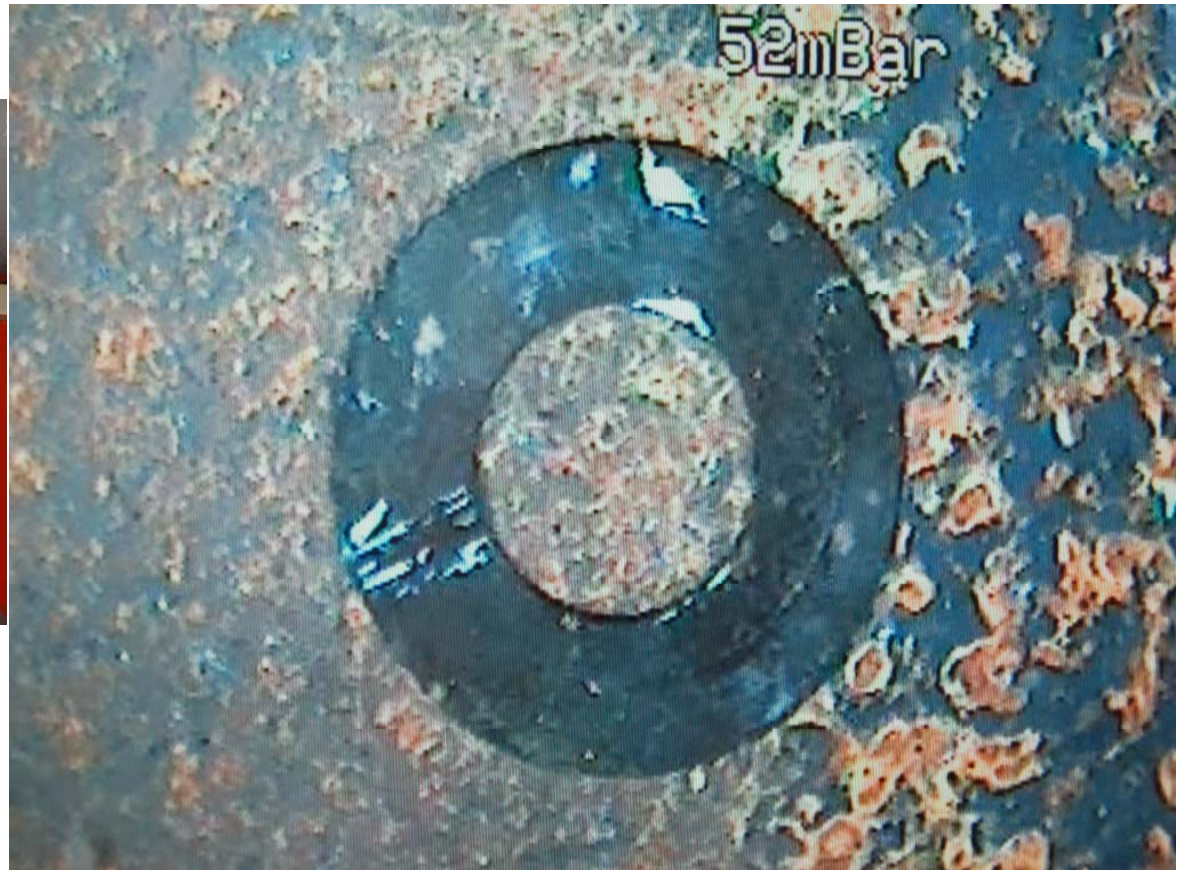
Clean water injection  
for backwash,  
including check-valve

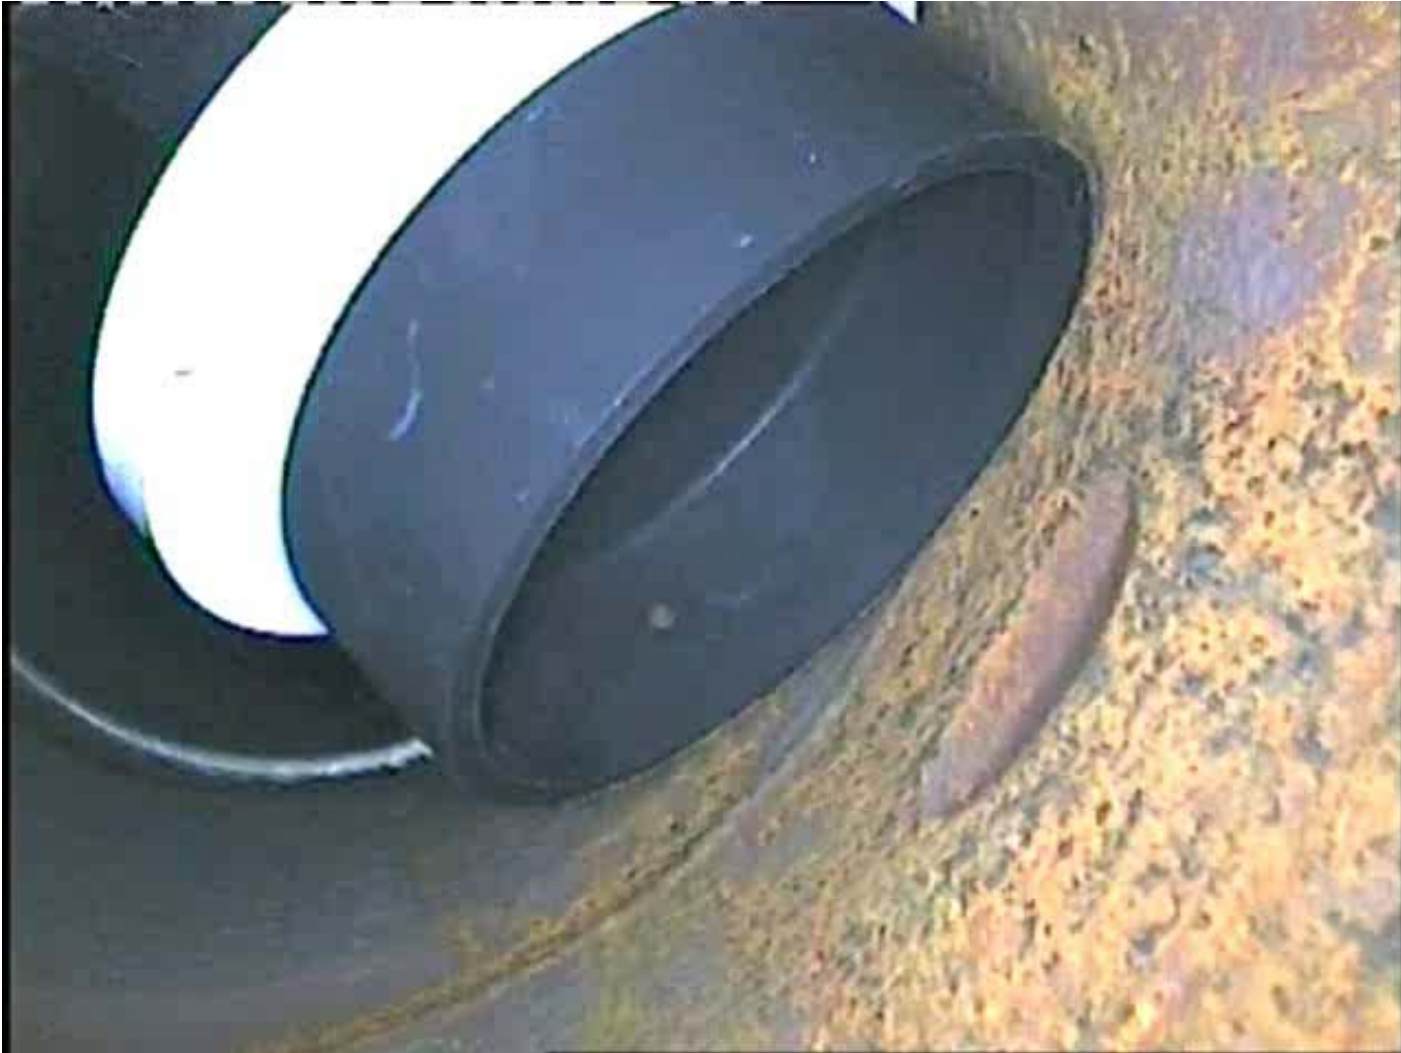
## Video: Hot-Spot vacuuming sequence drain line TG10S101

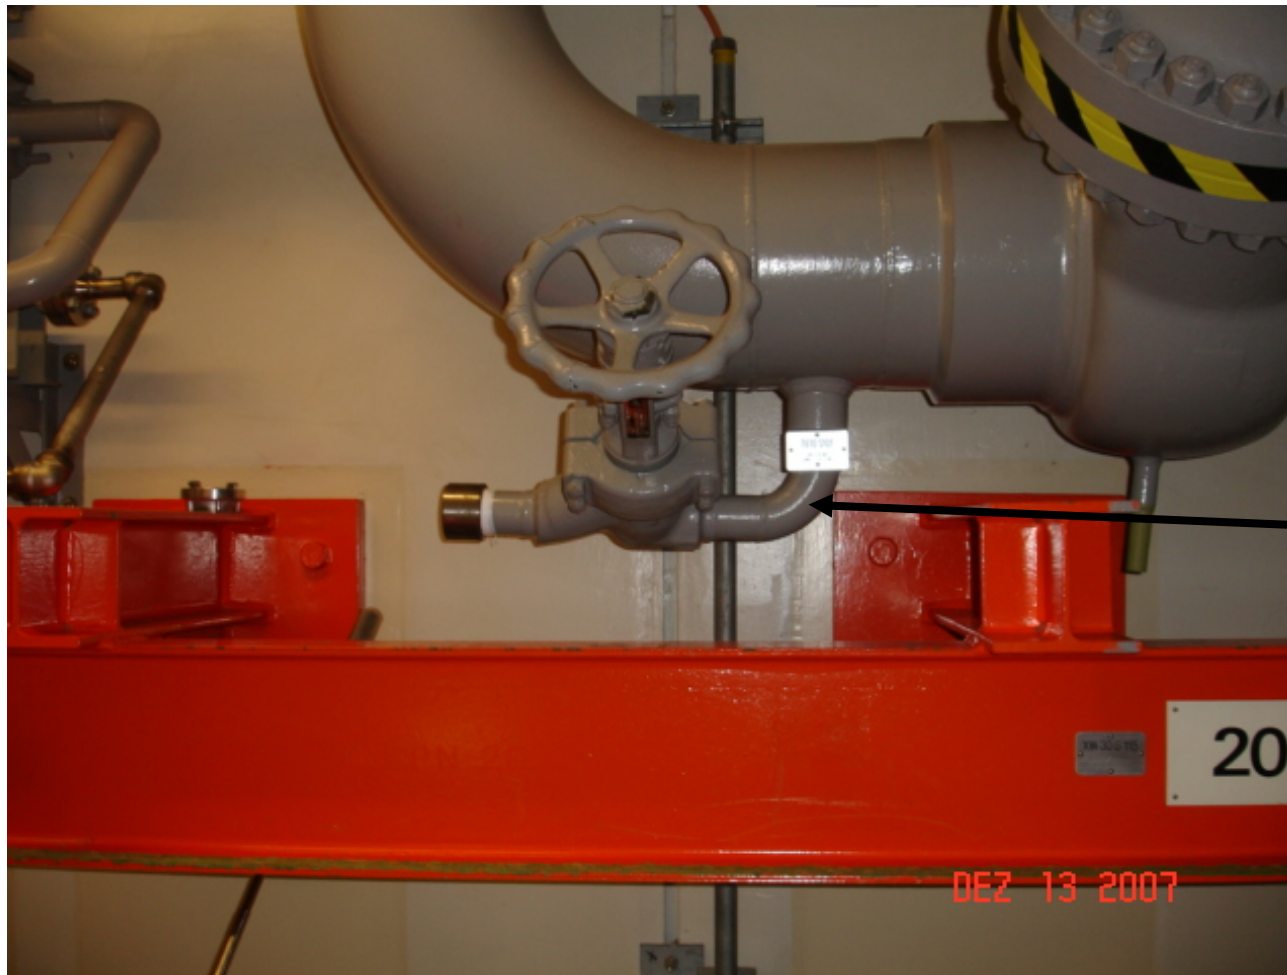
## Situation after Hot Spot #2 removal

6 mSv/h

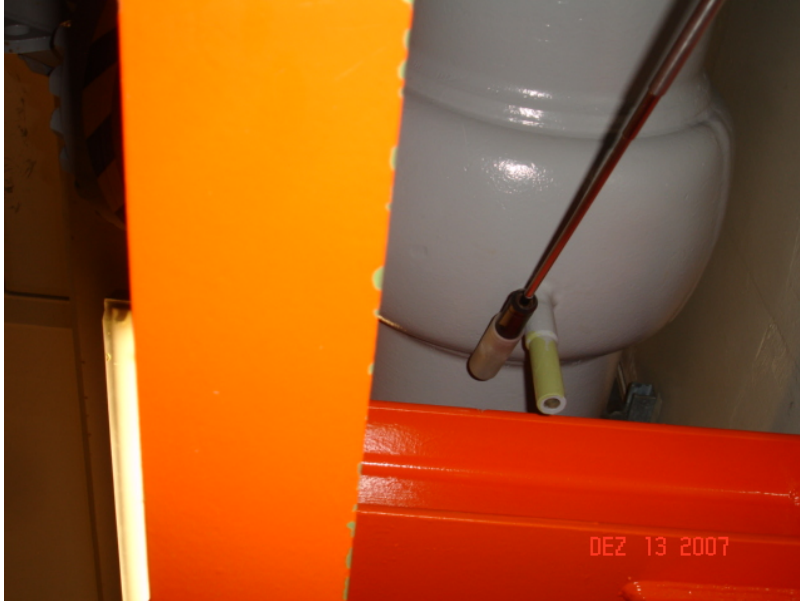
## Situation **before** and **after** RFO24

TG10S001  
5 mSv/h / 520 mSv/h

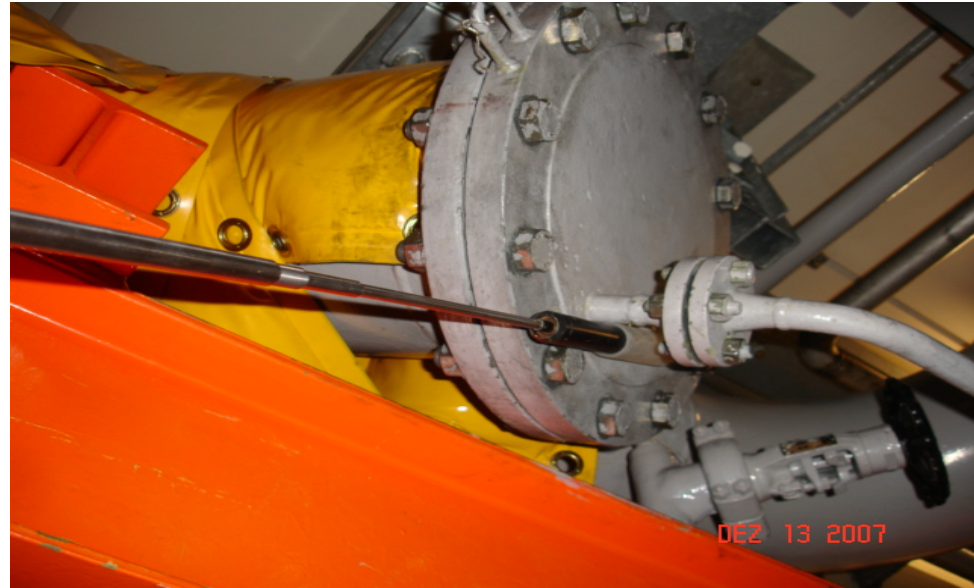
Drain line of FPCCU pump  
protection mesh  
620 mSv/h / 4'500 mSv/h

During RFO-24 fuel inspection fuel cladding needed to be brushed. Removed CRUD was pumped into FPCCU suction line. Good idea????

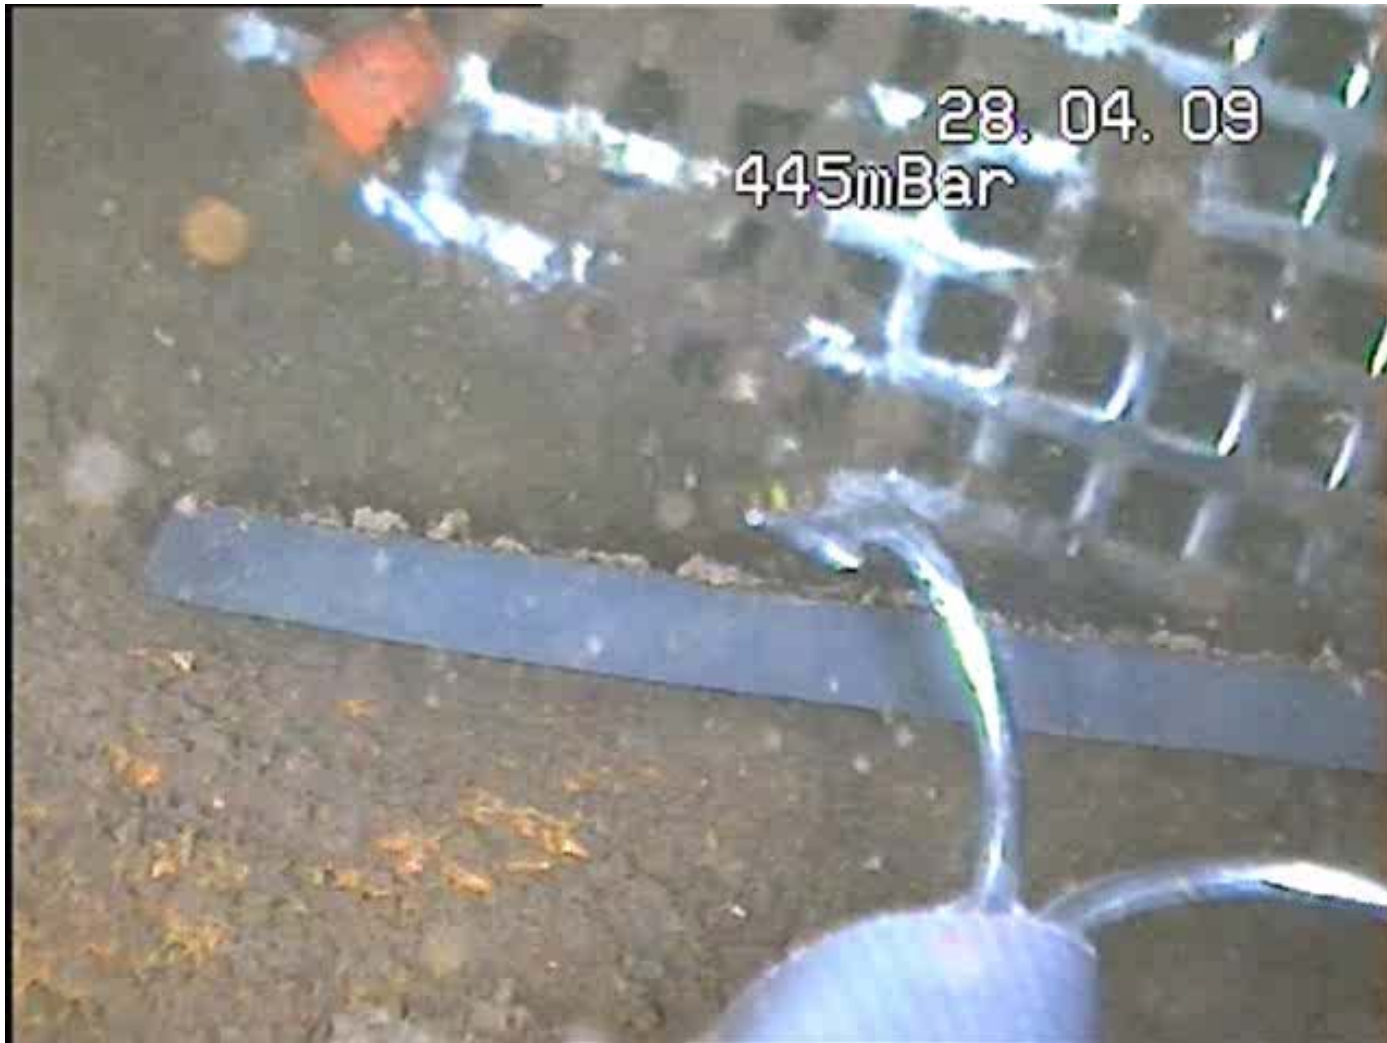
## Video: Hot-Spot vacuuming sequence TG10N100 pump protection mesh

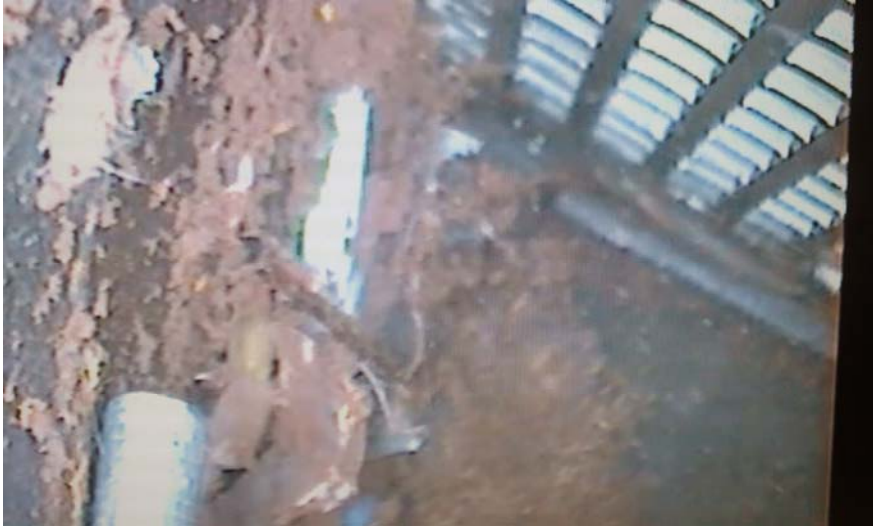
# Pump mesh before and after cleaning

Remaining Hot Particle #4  
1200 mSv/h

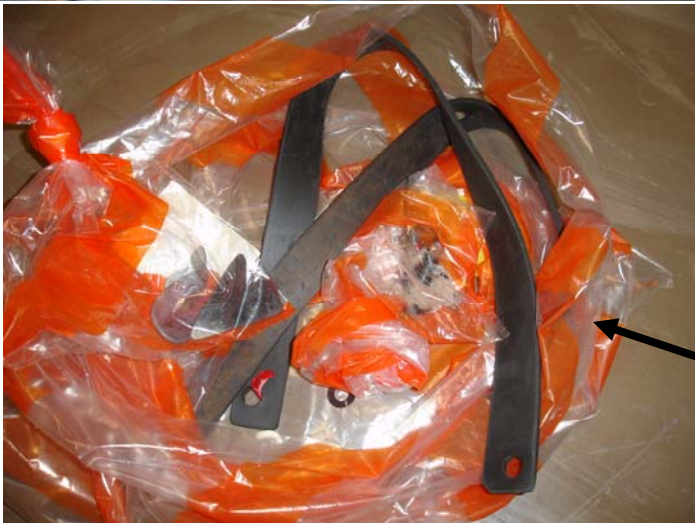
Removed foreign material

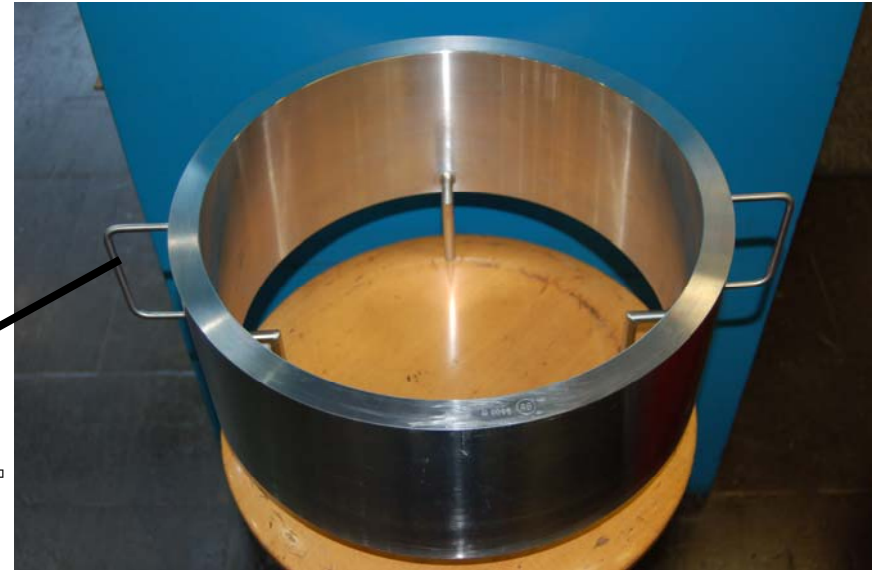
## Installation of collar

collar prevents heavy particles from being washed into suction line

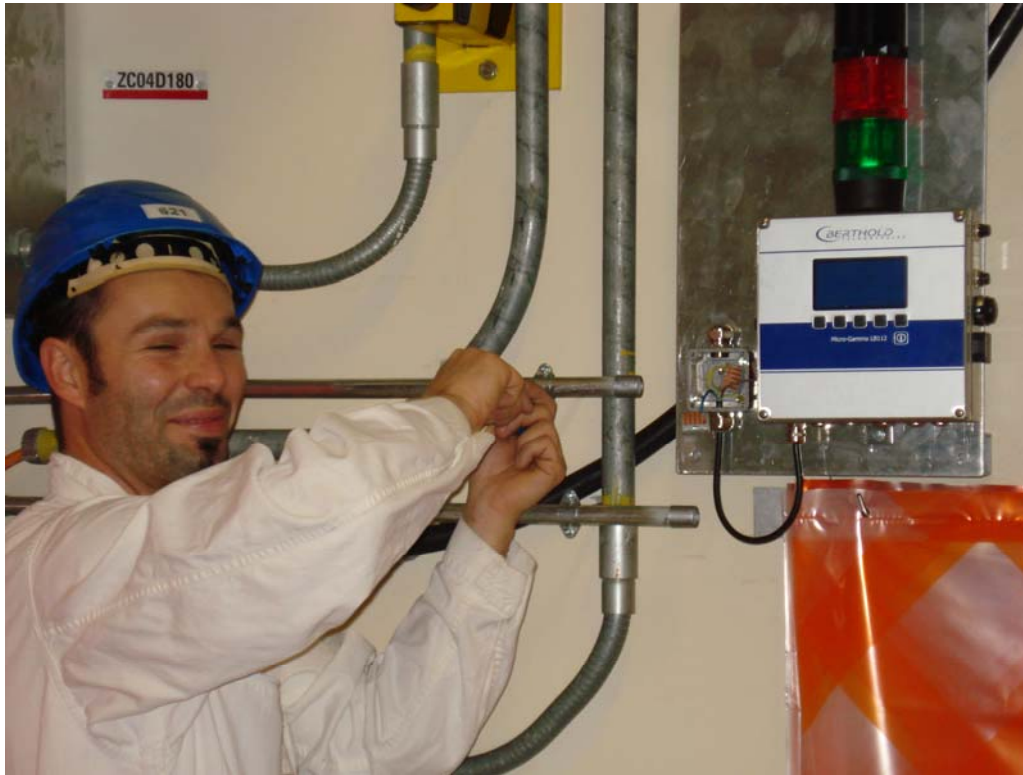
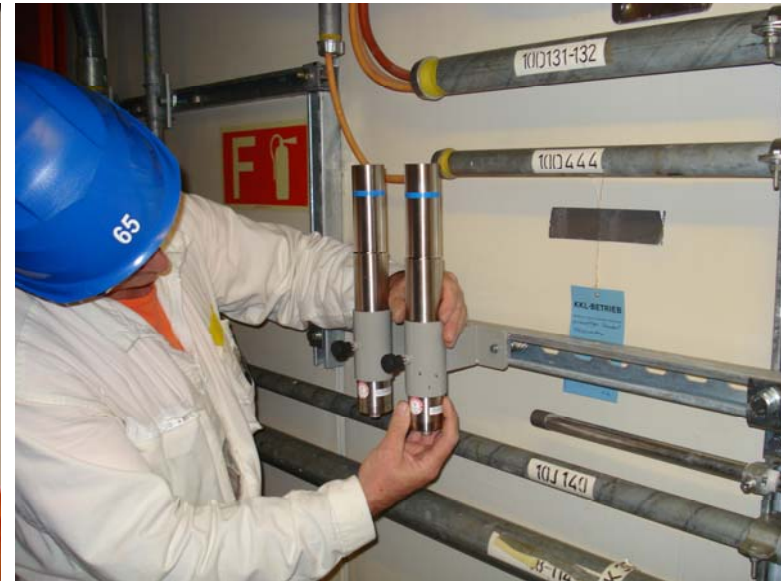
# Installation of additional Area Radiation Monitors

- Continuous survey of dose rate situation and warning
