Pickering ALARA Program Highlights

Leveraging Technology for Dose Reduction

Pickering 1-8 Dose Reduction Strategy Utilizing Robotics 1 Year later

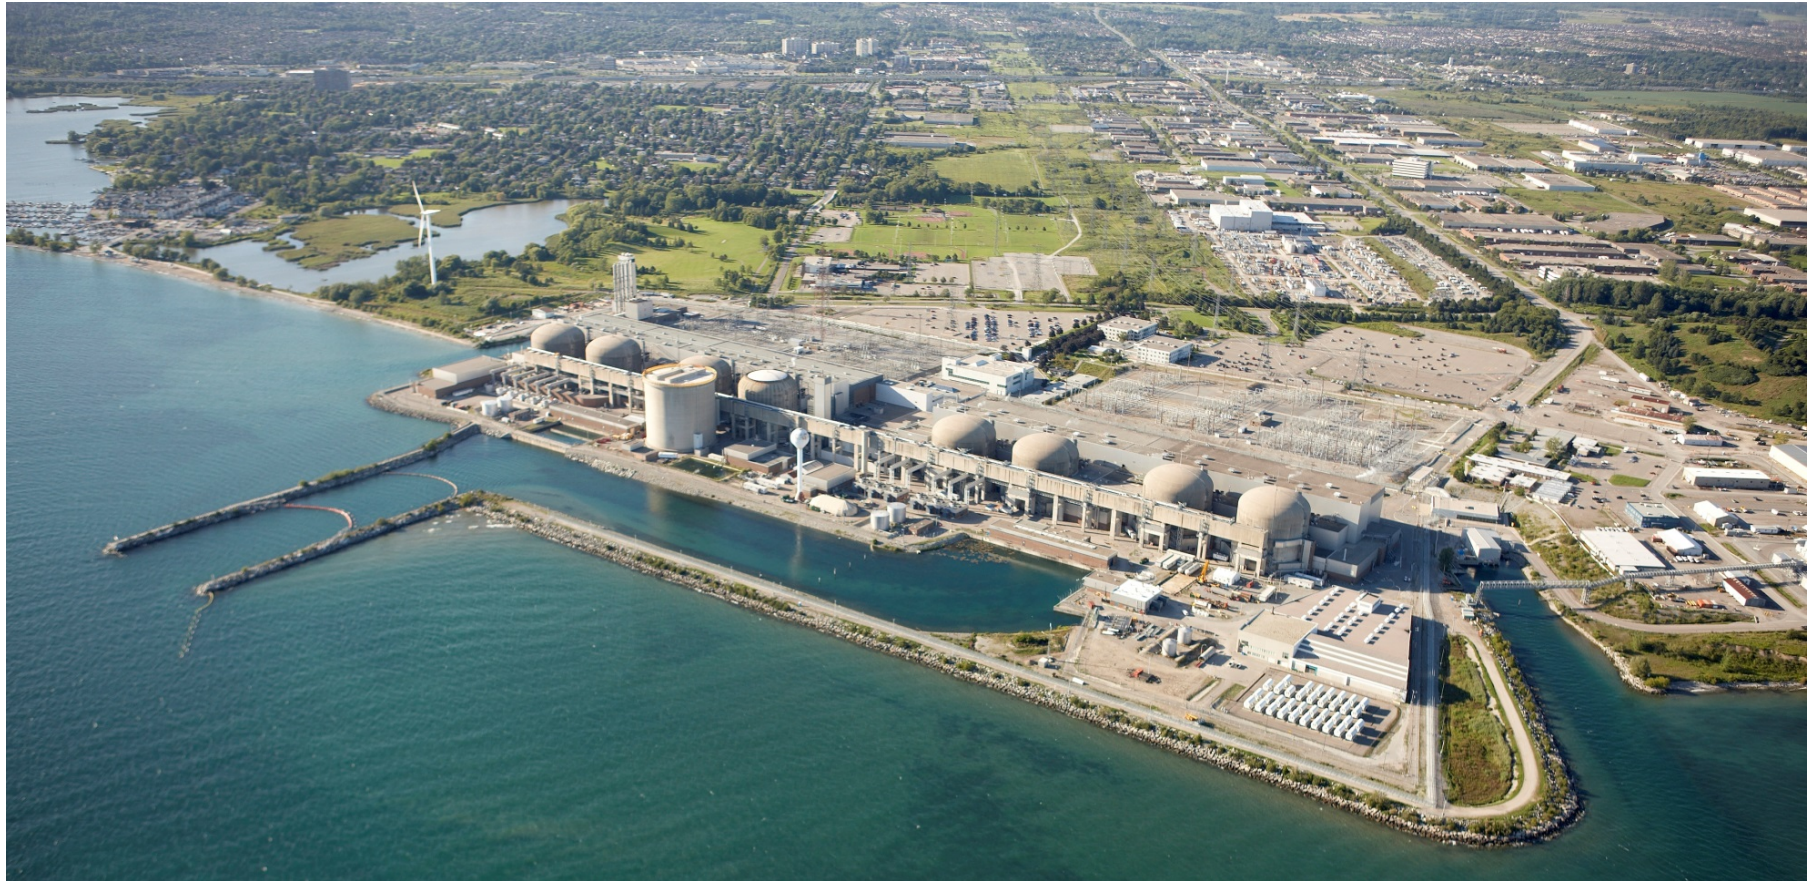
Pickering Nuclear

- Pickering Units 1 – 4
 - 540 MWe, 390 channels
 - In service 1971 – 1973
 - Units 2 and 3 in Safe Storage since 1998
- Pickering Units 5 – 8
 - 542 MWe, 380 channels
 - In service 1983 – 1986
- On power refuelling
- Self-protection & service protection RP model

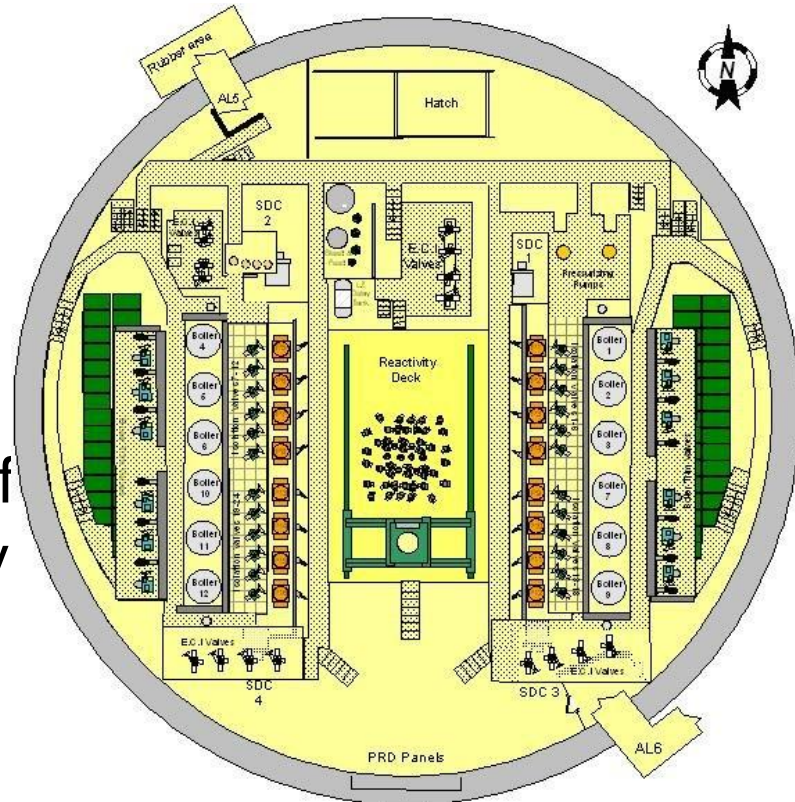
1-33120-NV112 Component USI

- Bleed Condenser check valve D2O leak contributing to elevated stack losses
- Leak location identified by PackBot
- Dose mapping strategy created for Maintenance staff to perform an on power entry to establish collection system.

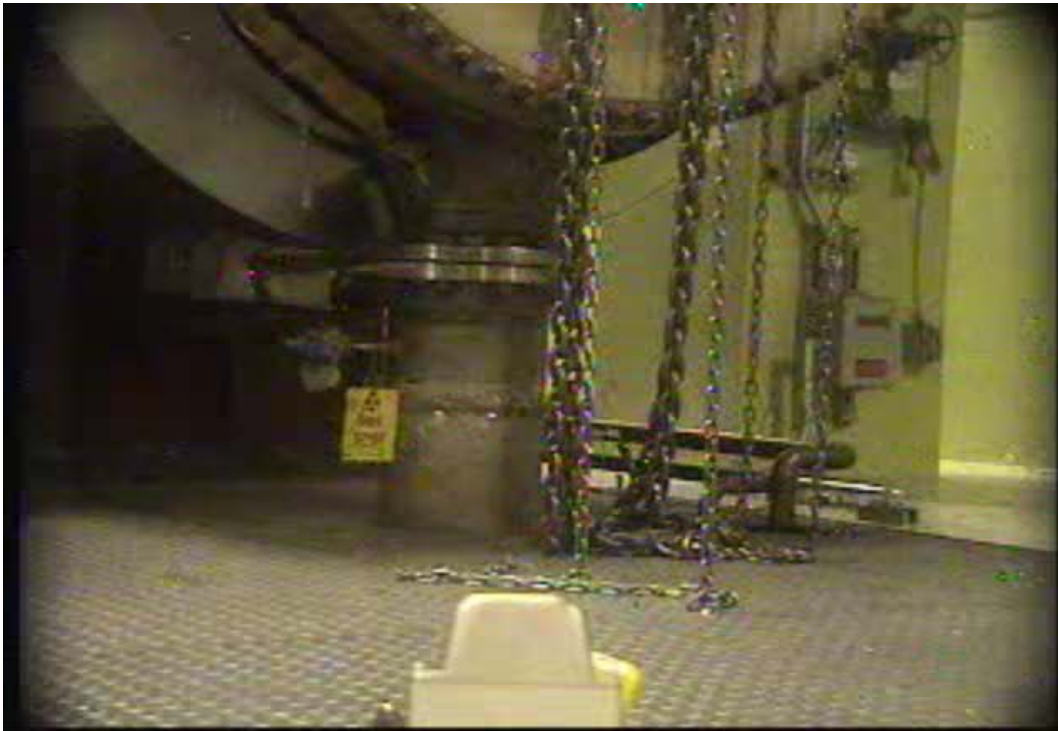
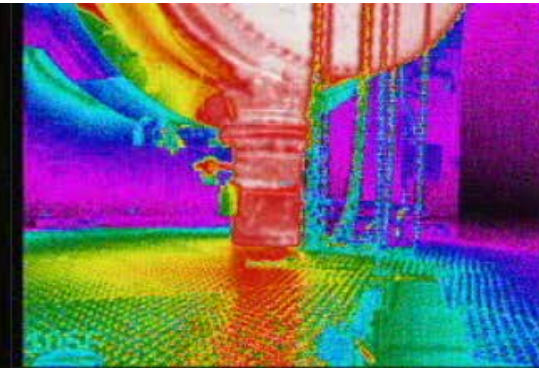
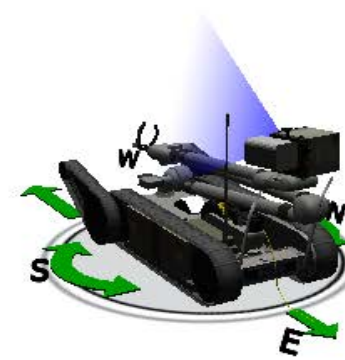
Unit 4 Moderator HX1

- Unit 4 moderator room access controlled entry at 100% full power
 - Completed via Moderator Purification room access door to Mod Room
 - First time the Moderator Room was accessed for inspection at 100% full power ever
 - Highest gamma and neutron environment PackBot has ever worked in wirelessly
 - Robot total Dose = 6347 mrem gamma
 - Robot peak dose during entry 21.4 rem/h
 - Ops dose = 2.1 mrem gamma

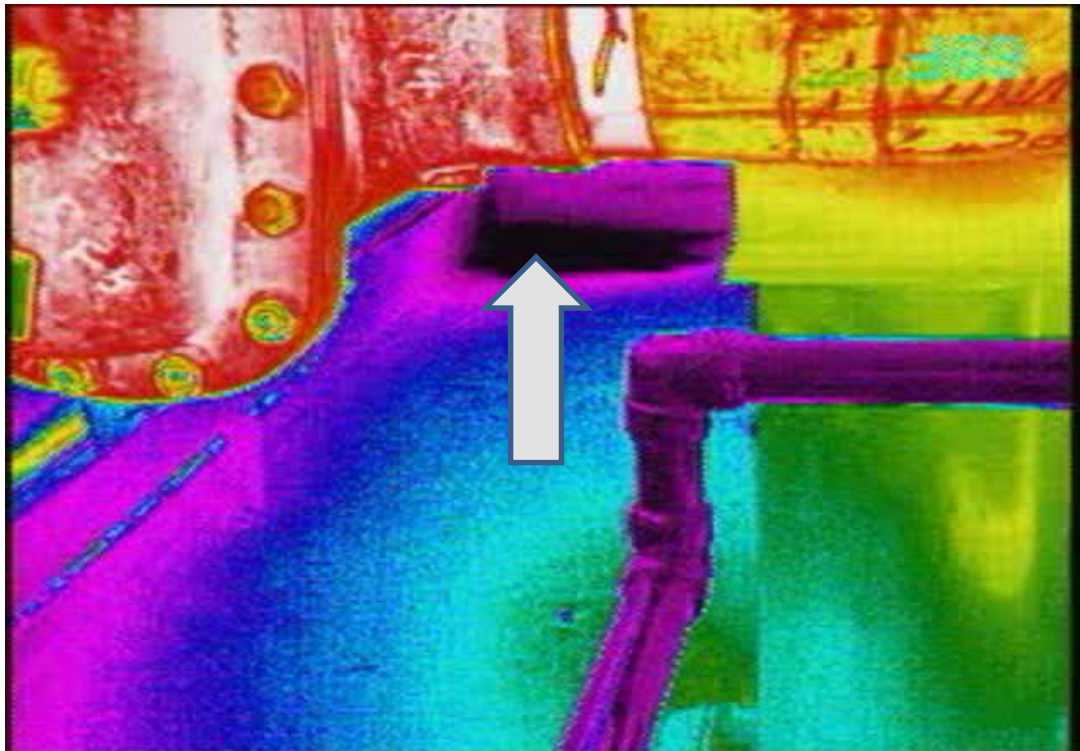
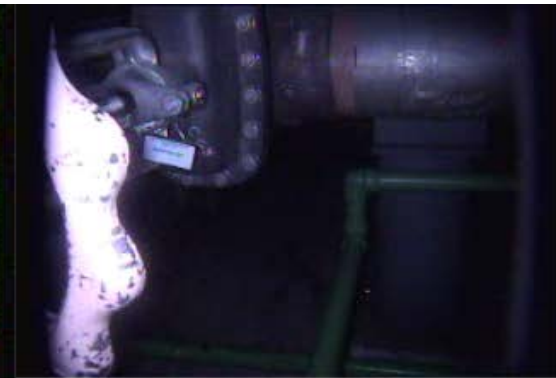
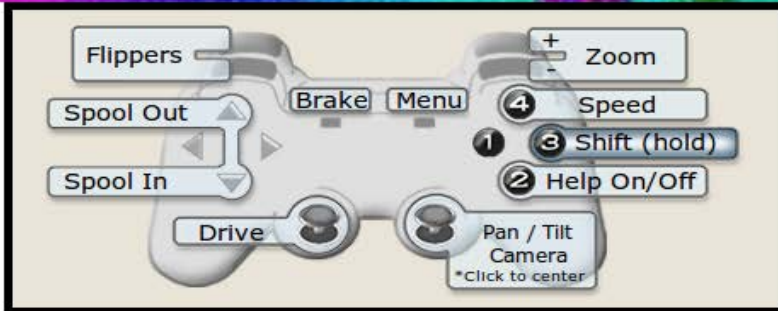
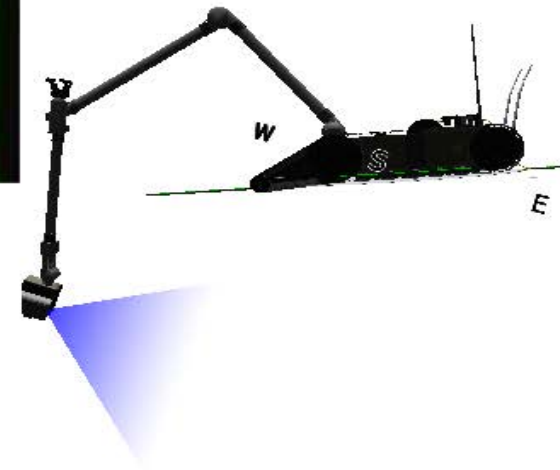
D2O located under platform (black)

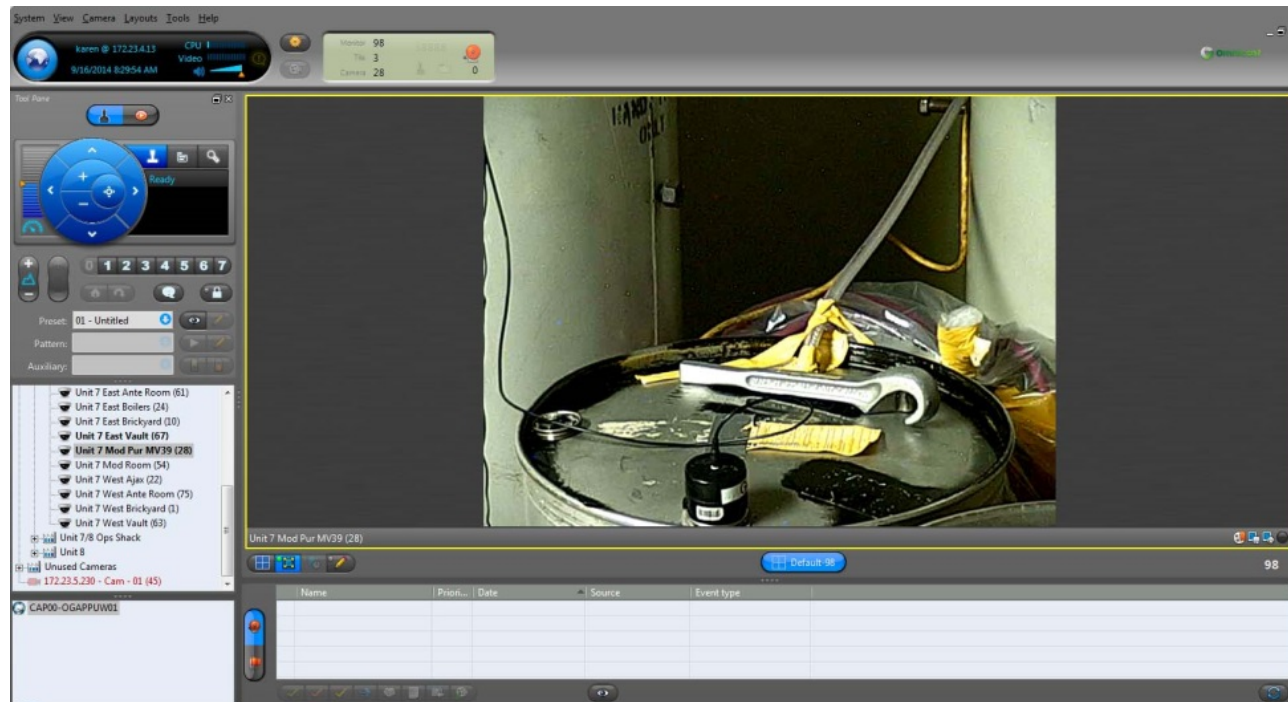
Teledose Enhancements

- Modified iCAMs to transmit data in real time
- ARMs on ET Vacuums to enable Civil Maintenance staff to manage their dose
- Developed remote level indication for D2O drums and remote power verification for ET Vacuums

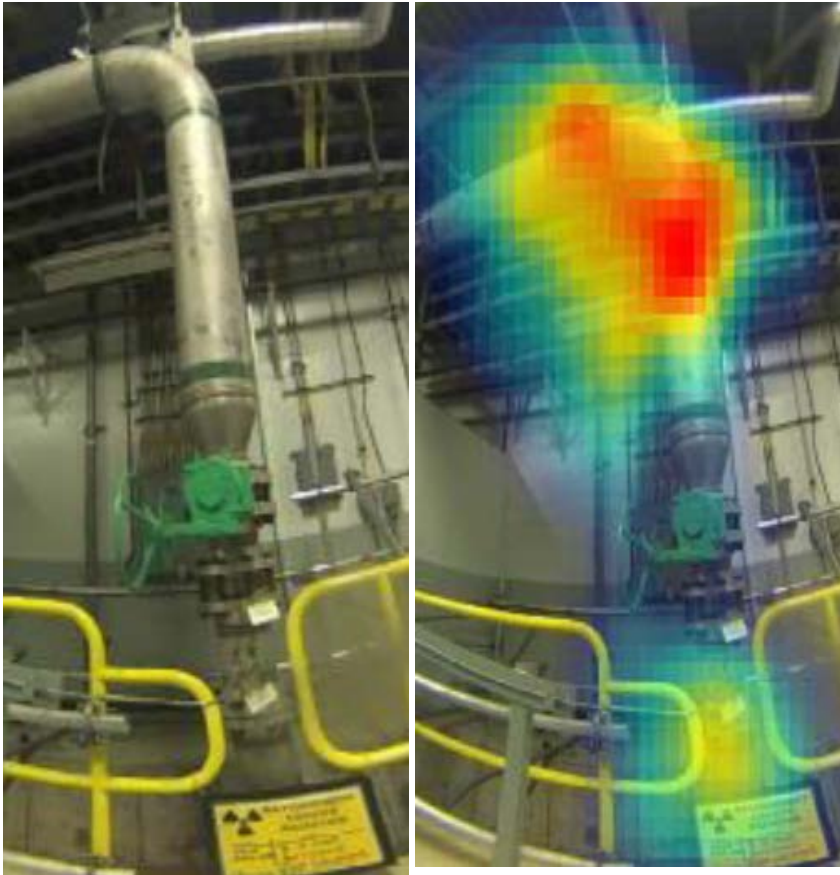
- WBM out of service
- Attempts to shield detectors unsuccessful
- Scan identified plugged IFB filter
- Filter changed, WBM returned to service just prior to a unit outage
