EDF Feedback on the management and the treatment of Ag-110m contamination

Moez BENFARAH
EDF, SEPTEN,
FRANCE

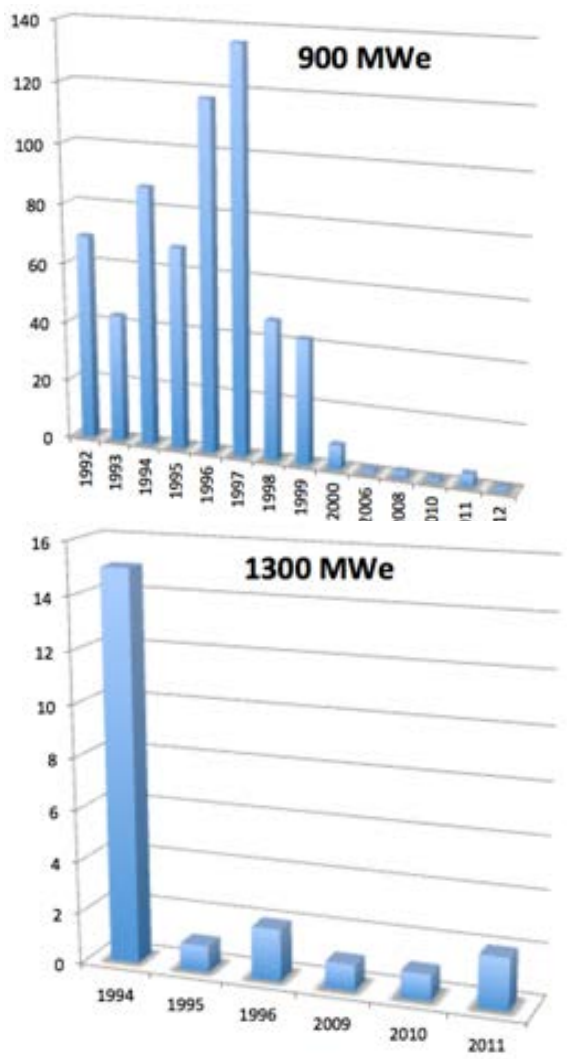
Number of AIC control rods with disseminating damage

- **900 MWe Fleet :**
  Control rods have been replaced progressively (1992-2006) by rods with anti-wear treatment (Cr plating or nitride treated).

- **1300 MWe Fleet :**
  - the cladding is twice thick compared to that of 900
  - larger gap between the absorber and the cladding
  - the rods contain two types of absorber : AIC, B4C
  - anti-wear treatment

Control rods of 4-loops fleet have been less effected by the wear than those of 3-loops fleet

Since 2006, all control rods at EDF units have had an anti-wear surface treatment.

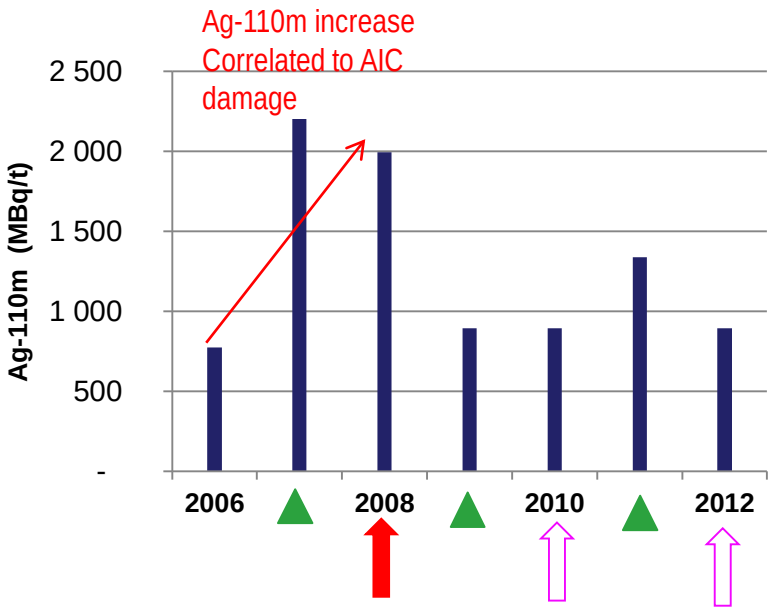
NPP : FESSENHEIM unit 2

How important has the contribution of the control rods been to the silver contamination since 2006 ? → Correlation between Ag-110m coolant activity at the shutdown and the inspection results of the control rods

No control rods inspection

Inspection : disseminating control rods

Inspection : no disseminating control rods

At EDF, since 2006, almost 25% of the cases of silver activity increase have been correlated to AIC control rod damages

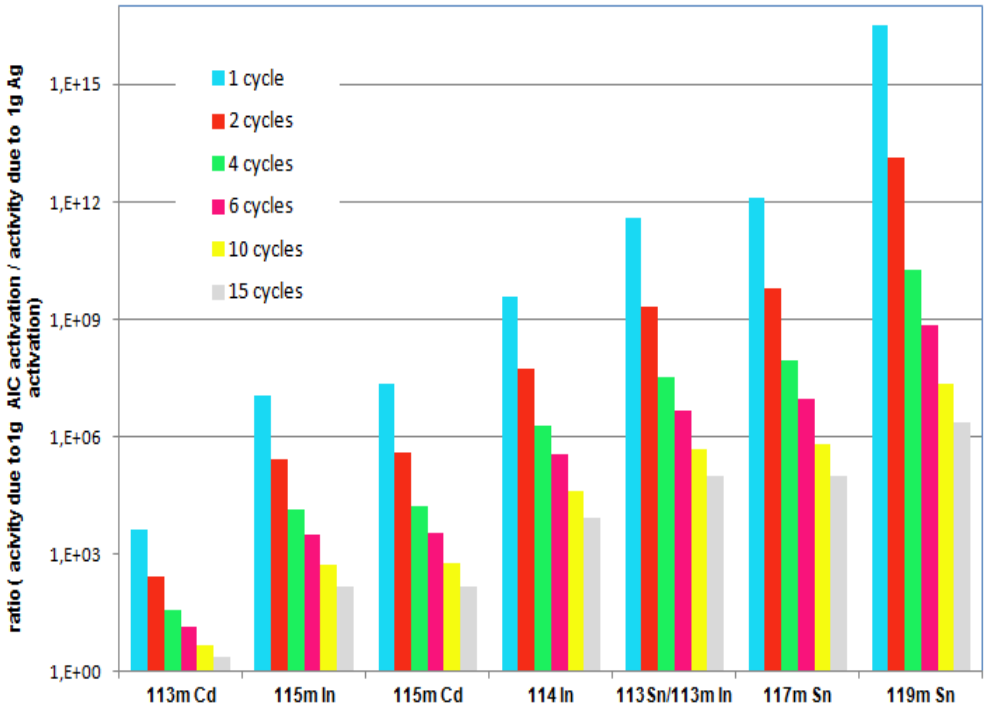
RATIO = (AIC activation) / (Ag activation

- few units for ^{113m}Cd
- few hundred for ^{115m}In ; ^{115m}Cd
- few thousands for ^{114}In
- **10^5 for $^{113}Sn/^{113m}In$; ^{117m}Sn**
- **10^6 for ^{119m}Sn.**

The higher the ratio is, the more selective the indicator is. consequently, a relevant tracer of an AIC control rod leaking can be selected among the following isotopes: ^{119m}Sn, ^{117m}Sn and ^{113}Sn /^{113m}In.

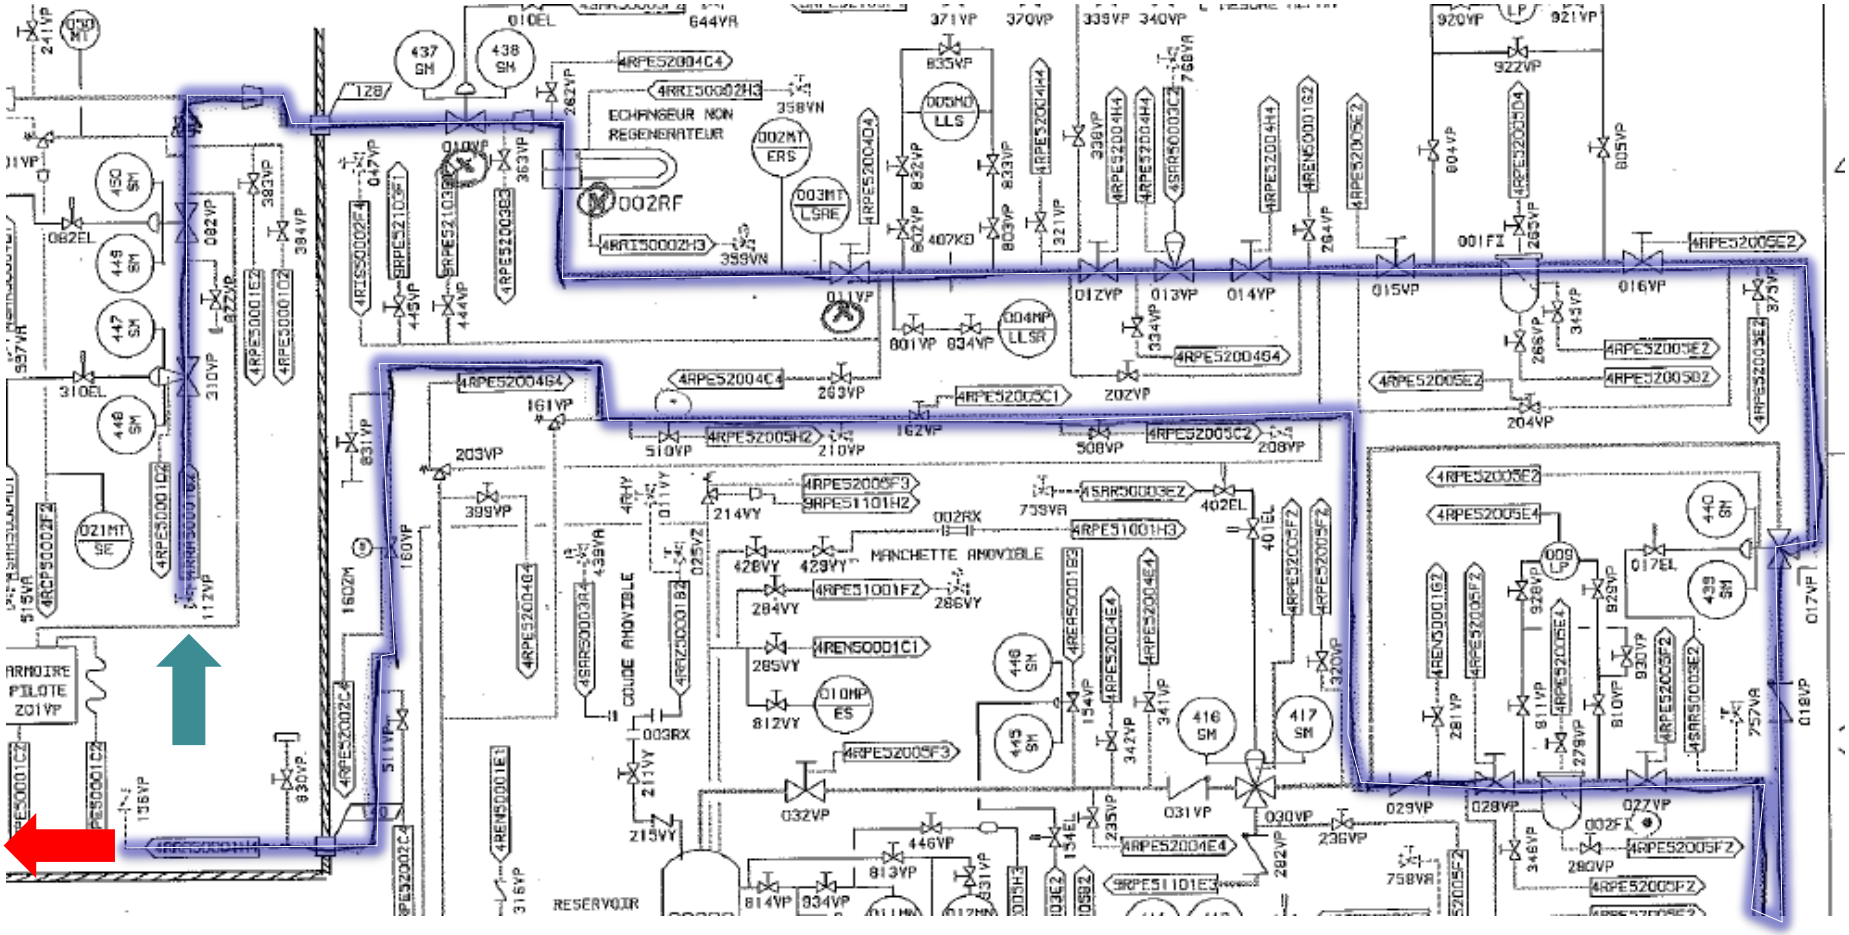
Part of the CVCS circuit decontaminated at BUG4-28 (includes heat exchanger and valves)

- During the shutdown 28 of Bugey 4, there was a significant increase of the dose rates on the discharge line and on the rooms containing CVCS components.

- These elevated dose rates prevent the realization of several important maintenance activities (exp : hydraulic test of the CVCS heat exchangers)

- The CZT measurements have confirmed Ag-110m contamination

- Decision to proceed with a chemical decontamination of the CVCS using EMMAg process

Material	DR before (mSv/h)	DR after (mSv/h)	Ratio (before/after)
Heat exchanger	51	6	8.5
Valve A	49	5	9.8
Valve B	20	3.6	5.5
Valve C	40	10	4

Average ratio = 7
