Radiological Investigation with the Polaris-H CZT Imaging Gamma Spectroscopy System at D. C. Cook

2015 ISOE NATC Alara Symposium

1. Hydrolase Event
2. Elevated Dose Rates in HTC
3. U1 W CTS Hx Elevated Dose Rates
4. Waste Gas System Elevated Dose Rates

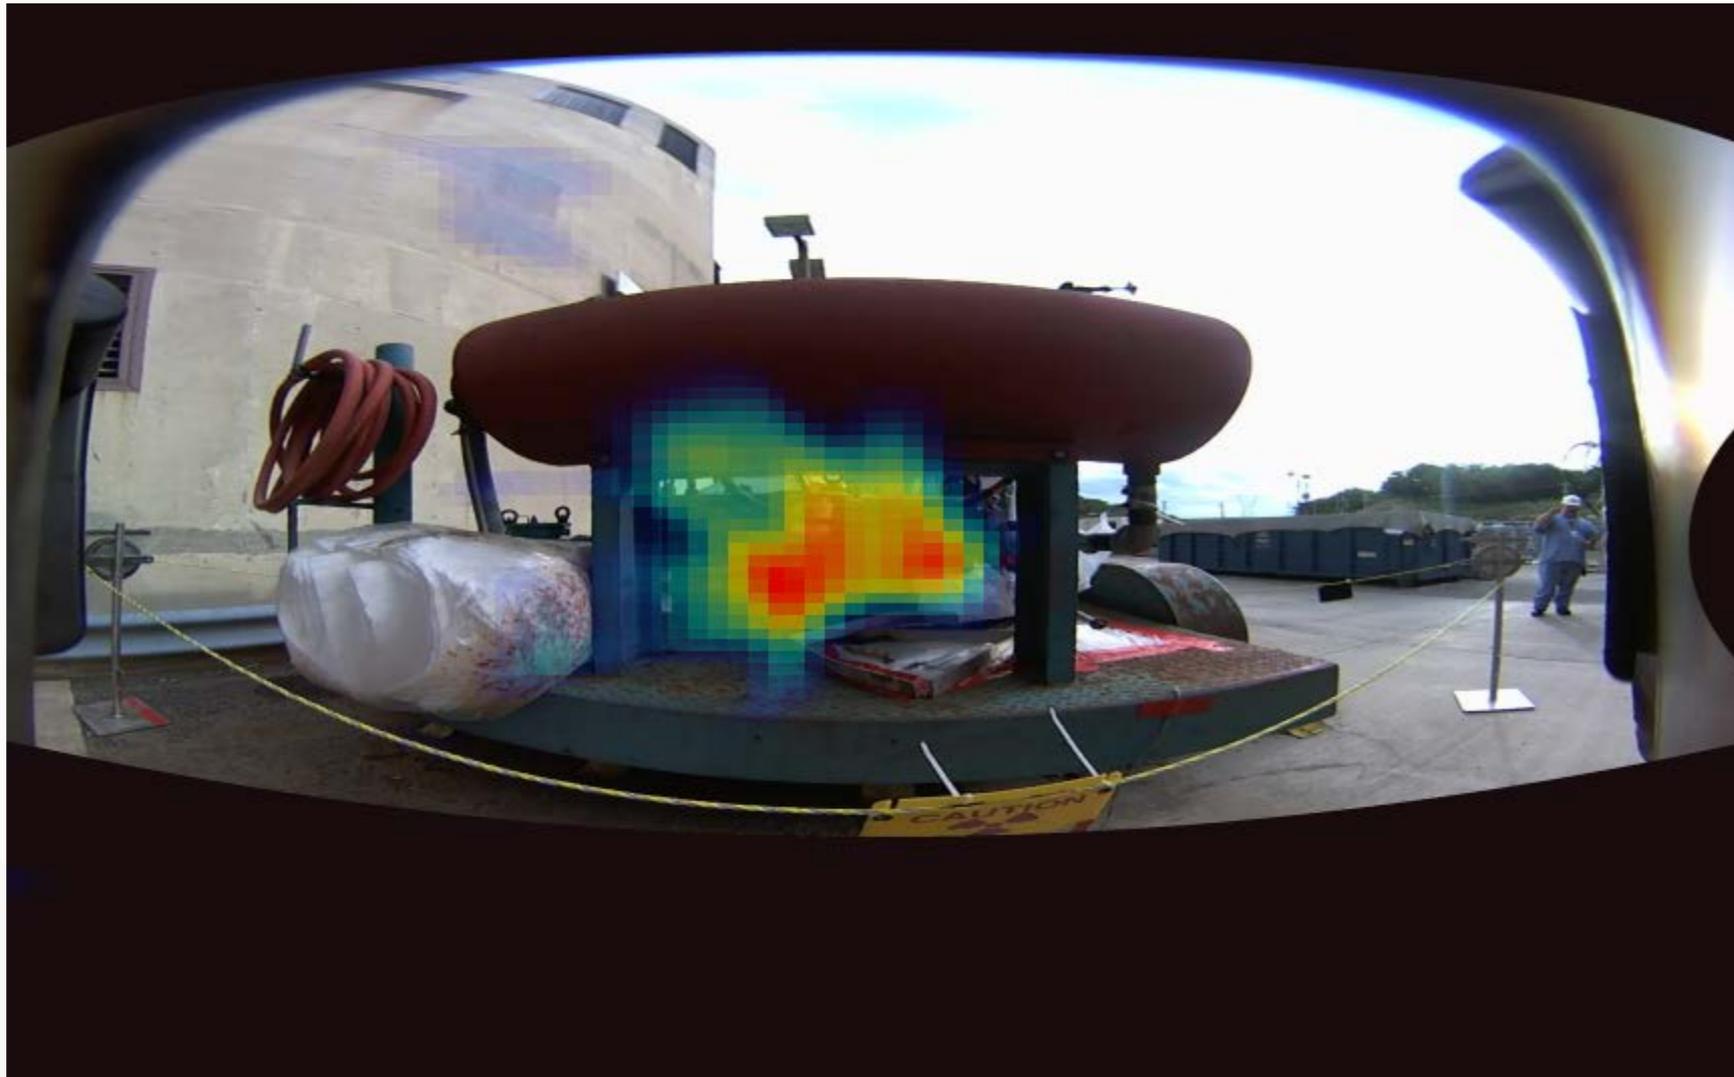
Hydrolase Internal Contamination Event

- Cause of internal contamination is the hose in the station drain line syphoned back into hydro pump.
- Check valve failed
- Hoses are usually drained on completion. Due to time constraints this did not happen.

- New hydro pump was procured
- Now pump into 55 gallon drums then to station drains
- Procurement of in-line check valve to prevent backflow
- Plant DI water was sampled at the source to the hydrolaser and found to contain no contamination
- No activity from this event entered the plant DI system

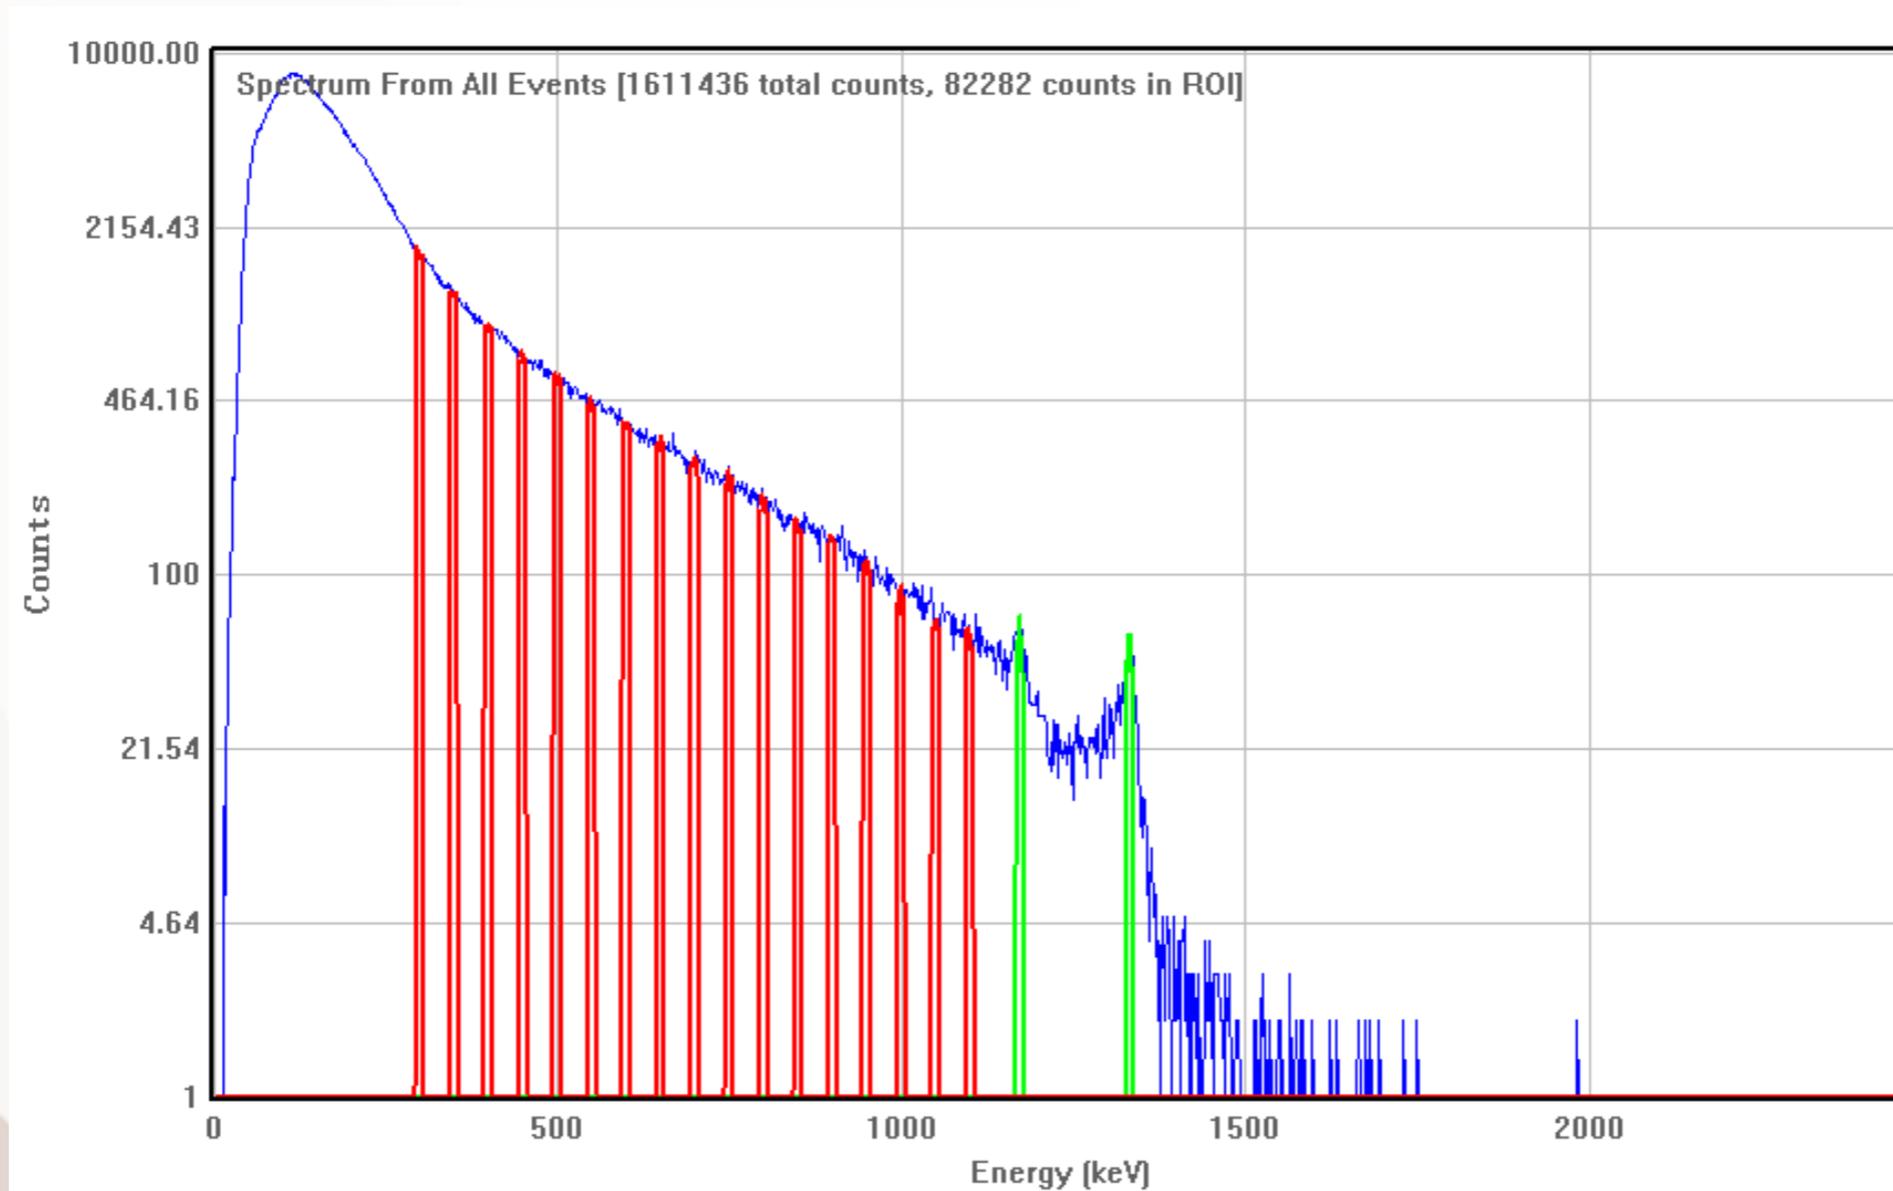
Elevated Dose Rates in Hot Tool Crib

- On 9/10/14, a tool crib worker received an unexpected dose accumulation of 0.1 mRem while in the Hot Tool Crib (HTC).
- Dose was streaming through the floor covers from a drained demin vessel.

- HTC Workers Instructed to avoid whole area near floor cover
- Increased Importance to Refill Demin prior to refueling outage
- Filled Demin decreased Dose Rates

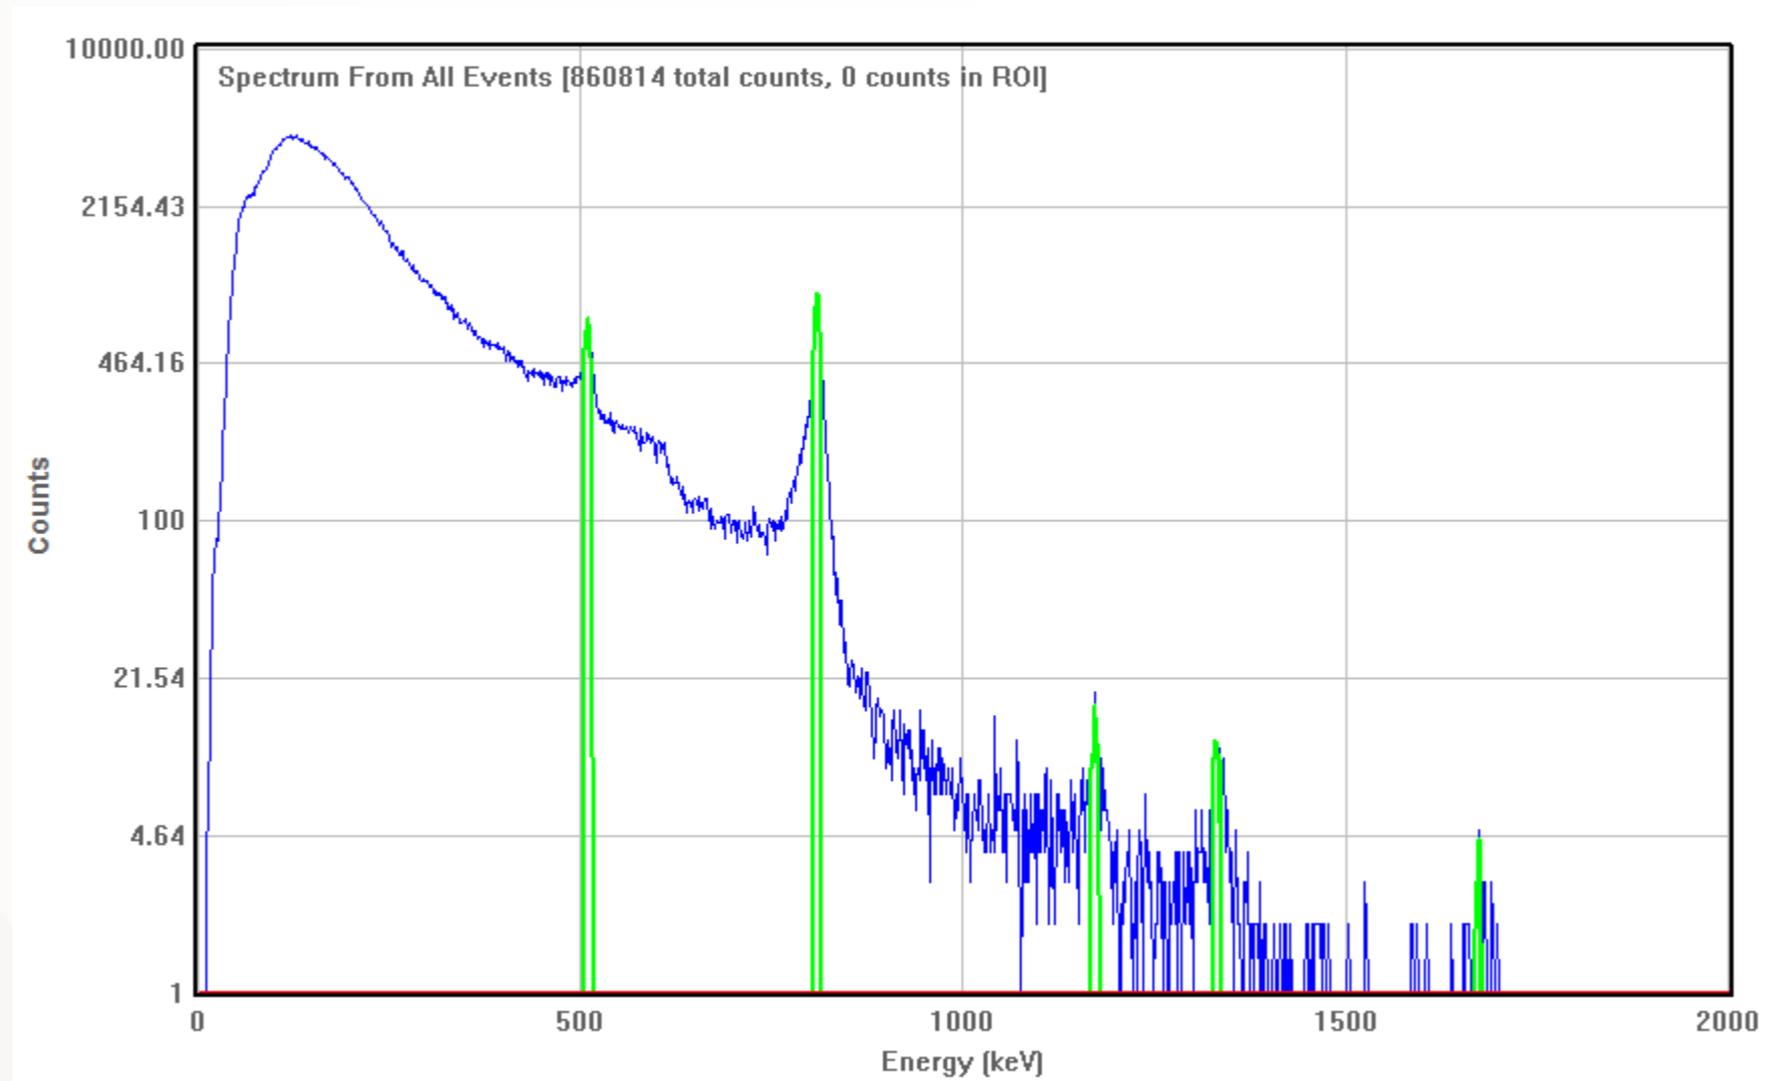
Elevated Dose Rates in CTS Hx Room

- Co-58 was primary contributor to increased dose rates.
- Dose Rates coming from line used for leak test
- Recommendation was made to decay system instead of flush system.

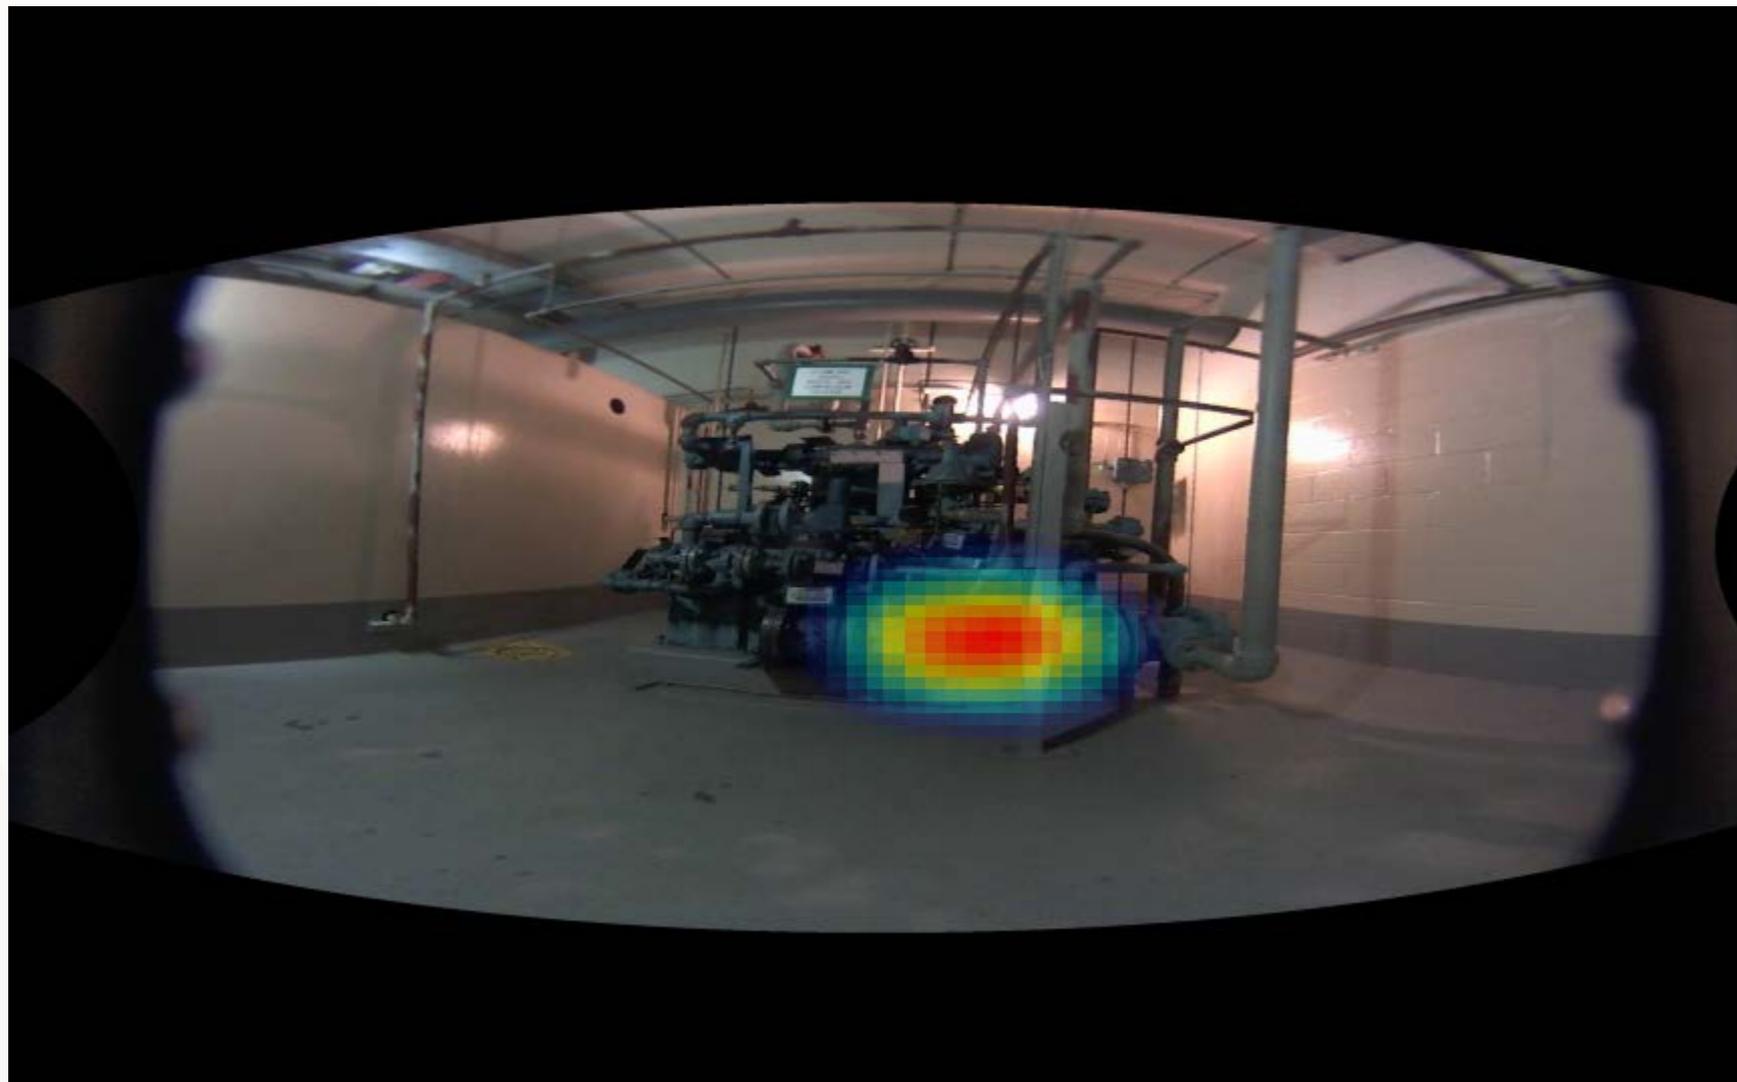
Elevated Dose Rates in Waste Gas System – S. Waste Gas Compressor

- Un-posted Radiation Area found on 609' in S. Waste Gas Compressor Room during routine surveys
- The small heat exchanger on gas compressor found reading 30 mR/hr on contact and 8 mR/hr at 30 cm.

- When the spent resin storage tank was filled water solid due to clogged resin, the vent path allowed water to enter the plant vent header.
- This water cleared out particles entrained in the piping and flowed down to the drain tank.
- The gas / vapor with the radioactive particles was drawn into the south compressor suction.
