ALARA in Practice

Reactor internal parts repair at the Temelín NPP

- Temelín NPP, Unit 2 refuelling outage 2011
- damage of the reactor inner parts:
 - block of protective tubes – bottom plate surface
 - core barrel – inner and outer surface
 - reactor vessel dividing ring – inner surface
- cause: mutual seizing with foreign objects (stainless steel pin, nut)
- damage: scratches, grooves, pressure marks

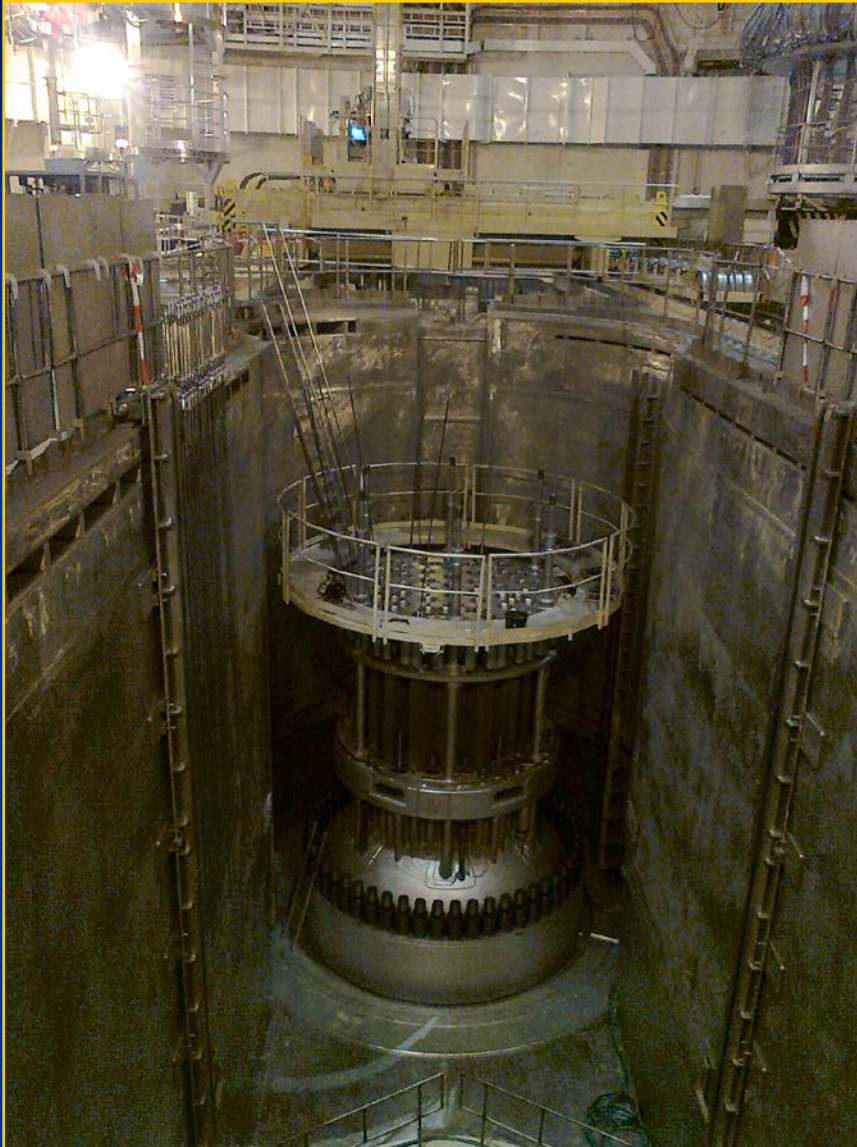
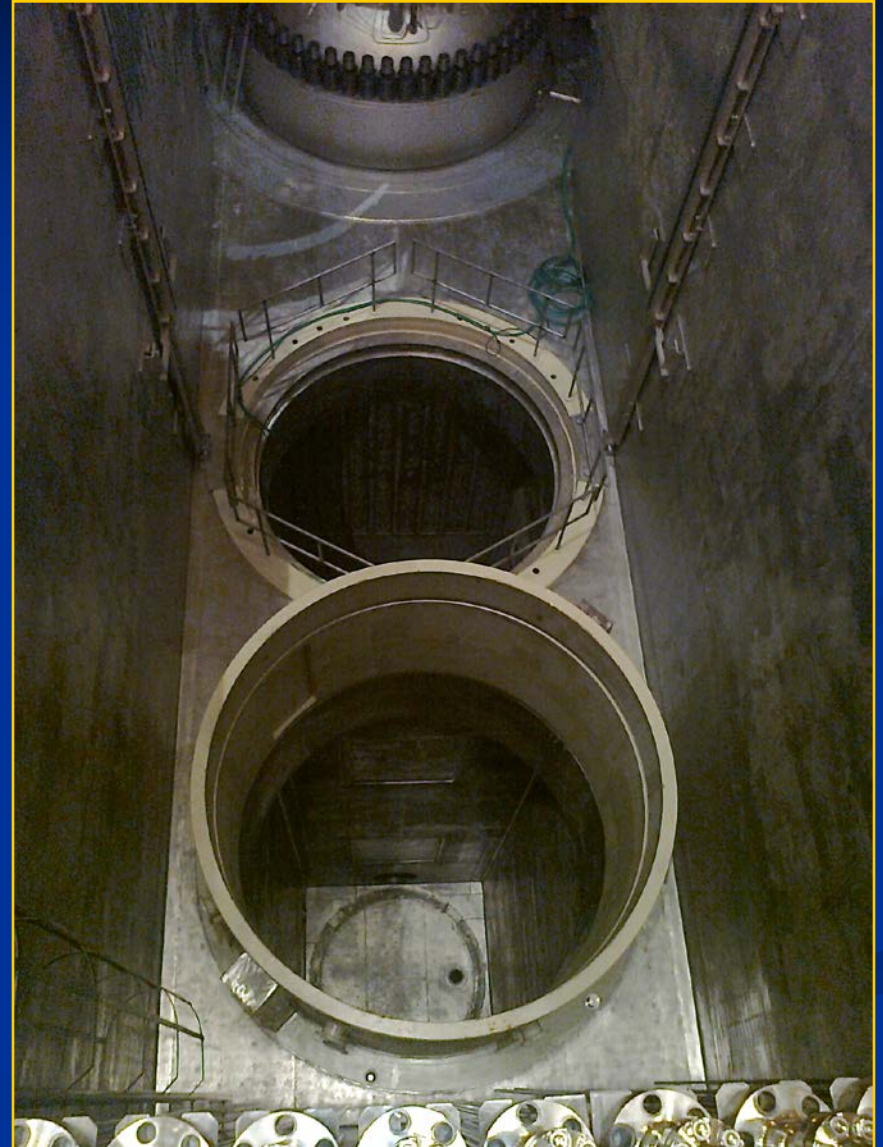
Transport cavity, inspection wells

- foreign objects removed
- block of protective tubes in inspection well
- fuel removed
- core barrel in inspection well
- reactor and both inspection wells filled with water
- surface damage – well known position, remote identification, imprints of scratches
- unknown radiation situation
