Ringhals - Operational Experience on Silver and Antimony related to doses

ISOE International Symposium Brussels
1-3 June 2016
Madelene Johansson, Ringhals NPP

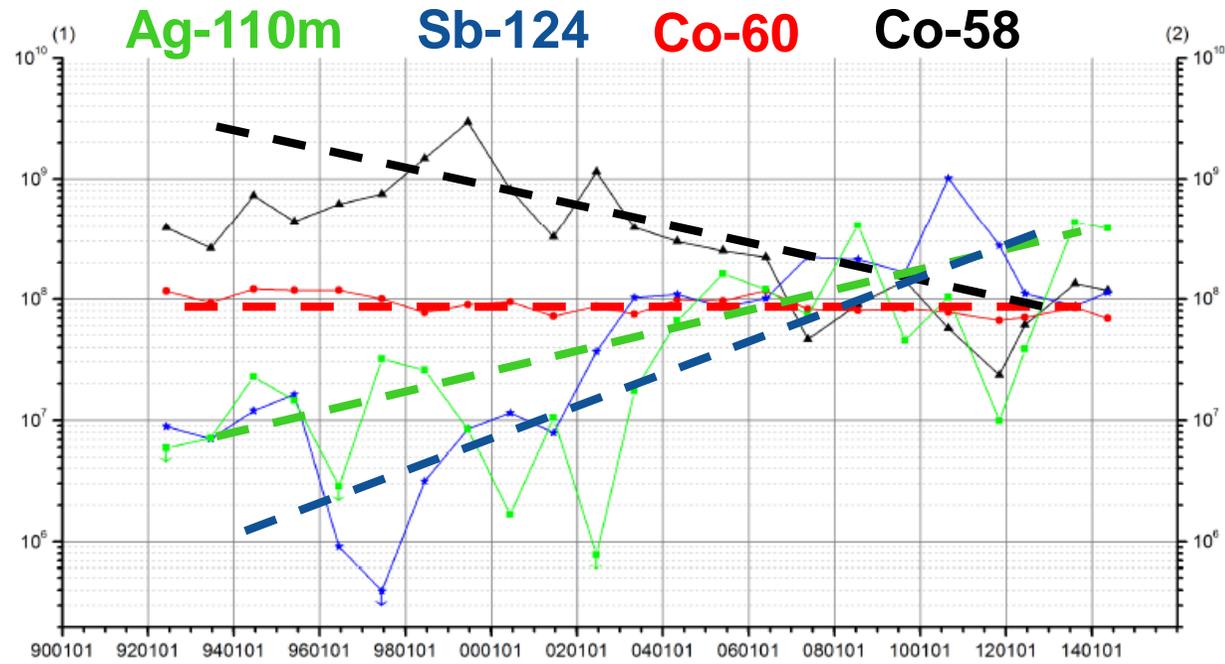
Gamma spec trend from SRMP point CVCS let down (Unit 3)

Co-60 is **NOT** the only concern...

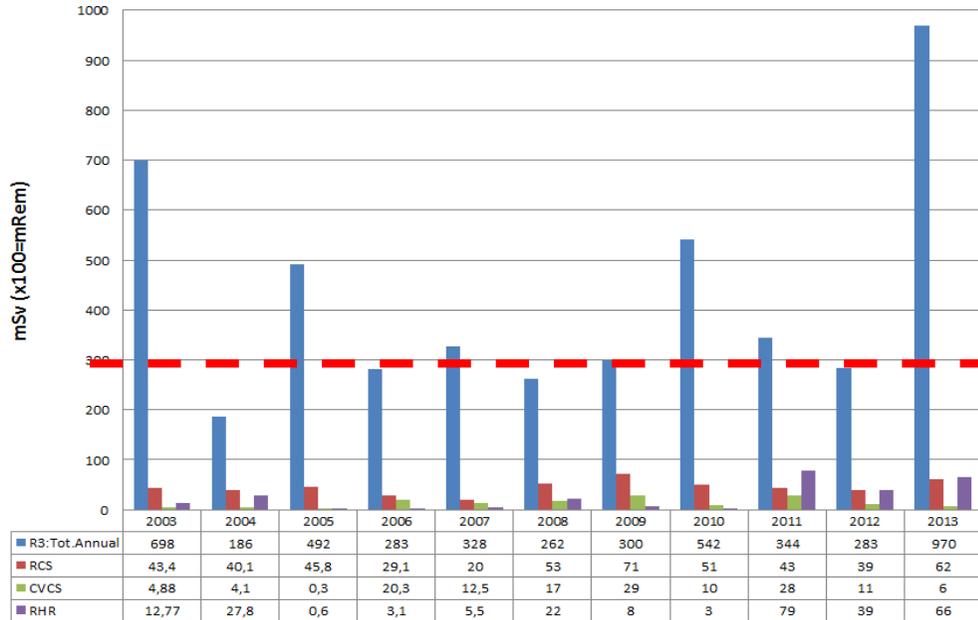
Collective Radiation Exposures – Ringhals Unit 3

From CRE best quartile to worst quartile....

ICES Report 310988, Increased Dose Rates due to High Amounts of Silver (Ag-110), Sept. 25

Unit 2 experienced Sb-124 transport and deposit on the RHR system. 60% Sb-124 contribution to dosrates. Radiation fields increased by a factor 2-3. Estimated additional outage dose 250 mmanSv.

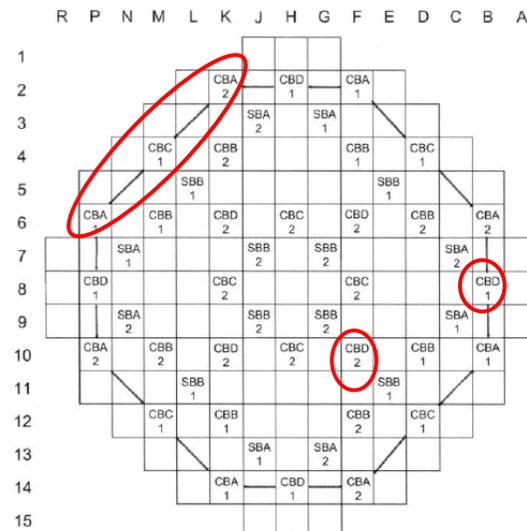
Even rods with tiny cracks (hairline crack) can cause leakage of the absorber materials into the reactor water. These cracks occurs by radiation-induced stress corrosion cracking (IASCC). This type the damage does not affect the control rod function but must be replaced due to ALARA and radiation safety concerns.

Experience from inspected control rods with cracks indicates that number of cycles in the core should be reduced (17 for R3 and R4, 15 for R2) and that the following limits on the permitted neutron fluence shall apply: $42 \leq \emptyset \leq 54$

Optimized positioning for control rod time in the core:

- 2 to 3 cycles in CBD-position
- 8 to 9 cycles in inner core region
- 3 to 4 cycles in outer region non CBD pos.

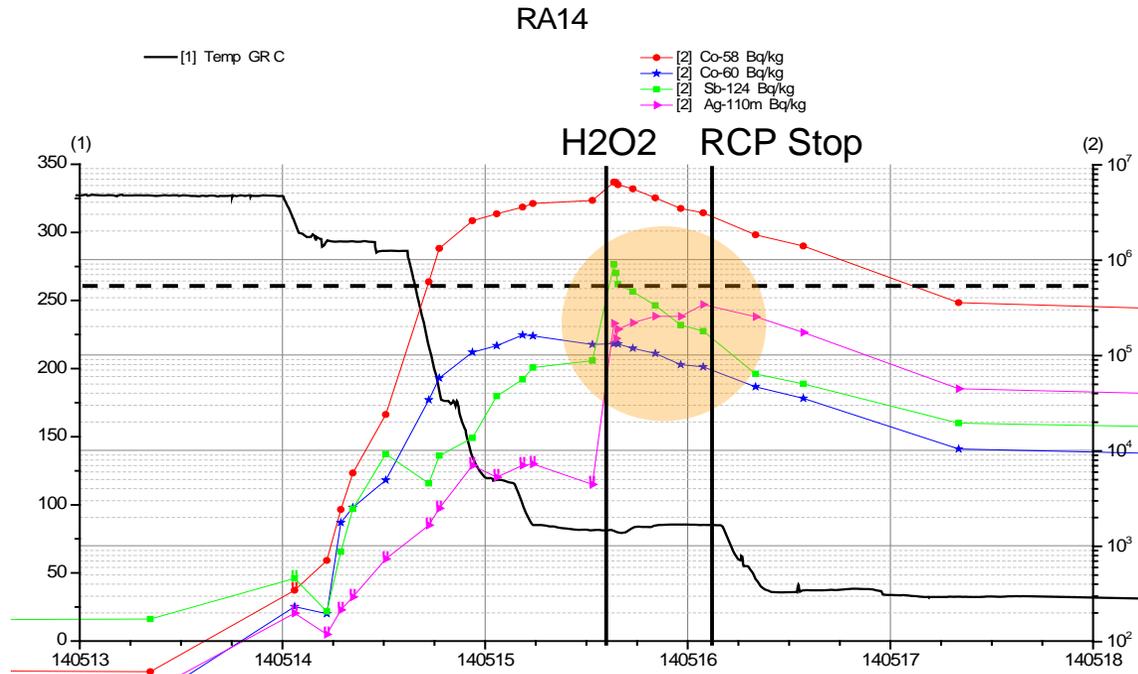
Shut Down Release Unit 3

Different behaviour for Ag-110m observed

Only one criteria for shut down release clean up:

- lifting reactor vessel head 5E5Bq/kg (Co-58)
- No criteria for Ag
- No criteria for Sb

**Extended RCP run time
from 12 hours to 18 hours**

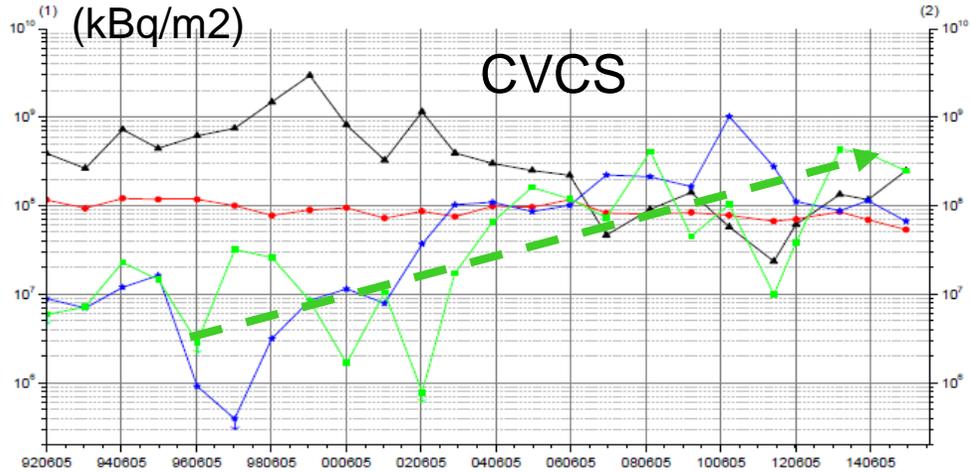
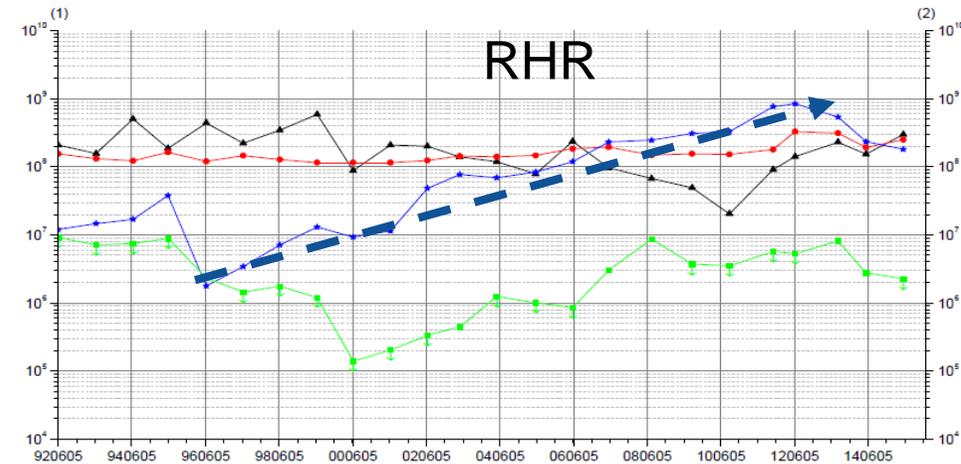
Trending data Ringhals 3

Co-60 **Sb-124** **Co-58** **Ag-110m**

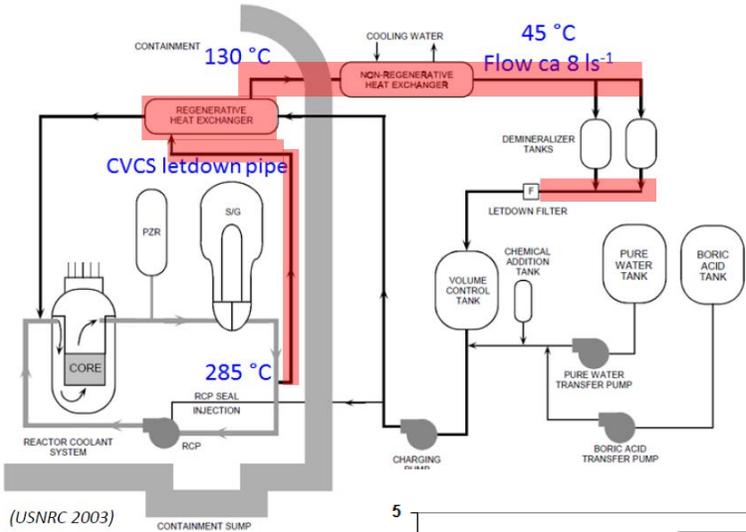
Silver and Antimony deposition Impact on radiation fields

Deposition of Ag-110m occurs mainly in CVCS where it locally can cause very high radiation fields.

Deposition of Sb-124 occurs mainly in RHR and CVCS
