2013 INTERNATIONAL ISOE ALARA SYMPOSIUM

Lessons Learned from the Fukushima Daiichi NPP's Accidents for Achievement of the First Class Safety in the world

Dr. Tadashi NARABAYASHI Nuclear and Environmental Systems Hokkaido University

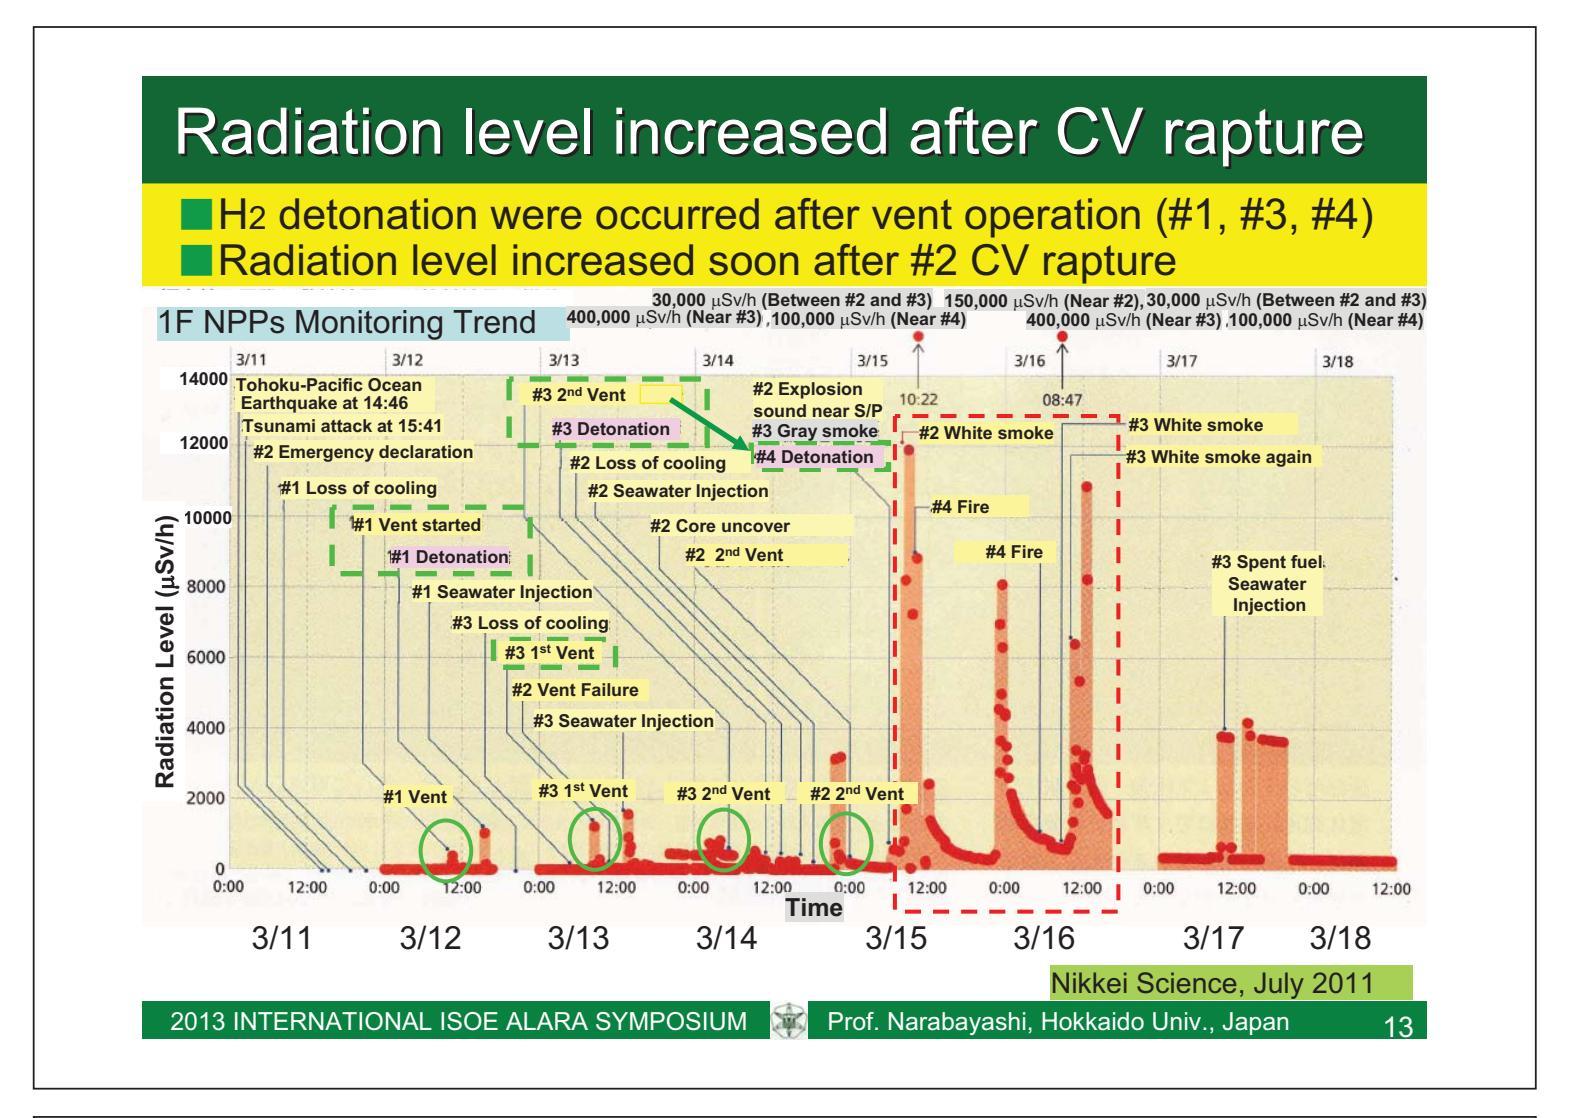
Failure of prompt water injection in #2

- Failure of prompt water injection after RCIC stopped in unit #2 caused the core damage and H2 generation started.
 High-pressure discharge pump driven by diesel engine should
 - be used.
