Cook 1&2 US Lowest 4 Loop PWR Refueling Outage Dose: ALARA Achievements & Lessons Learned David W. Miller, PhD Cook Nuclear Plant 2010 ISOE International ALARA Symposium Cambridge, UK

Cook Improvements in Outage Dose, CRE Performance & Five Year ALARA Plan to Meet INPO 2015 PWR Goal

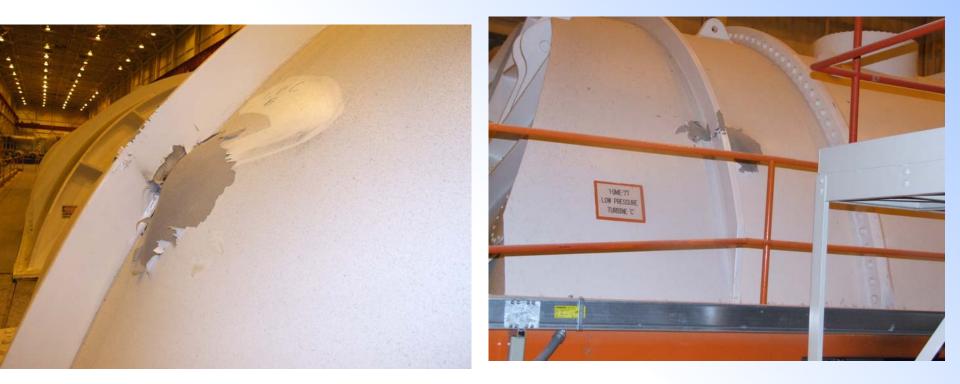
- LP turbine exhaust hoods
 - LP turbine exhaust hoods display evidence of blade impact
 - All blades were contained within turbine hoods
 - Bearing housings were displaced
 AMERICAN®

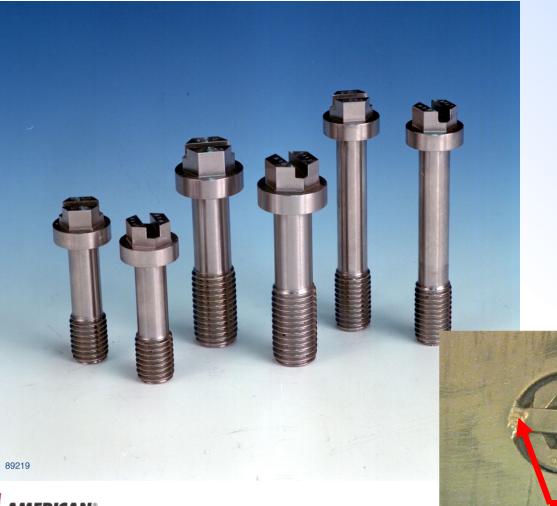
What is a baffle bolt?

Baffle bolts hold the vertical baffle plates to the horizontal former plates.

Cook's baffle bolts are 5/8 inch in diameter and about 2 inches long.

Once bolted in place, a lock bar is welded across the bolt head to secure the bolt.

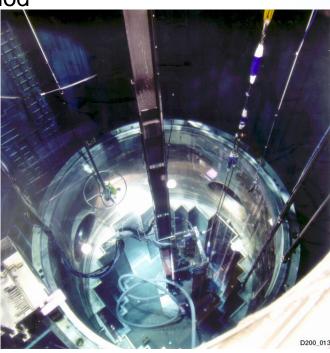
Highly specialized repair equipment

• *(right)* diagram of repair tool and picture of tool in place

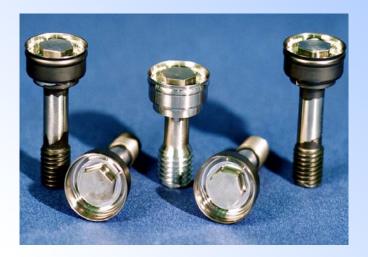
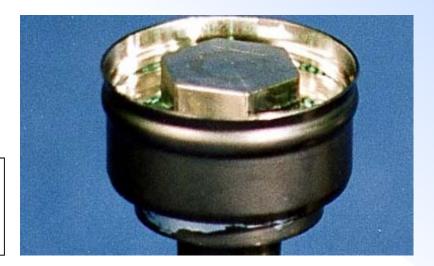
Replacement bolts don't require welded lock bar
