ISOE ASIAN ALARA Symposium 2014
on Occupational Exposure Management at Nuclear
Facilities
Gyeongju, South Korea, September 23-25, 2014

Radiation Protection Management in Fukushima Daiichi NPS and Post-accident Measures

*Tokyo Electric Power Company,
Radiation Protection and Management Group
Shiro TAKAHIRA*

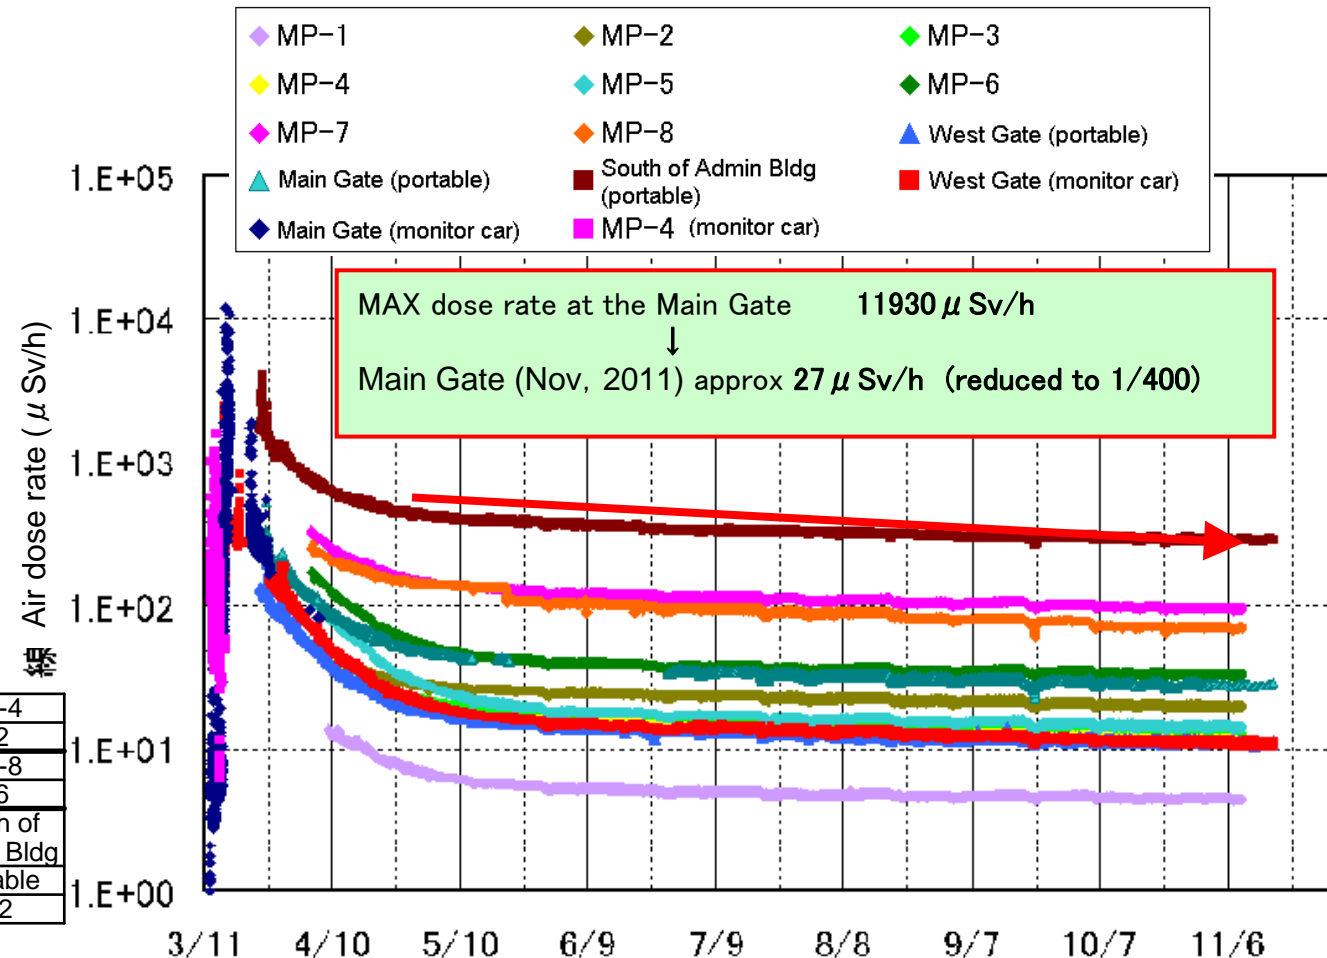
Measurement date: May 6, 2014

Dose rate monitoring at Monitoring Post

- The air dose rates at each point were dramatically increased by the accident. After that, indicated steady downward trend and at this moment, at the background level at each point.

MP-1	MP-2	MP-3	MP-4
2.4	4.1	4.6	4.2
MP-5	MP-6	MP-7	MP-8
4.4	1.6	2.3	2.6
West gate		Main gate	South of Admin Bldg
monitor car	Portable	Portable	Portable
2.6	12	4	122

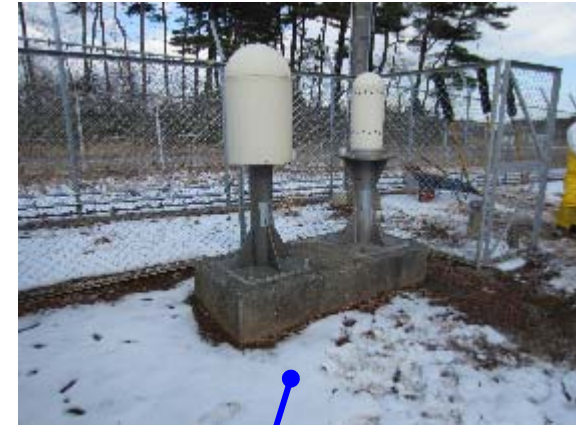
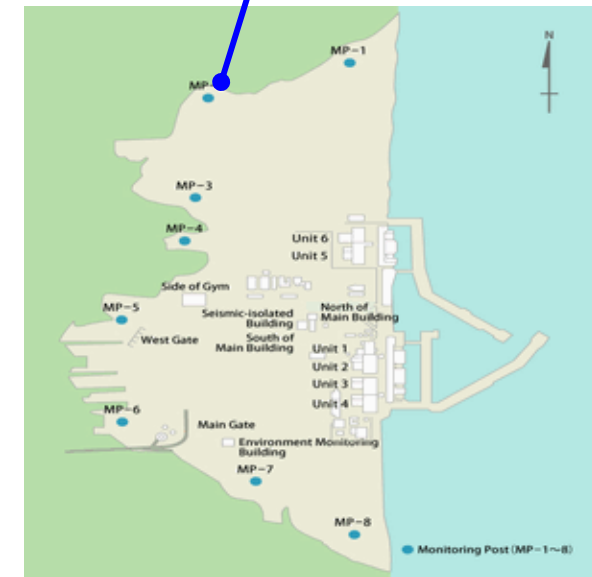
Monitoring post No.2

- There are 8 monitoring posts around 1F site.
- We were monitoring air dose rate continuously.
- We also transmitting monitoring data to the self-governing body and disclosed it on our homepage continuously.

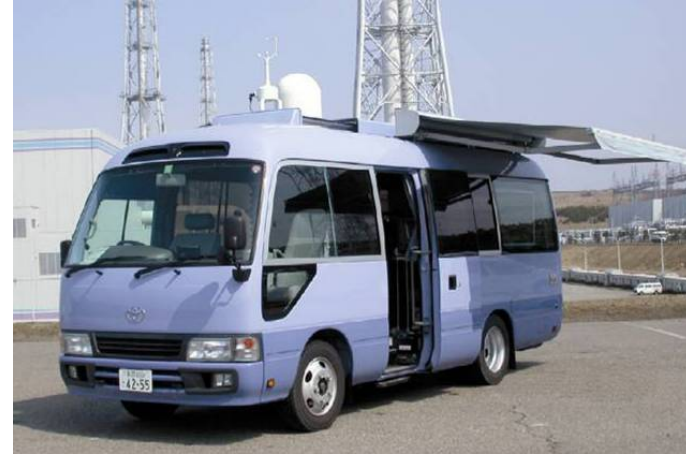
Monitoring car (KK)

- Because of power loss, all monitoring posts became inoperable.(~Apr.8 2011)
- We measured air dose rate by two monitoring cars and three portable monitoring posts.

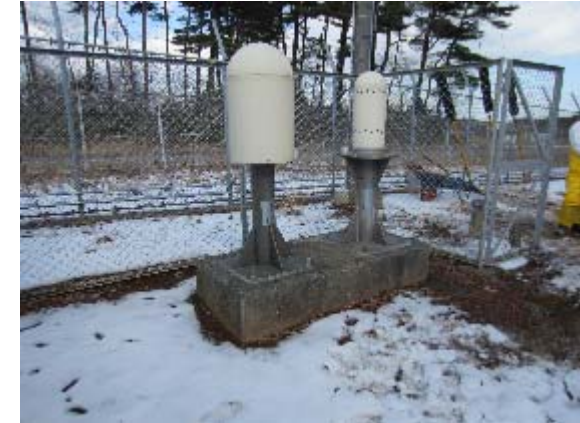
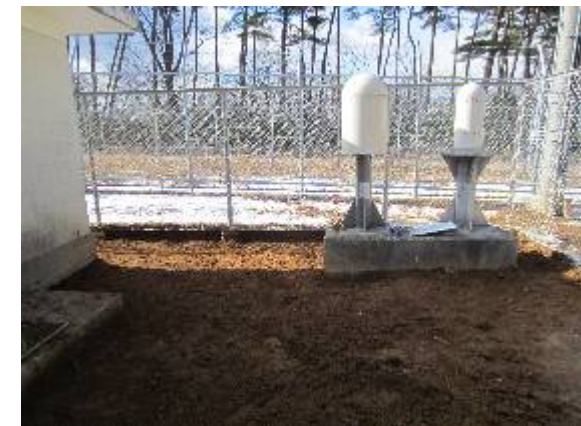
Monitoring post No.2

- Because of fallout, dose rate of monitoring post kept high level.
- We reduced the influence of fallout by surface soil stripping or shielding around monitoring post.

Air dose rate ($\mu\text{Sv/h}$)	
	Before (Feb 2012)	After (Apr 2012)
MP-2	18.5	7.9
MP-7	83.6	9.7

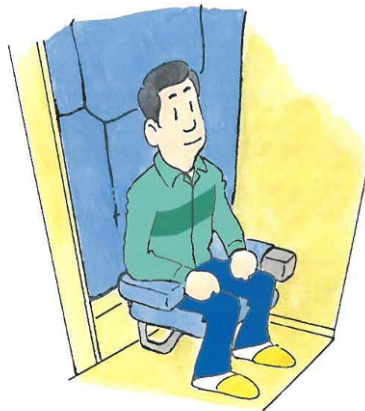
Whole Body Counter (WBC)

Fukushima Daiichi: 4 units
(1 for spectrometry analyses)
Fukushima Daini: 4 units
(1 for spectrometry analyses)

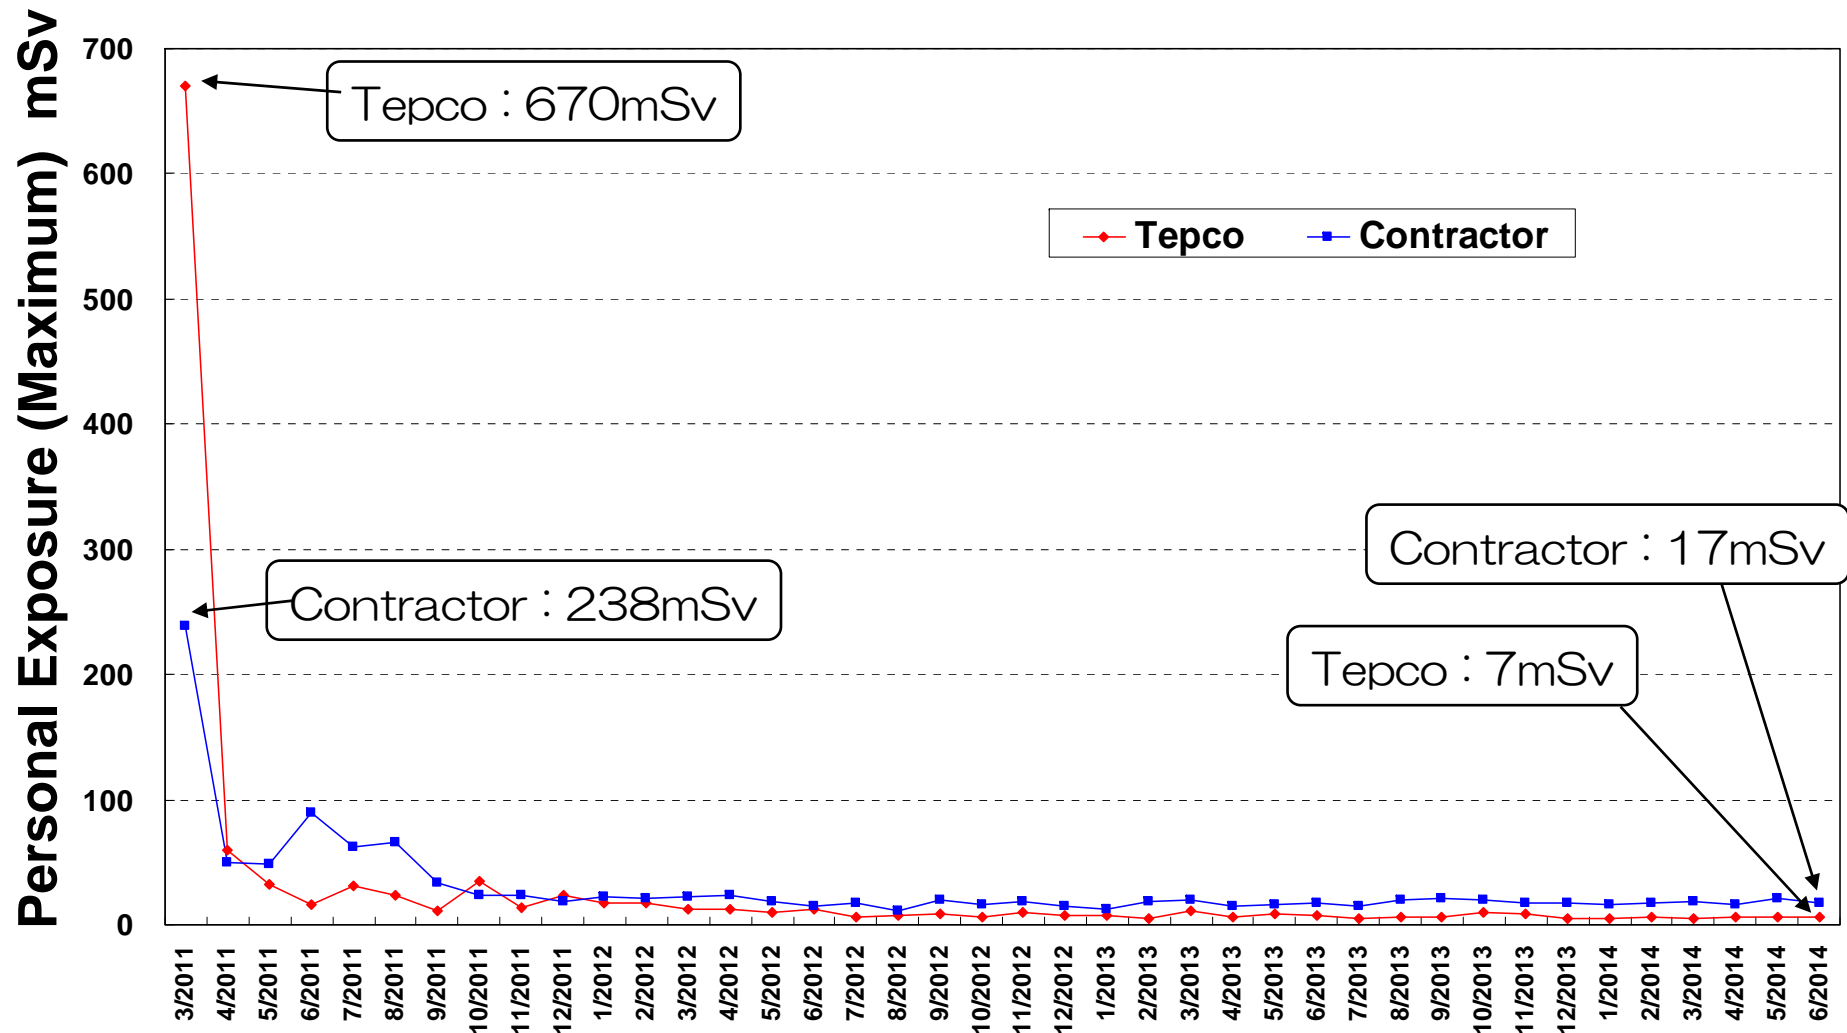
Worker's exposure dose (Maximum value of the month)

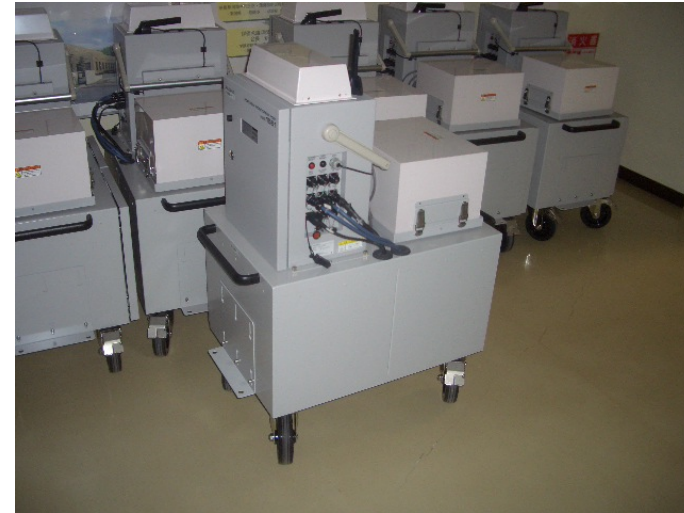
Portable monitoring posts

- Adding portable monitoring posts
- Reinforcing the power supply of monitoring posts (emergency generator)
- Reinforcing the transmission system of monitoring posts (satellite antenna)

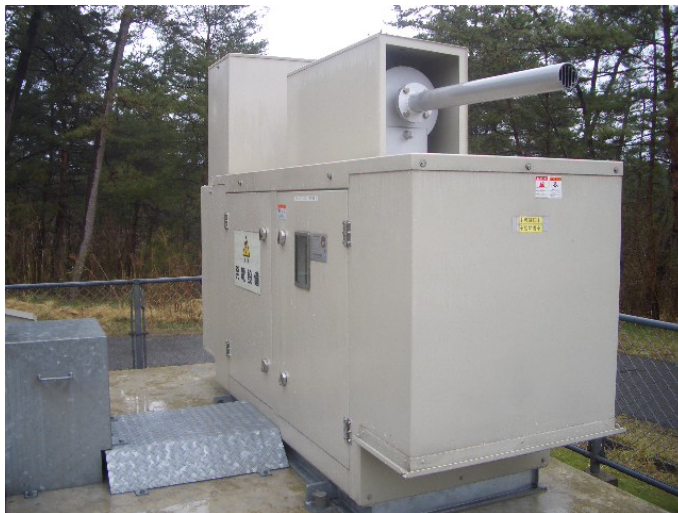
Generator to backup power supply to monitoring posts

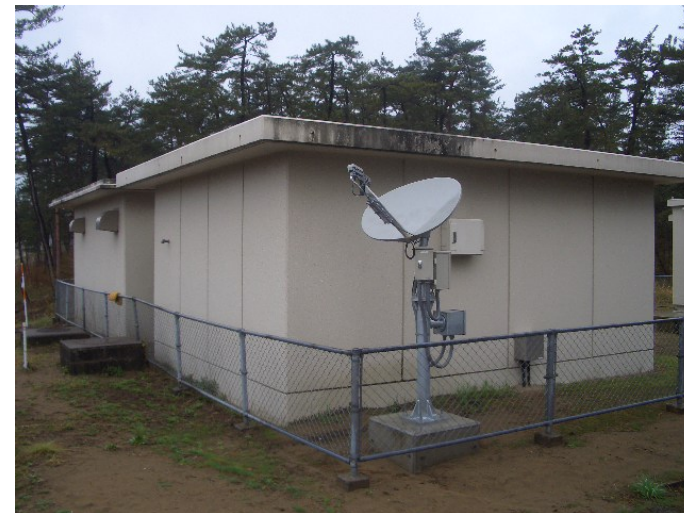
Satellite antenna for monitoring posts

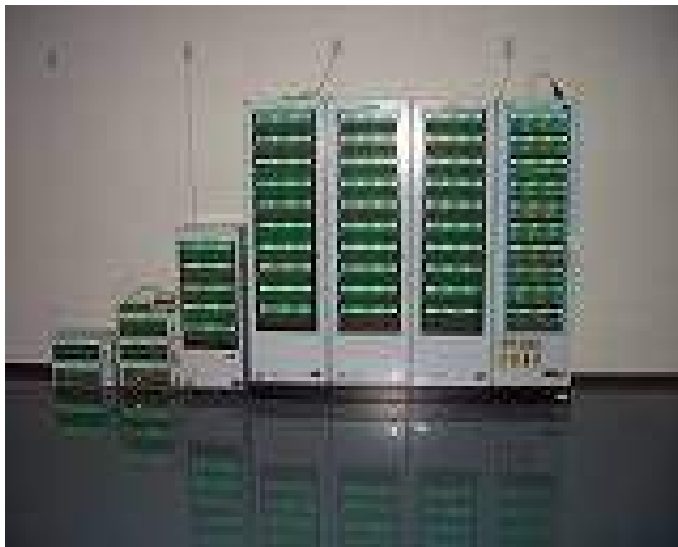
APD 120→500 units

- APDs are added to the important anti-seismic building (120 units→500 units).
- (March 2012) 7 units of APDs are installed in each MCR.
- A simple access control system is deployed.
- Radiation protection equipment for 8 days are stored for restoration staff.

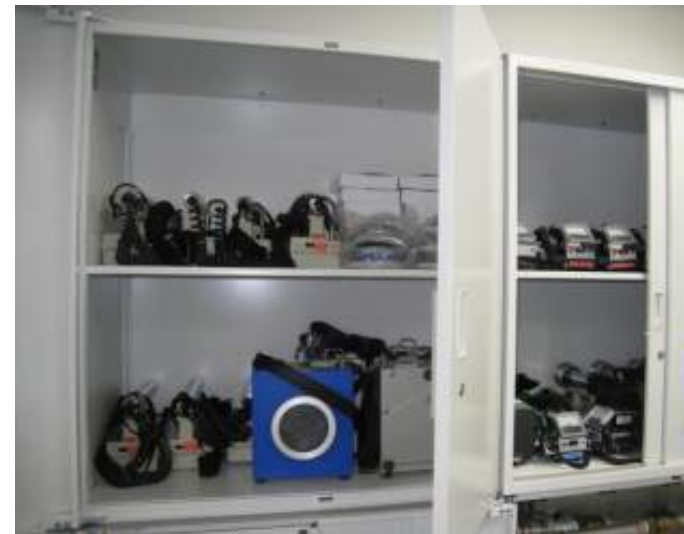
Radiation control materials/equipment

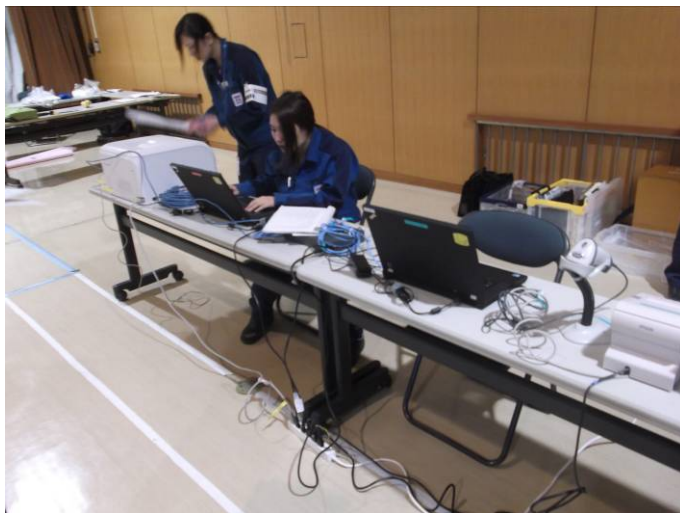
Training to setup access control area

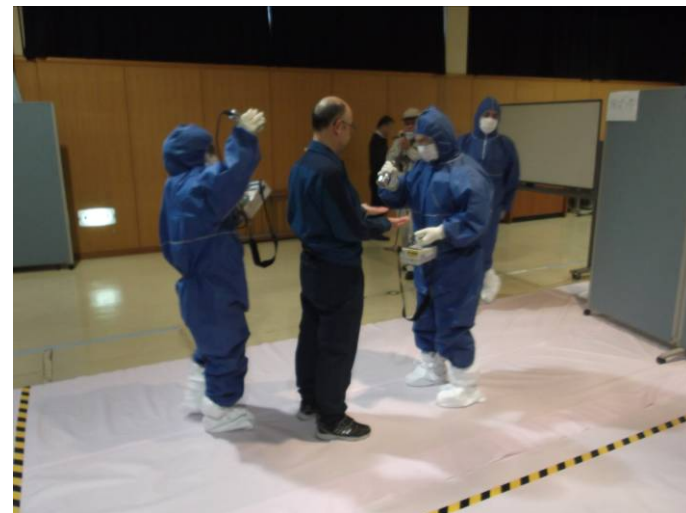
Training of setup screening area

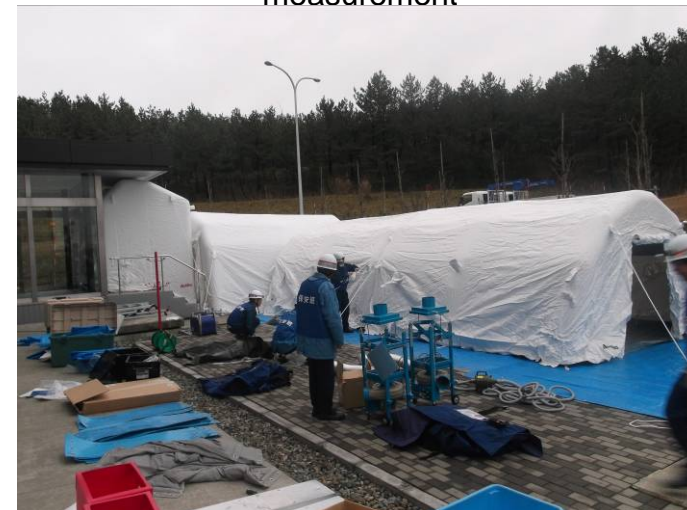
Training to setup screening area at emergency response room
