ISOE NEWS

ISOE News No.17, September 2011

Fukushima Dai-ichi Nuclear Accident

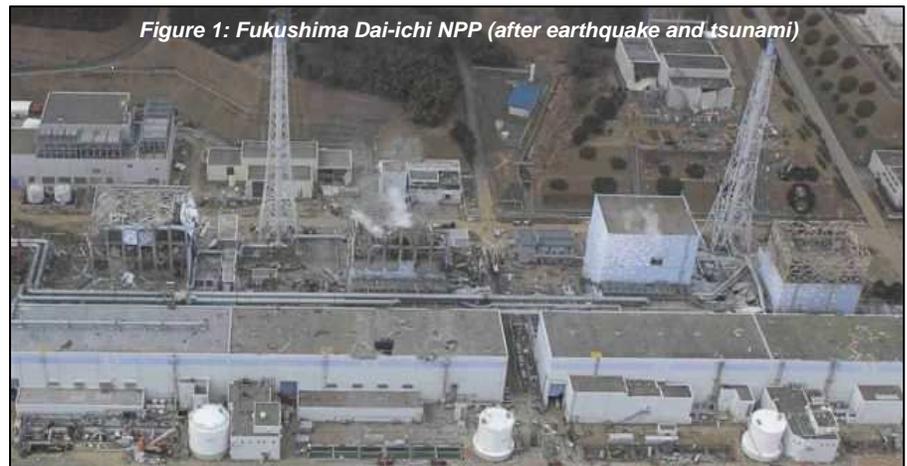
Figure 1 shows crippled Dai-ichi NPP Units 4-3-2-1, from left to right. During the early hours of the accident, core meltdown happened in Units 1, 2 and 3, as they were in operation before the earthquake. It is assumed that most of the radioactive noble gases were released from the damaged reactor cores to the atmosphere and about 10 % of iodine-131 and cesium-137 (from Japanese SEEDI -*Radiation Dose from Plume Release in Nuclear Accident*- software results) or at least 1 % (from TEPCO report). Unit 4 was not in operation due to outage but it is assumed that hydrogen generated in Unit 3 leaked through the connection piping of gas treatment system to the ventilation stack exhaust, and a hydrogen explosion also damaged the roof of Unit 4 reactor building.

conduct their preparation in the response headquarters established in the quake-proof building (main anti-earthquake building located at the site in the direction of the upper right corner of Figure 1), and that distribution of APDs and recording of doses were performed in this building.

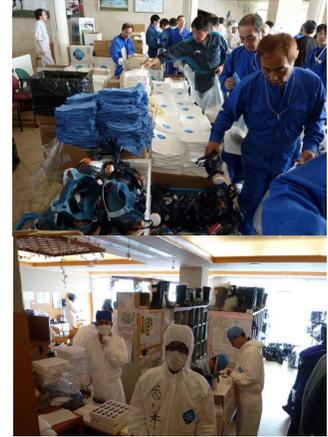
Figure 3: Arrangements for workers at J Village

Shortly after the accident from March 17, J Village, a soccer training facility located at a point about 20 km south of Fukushima Dai-ichi NPP, was utilized as a place for preparing workers for entry into Fukushima Dai-ichi NPP, where they put on their protective equipment, and performed decontamination tests when leaving, etc (Figures 2 and 3).

Due to the high concentration of radioactive materials over the entire site of Fukushima Dai-ichi, TEPCO requires workers to wear Tyvek and other protection clothes, gloves, and protection masks. It also requires appropriate protective clothes (anoraks, etc.), rubber gloves, and shoe covers taking into consideration weather conditions and contamination levels of the work sites (Figure 3).

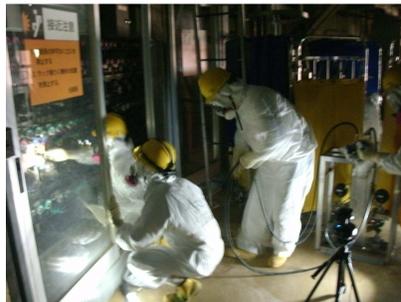
Figure 5: Temporary indicator set-up at Unit 2

Figures 4 to 6 show workers engaging in supportive radiation work, temporary indicator set-up at Unit 2 and installation of a shielding wall at the same unit.

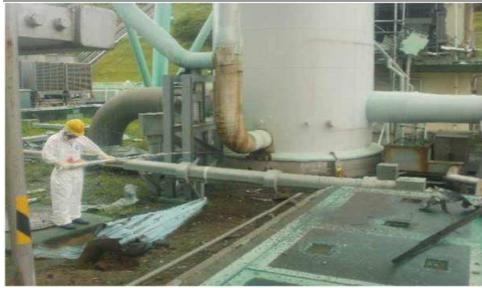
Figure 10: Measuring hot spots

At the beginning of August, two localized very high radiation fields were identified in the range of 10 Sv/h. Figure 10 shows a RP worker taking measurements of high dose area at the main exhaust tower between Unit 1 and 2, the location of the stack drain pipe. At the bottom of the stack drain pipe the dose rate was measured by telescopic detector to be 3,6 Sv/h.

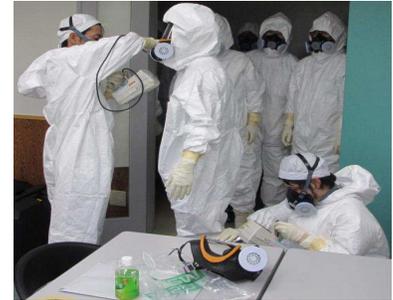
Figure 14: Training of radiation workers

From August 16, TEPCO introduced a system which can output radiation exposure data on receipts and at the same time automatically acquire individual radiation exposure data of workers. Protective equipment appropriate to the work environment is provided to workers in order to improve safety during radiation related work, such as air filtering personal protection suits and masks (Figure 14).
