Critical Surveys

Innovations are Alive and Well in Radiation Protection

**Bob Hite - RP, Chemistry, Environmental Director
American Electric Power - Cook Nuclear Plant**

**ISOE ALARA Symposium
January 13-15, 2014**

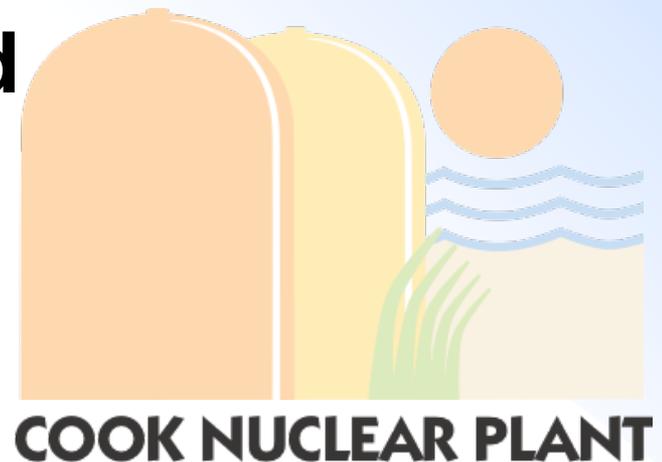
U1 E RHR Hx Mid-Outage

- **Measurement info: 04-02-2013 13:38:03 (22.2 min) U1 E RHR Hx**
- **Isotopes: Co-58, Fe-59, Co-60, Sb-124, Cs-137**
- **Trace amounts of: Cr-51, Nb-95, Zr-95**

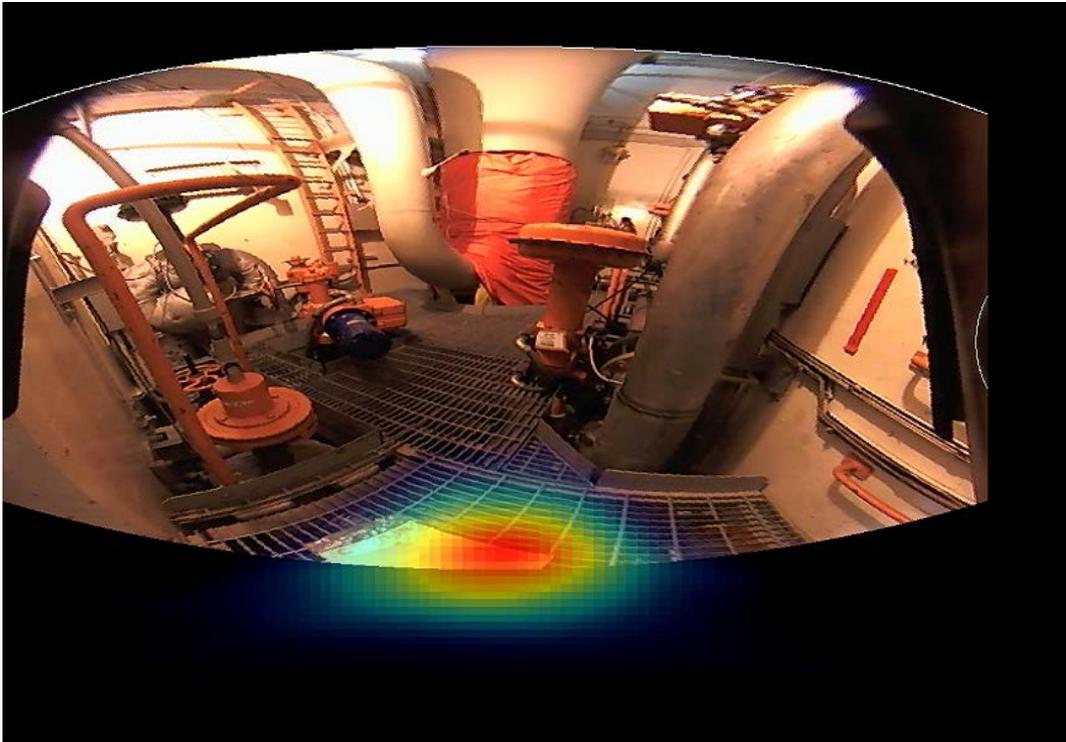
U1 E RHR Hx Mid-Outage

- **Measurement info: 04-02-2013 13:38:03 (22.2 min) U1 E RHR Hx**
- **Selected Isotopes in Post-Processed Imaging: Cs-137**

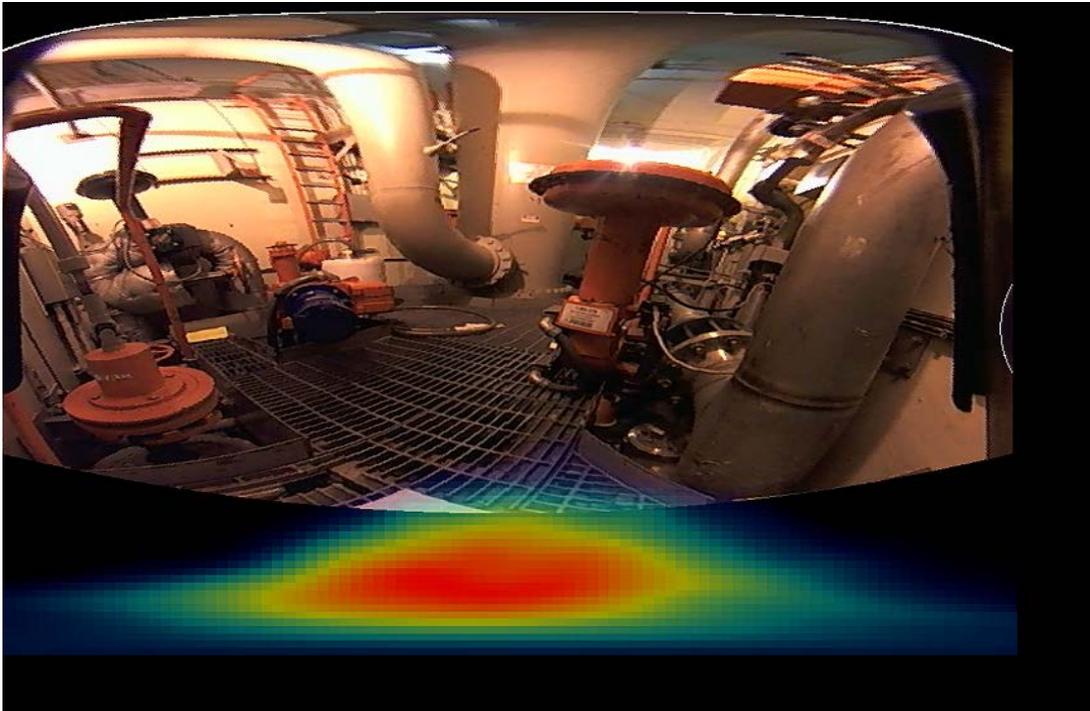
U1 E RHR Hx Post-Outage

- **Measurement info: 05-16-2013 12:36:55 (16.5 min) U1 E RHR Hx GA**
- **Selected Isotopes in Post-Processed Imaging: Cs-137**

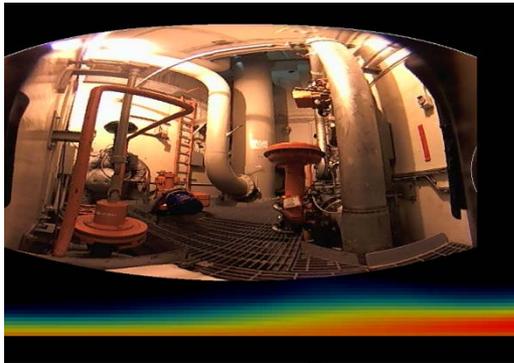
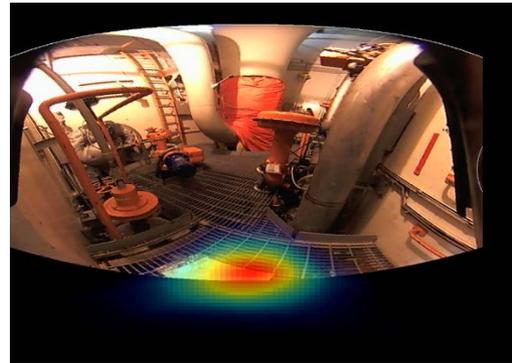
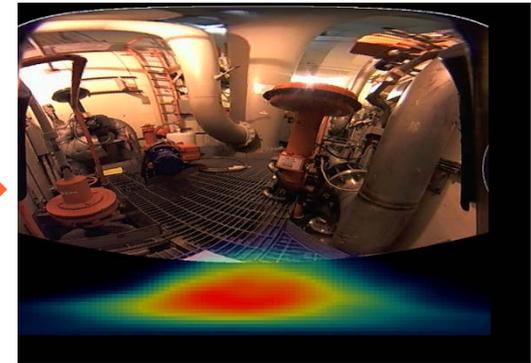
U1 E RHR Time-lapse

Cs-137

Pre-Outage

Beneath
Detector

Mid-Outage

Post-Outage

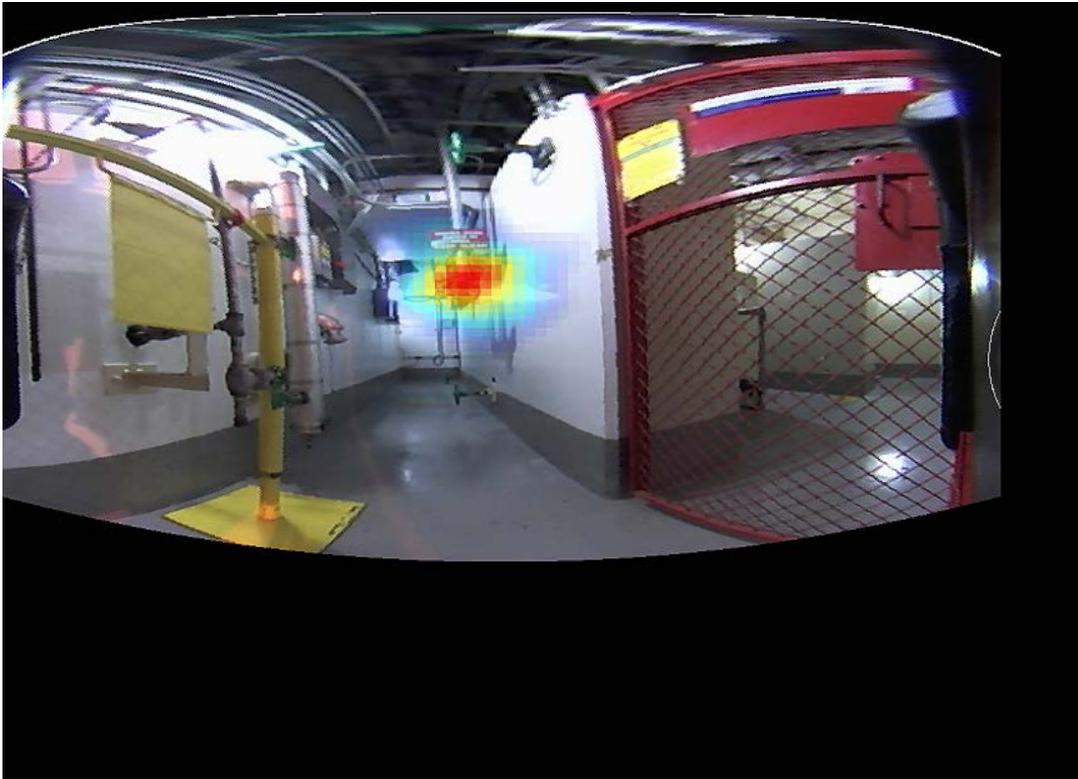
587' Aux RA

Image of the hallway next to north waste evaporator filter/pump room. It is the only RA on the 587' level that is not located in a room. Current hot spot is 60 mR/hr contact and 5 mR/hr at 30 cm. Cobalt-60 is concentrated on valve 12-WD-322 in the waste disposal system. Cesium-137 is embedded in the floor, walls and piping.

- **Measurement info: 06-03-2013 13:40:32 (11.6 min) N. Waste Evaporator Feed/Filter Pump Room**
- **Selected Isotopes in Post-Processed Imaging: Co-60**

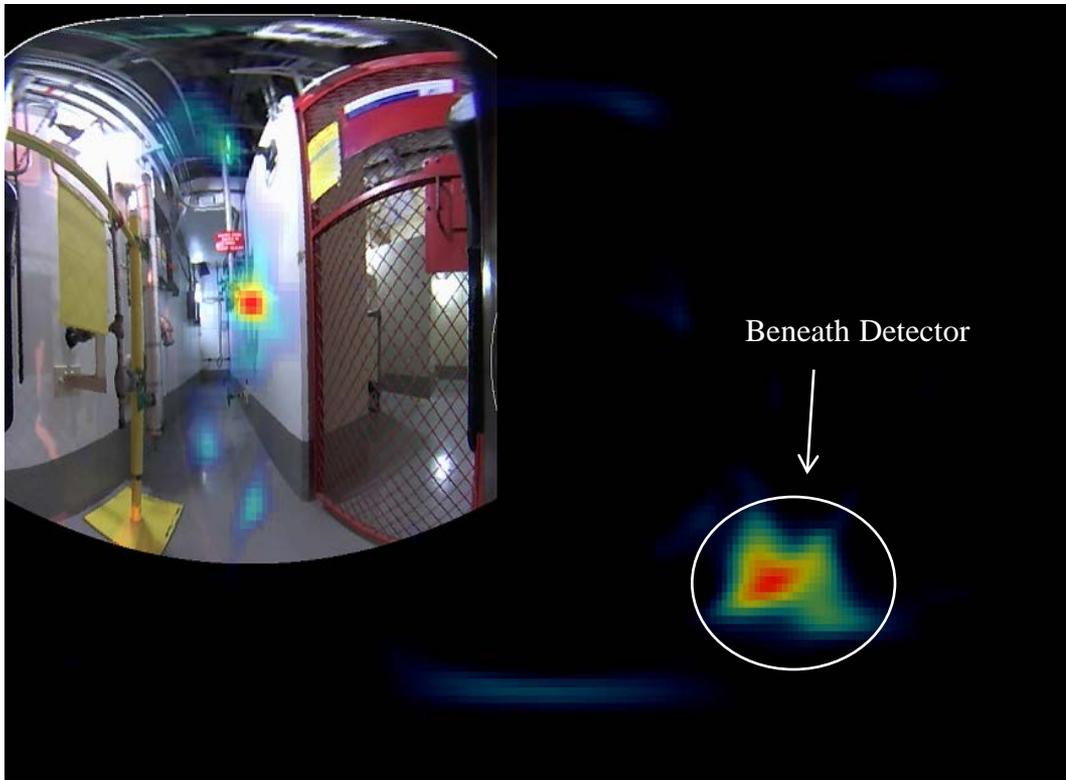
587' Aux RA

- **Measurement info: 06-03-2013 13:40:32 (11.6 min) N. Waste Evaporator Feed/Filter Pump Room**
- **Selected Isotopes in Post-Processed Imaging: Cs-137**

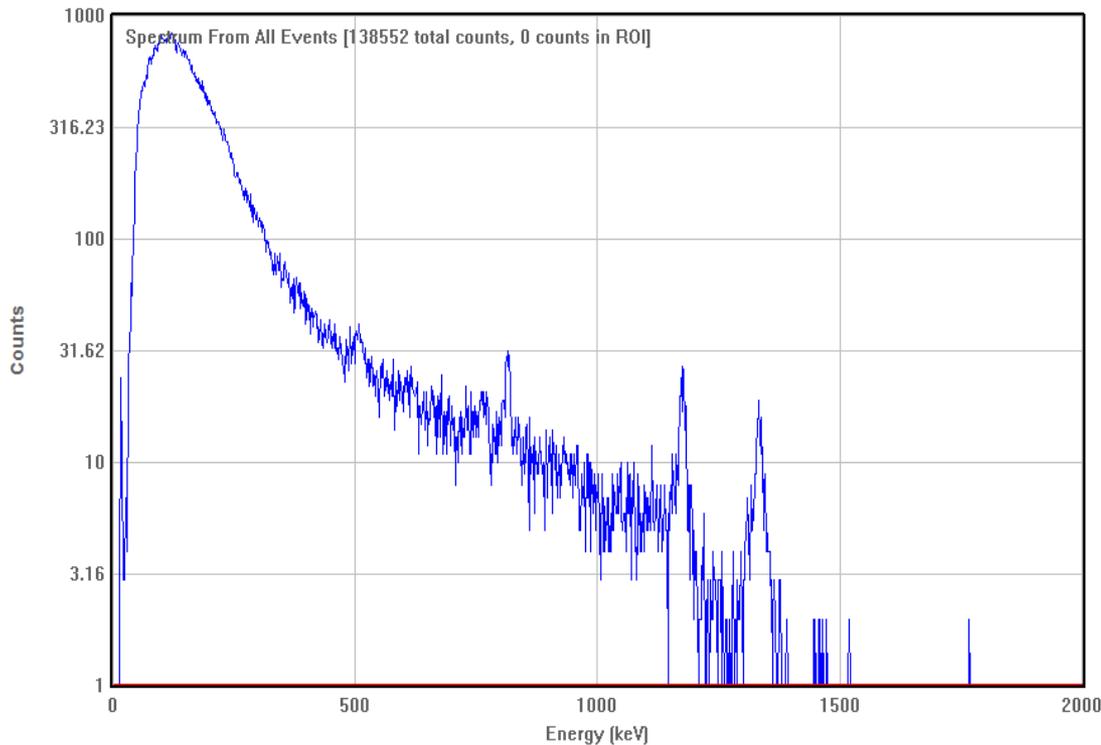
650' Aux Building

120,000 ccpm personnel contamination occurred in a “clean areas” on the 650’ aux building. This measurement located areas for follow-up smears by RP technicians. Two 2,000 ccpm particles and one 140,000 ccpm particle were found and removed.

- **Measurement info: 05-20-2013 15:24:09 (30.5 min) 650' Elevation O/S Vital Area**
- **Isotopes: Co-58, Co-60**
- **Trace Amounts of: Nb-95**

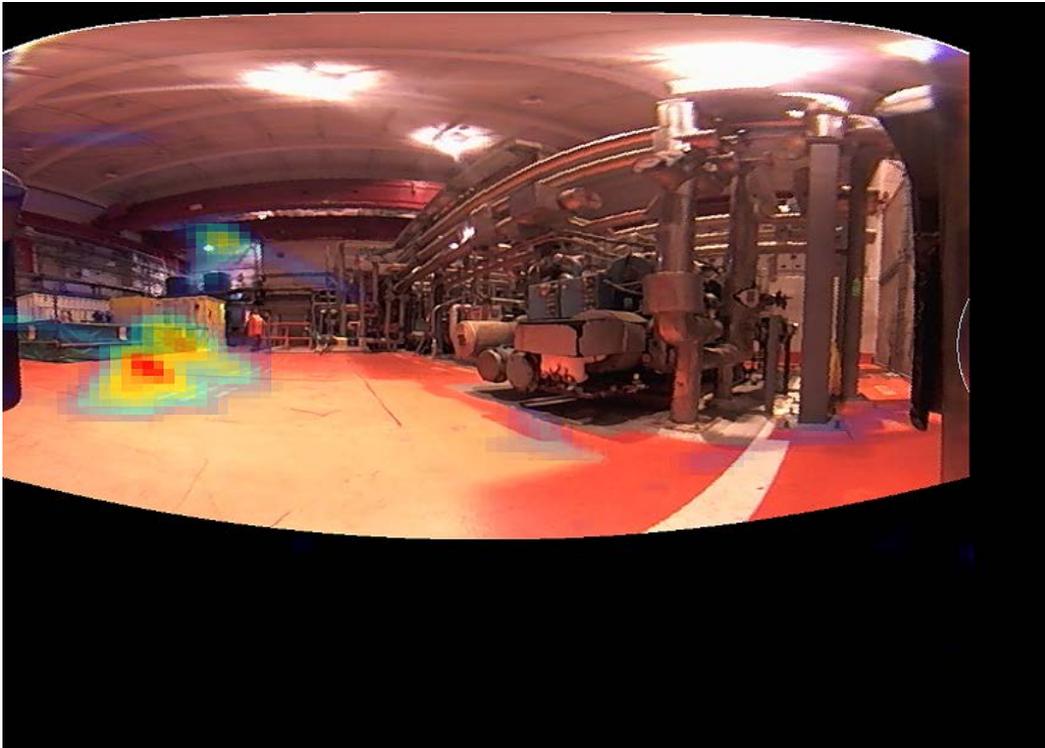
650' Aux Building

- **Measurement info: 05-20-2013 15:24:09 (30.5 min) 650' Elevation O/S Vital Area**
- **Selected Isotopes in Post-Processed Imaging: Co-58**

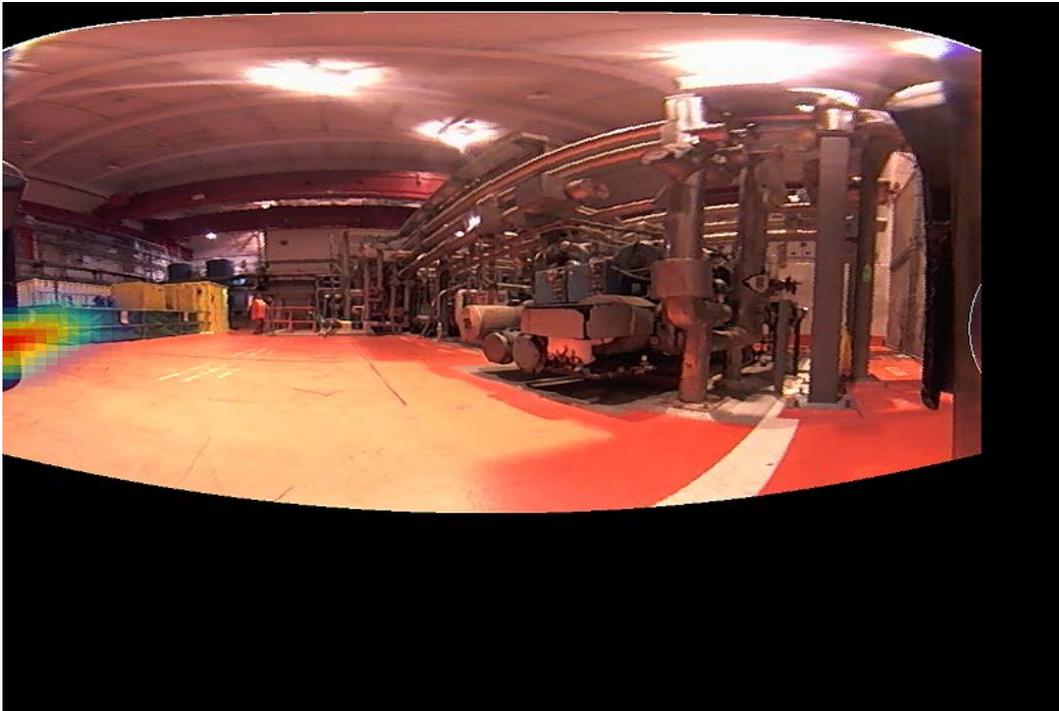
650' Aux Building

- **Measurement info: 05-20-2013 15:24:09 (30.5 min) 650' Elevation O/S Vital Area**
- **Selected Isotopes in Post-Processed Imaging: Co-60**

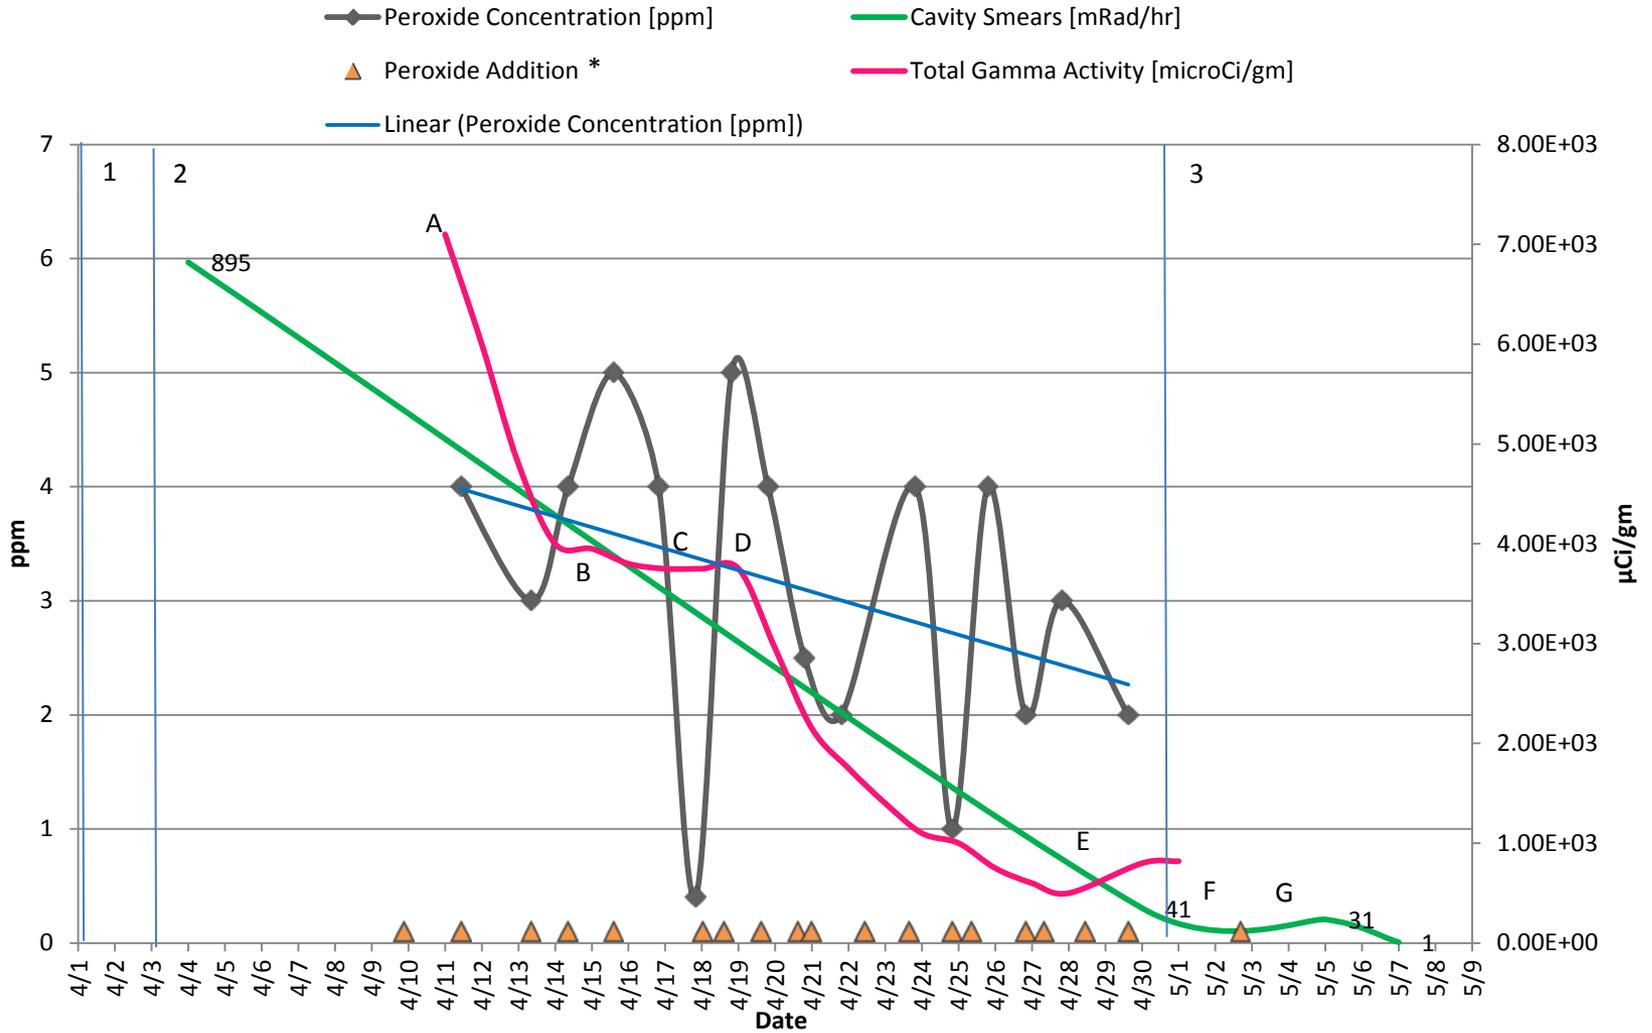
Total Gamma Activity - Reactor Cavity/Refuel Canal 1

- **Reactor cavity clean using peroxide addition and recirculation of cavity water through the spent fuel pool demineralizer using PRC-01 resin was effective**
- **See Graph**
